# CLIMATE RESILIENCY ACTION PLAN

CHIGNIK BAY TRIBAL COUNCIL  
Chignik Bay, Alaska

FINAL (Revision 0)

Bristol Project No. 3222067

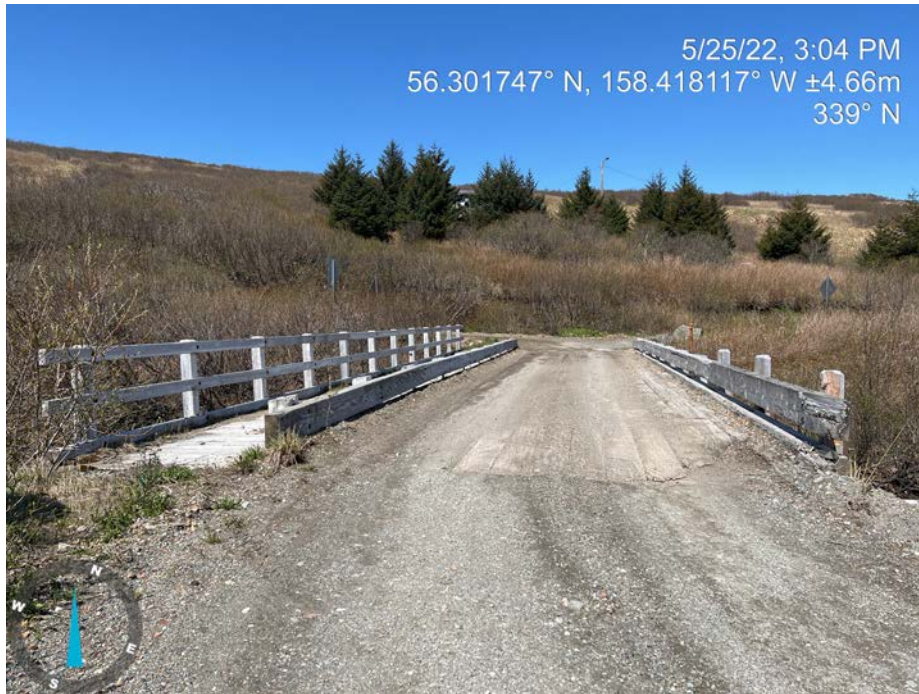
Cause of Failure (if any, date issue started):	Erosion at abutments, wear and tear from vehicle traffic
Proposed facility improvements:	Replace bridge structure components as needed
Defend in place strategies:	Stabilize areas of erosion
Alternative locations:	N/A
Other Notes:	*Wood surface decking worn down on side closest to quarry. *Some wood posts and rub rails are cracked on the surface

Damaged Decking & Rub Rails

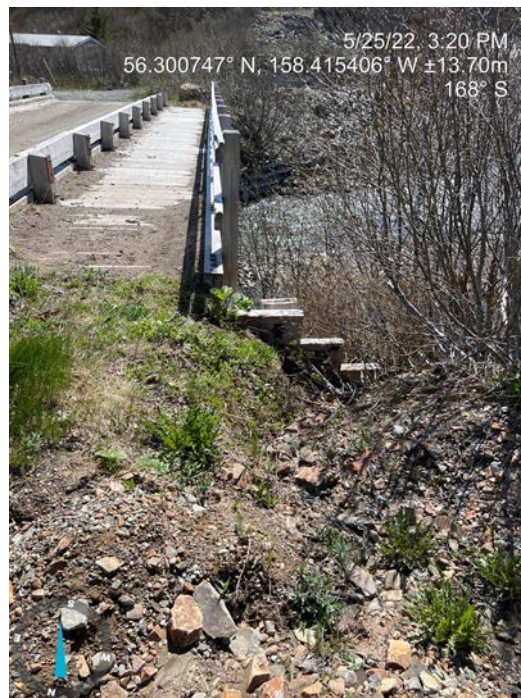
Erosion at South Abutment Wood Wing Wall

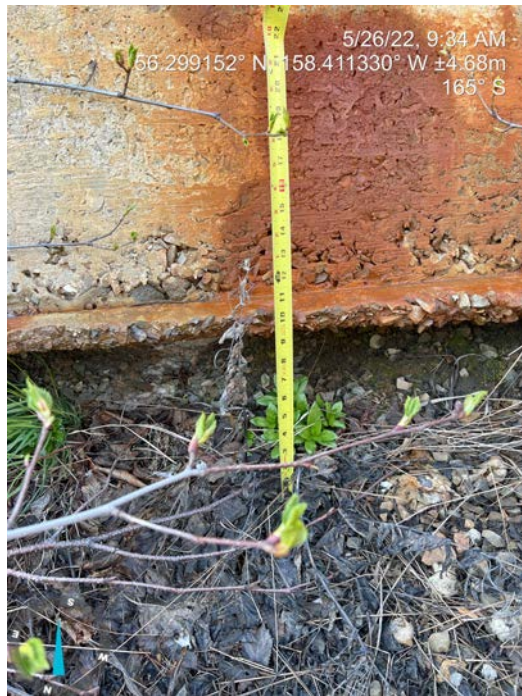
Foundation Pitting & Lack of Fill  
1 of 2

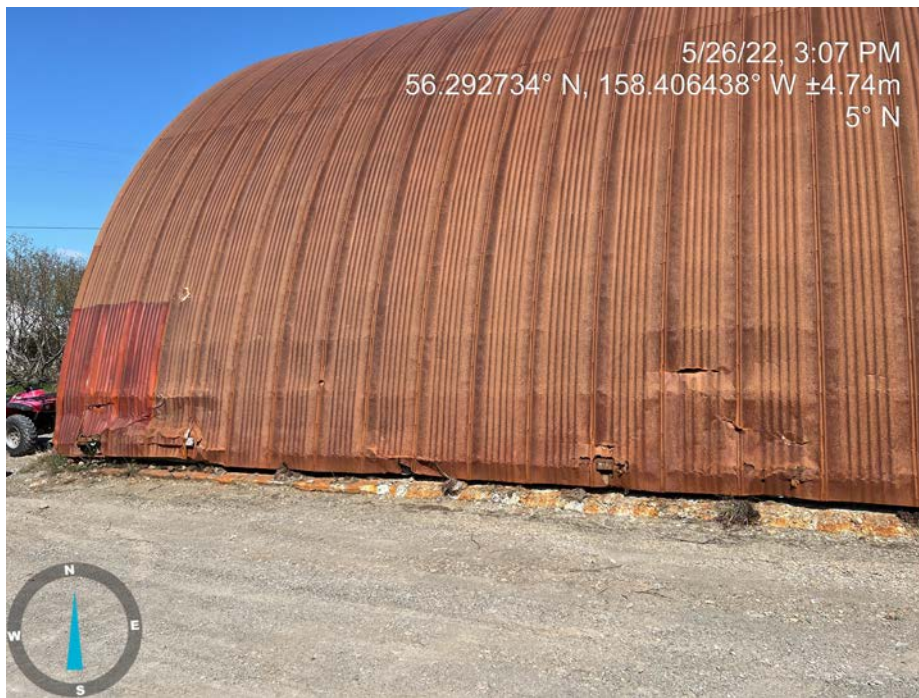
Damaged Exterior Dome  
1 of 2

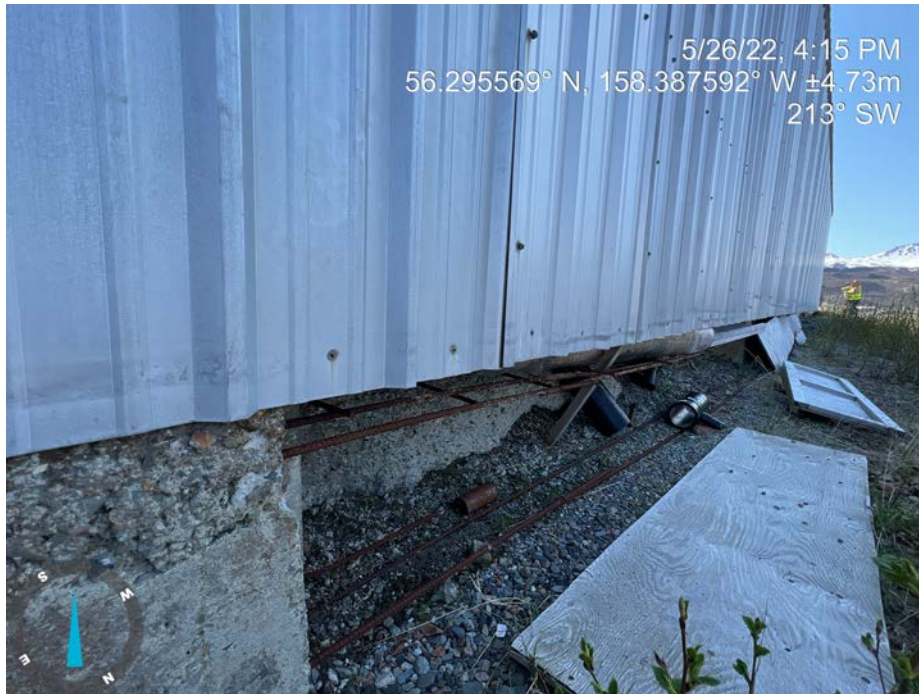
Damaged Concrete Foundation

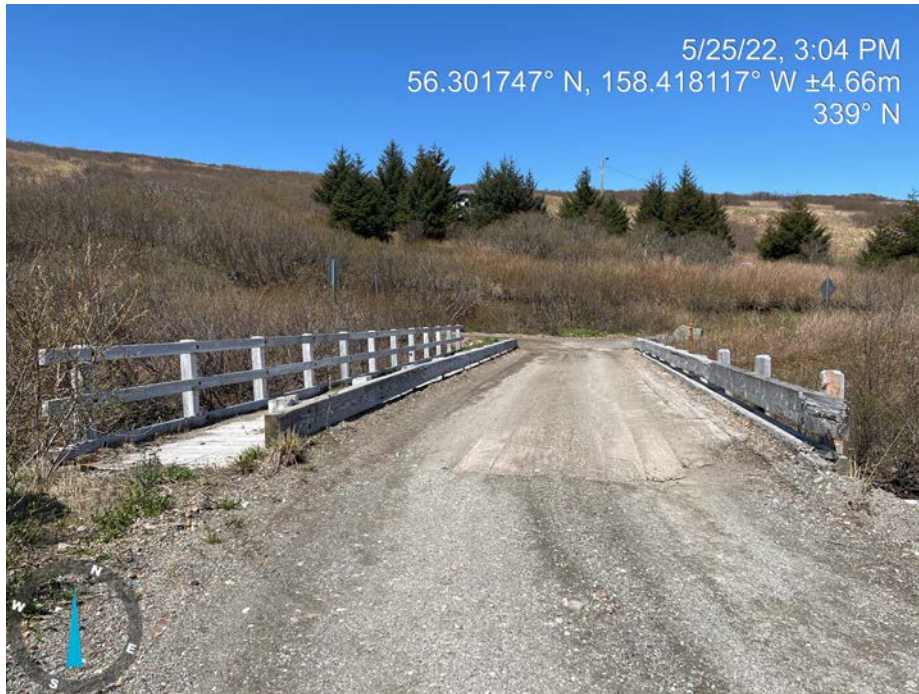
Damaged Decking & Rub Rails

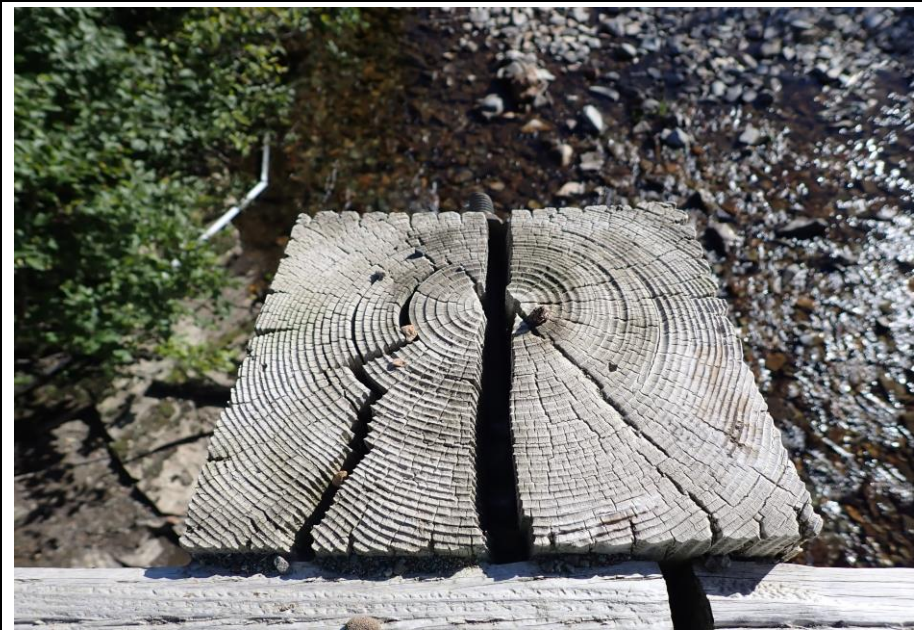
Bridge No.	1764	Br. Name	Indian Creek	Date	09/21/22
Inspector	David McAdoo / Javier De Leon		Frame	20	
Rail Post, Typ.			File	P9210415.jpg

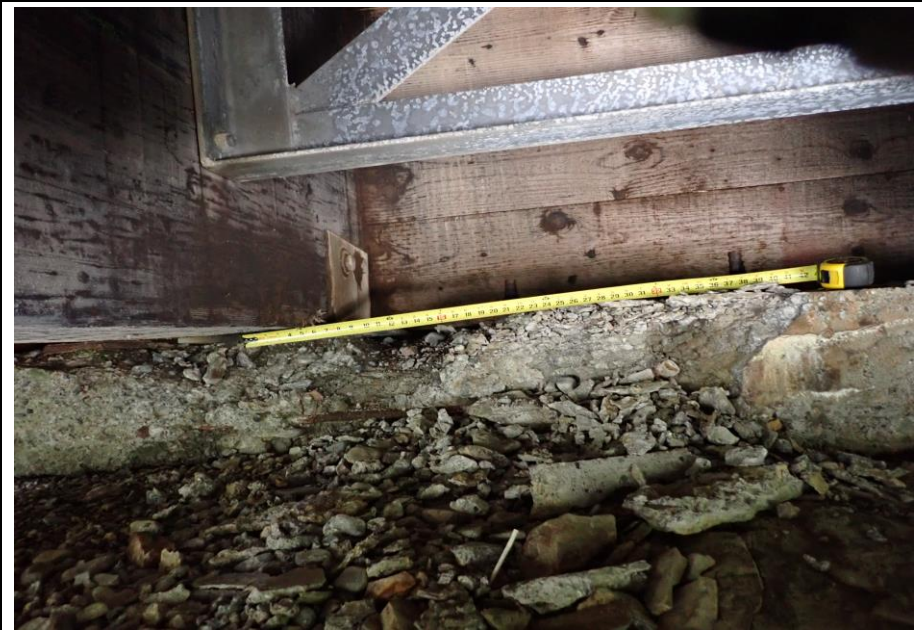
Bridge No. 1764 Br. Name Indian Creek Date 09/21/22  
 Inspector David McAdoo / Javier De Leon Frame 24  
 FE Abutment Cap Spall File P9210431.jpg

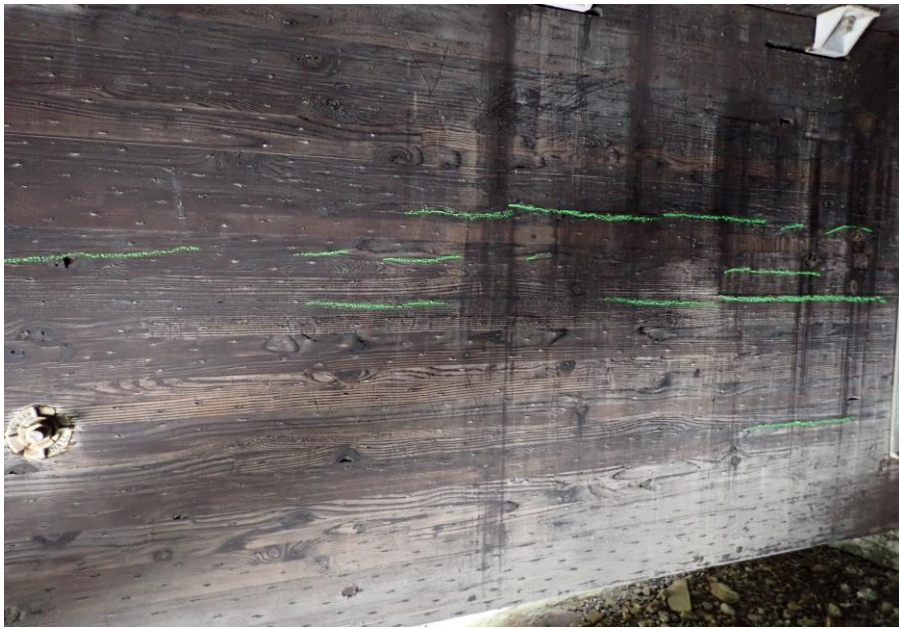
Bridge No. 1764 Br. Name Indian Creek Date 09/21/22  
 Inspector David McAdoo / Javier De Leon Frame 25  
 Girder 1 FE DS Face Splits File P9210432.jpg

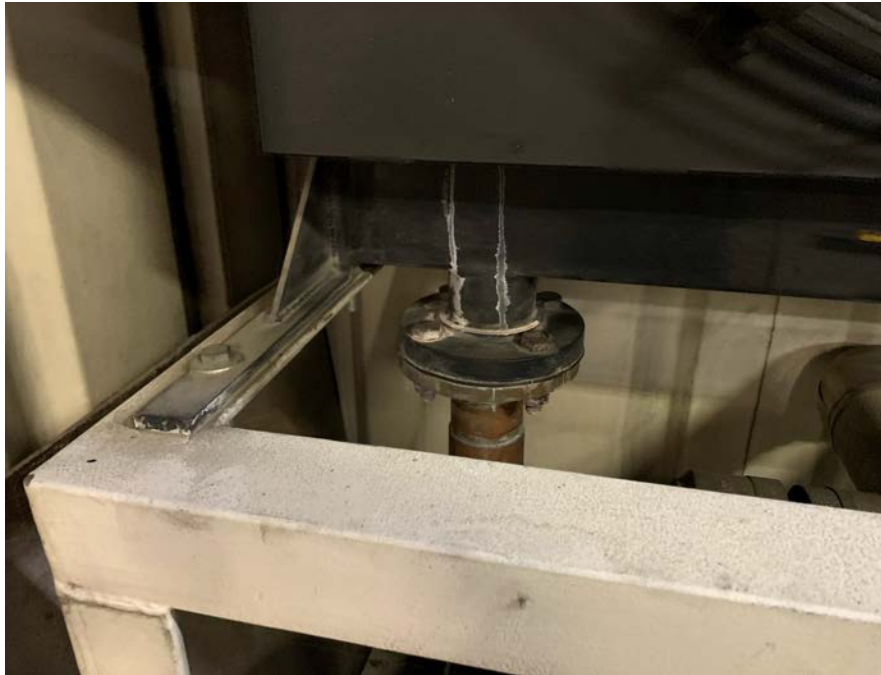
23 - Radiator Leaks

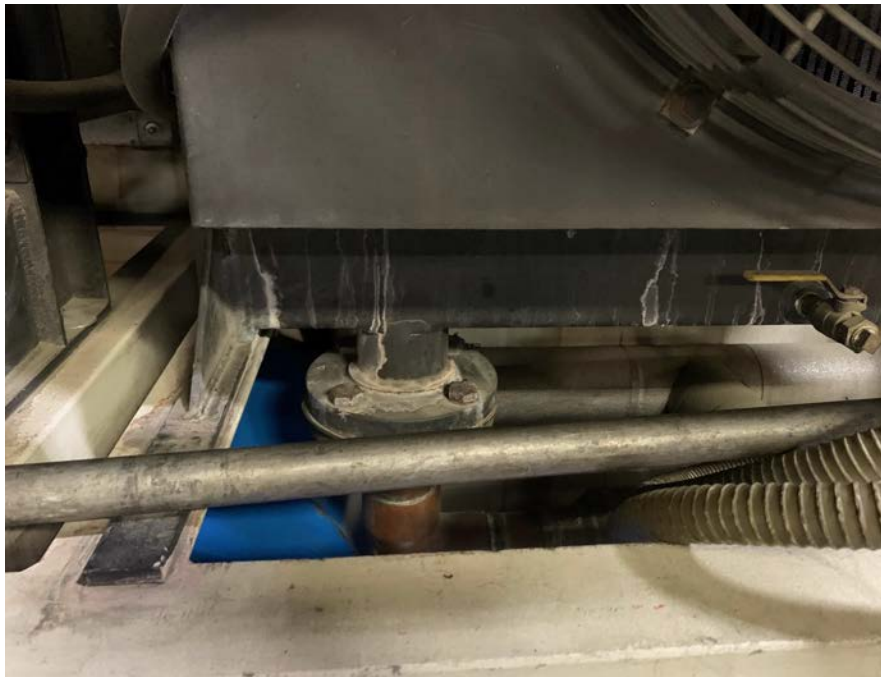
24 - Radiator Leaks

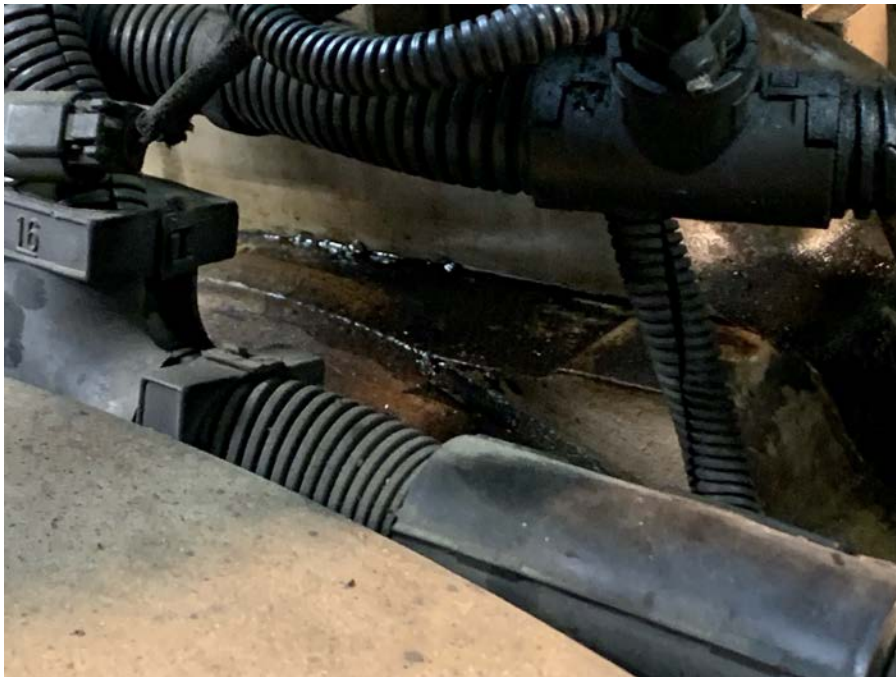
30 - #3 Engine Oil Leak

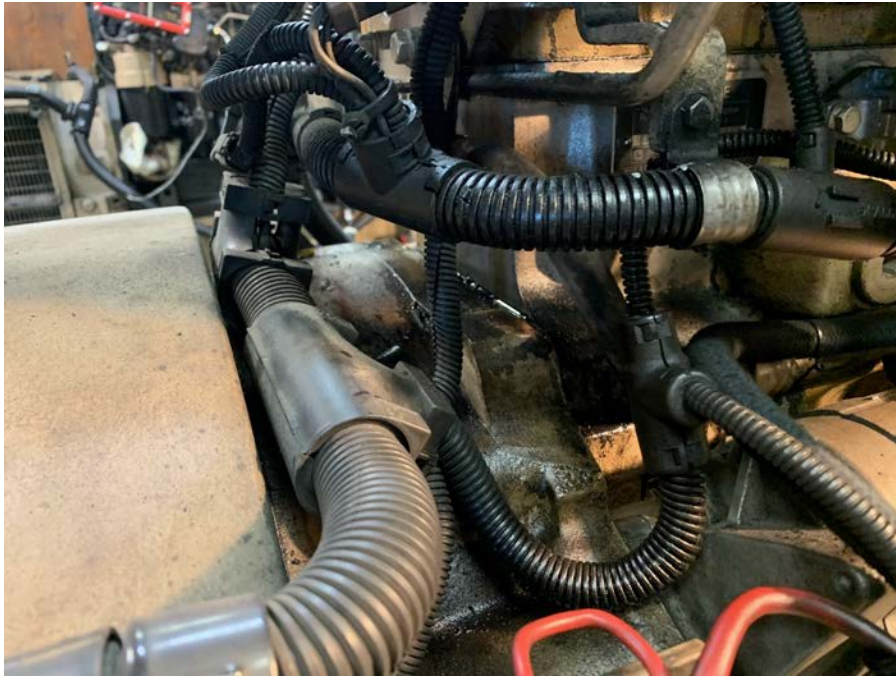
33 - #3 Engine Oil Leak

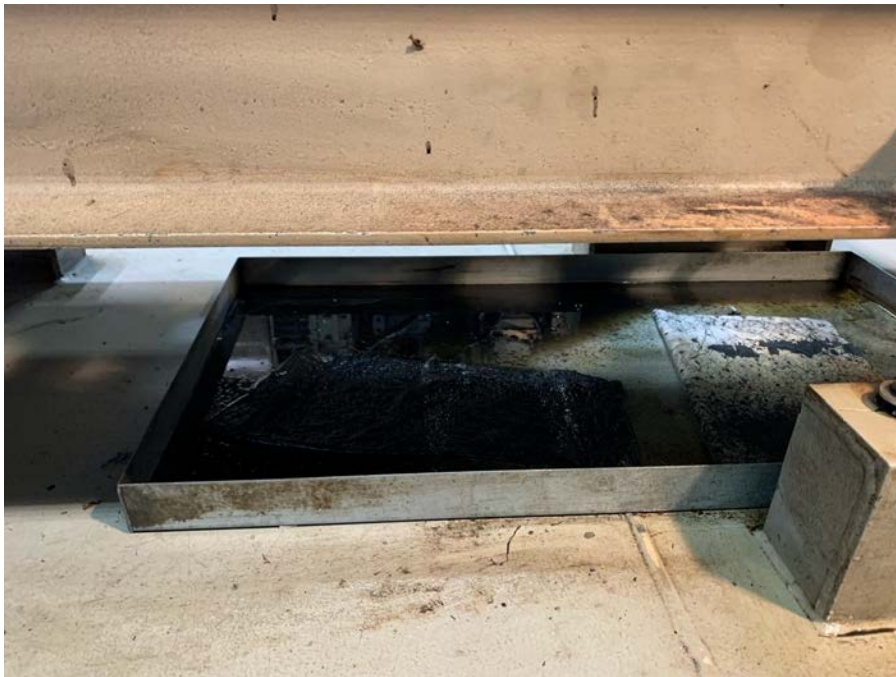
34 - #3 Engine Oil Leak

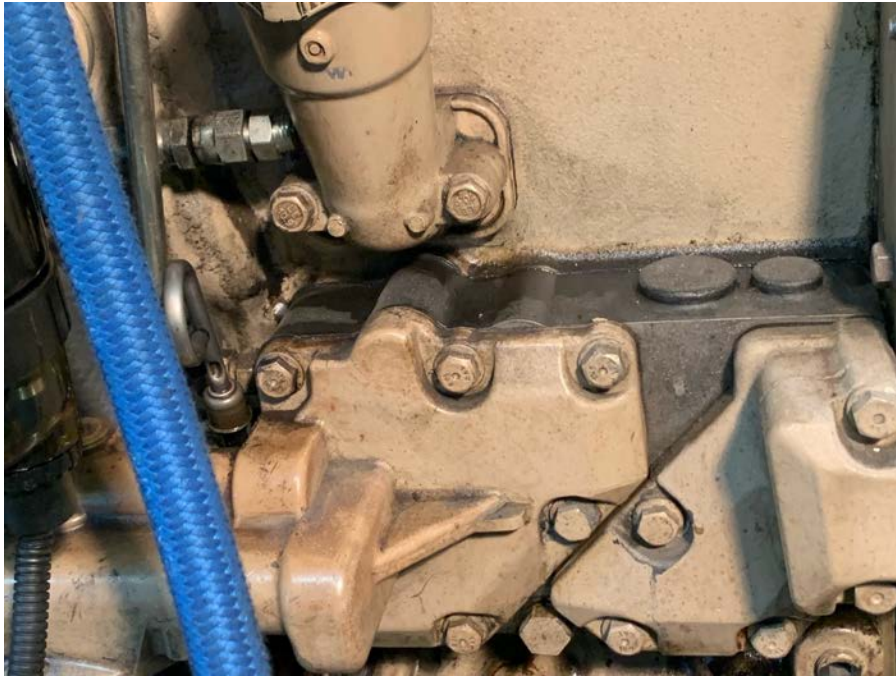
35 - #3 Engine Oil Leak

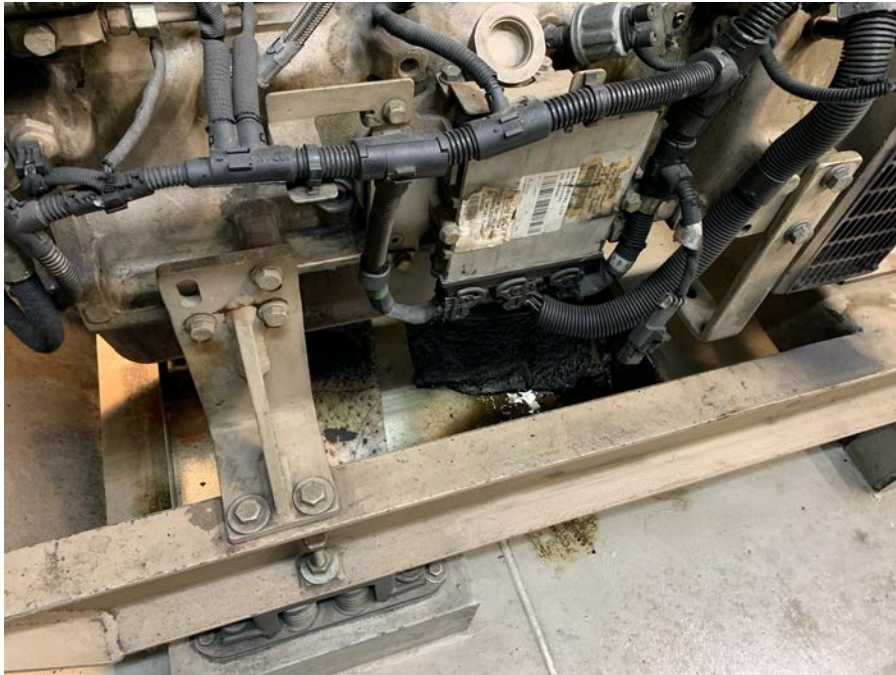
37 - #3 Engine Oil Leak
