COMMUNITY-BASED MONITORING: SHORELINE CHANGE IN SOUTHWEST
ALASKA

Jessica Ellen Christian, B.S. Marine Science

Geoscience

University of Alaska Fairbanks

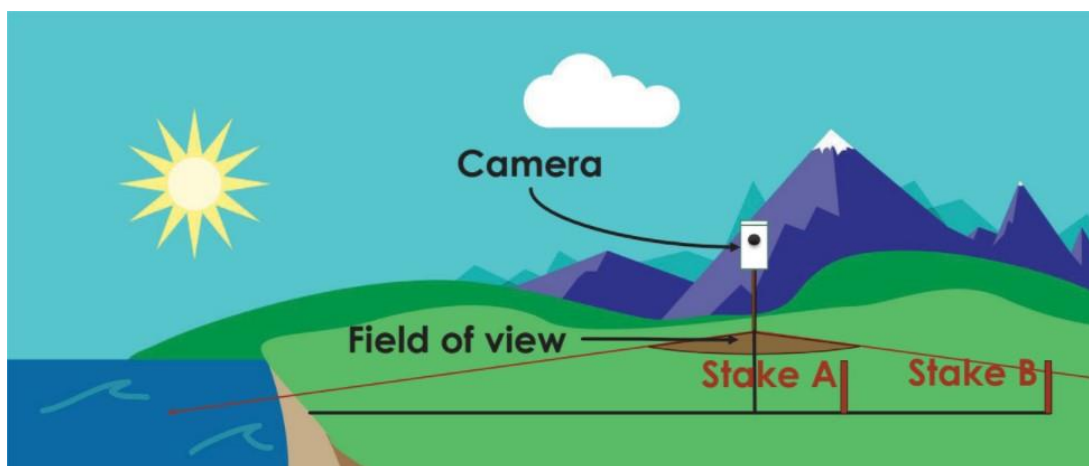
Figure 2.5 Example of time lapse camera site set up. Stakes A and B are installed near the eroding feature and make up a single transect (i.e., a line parallel to the eroding feature). A time lapse camera is installed a distance back and facing the transect to capture the two stake locations and the eroding feature in the swath of the image. Cameras take pictures hourly, and local environmental observers carry out maintenance and send in SD cards when full (from Buzard et al., 2019a).

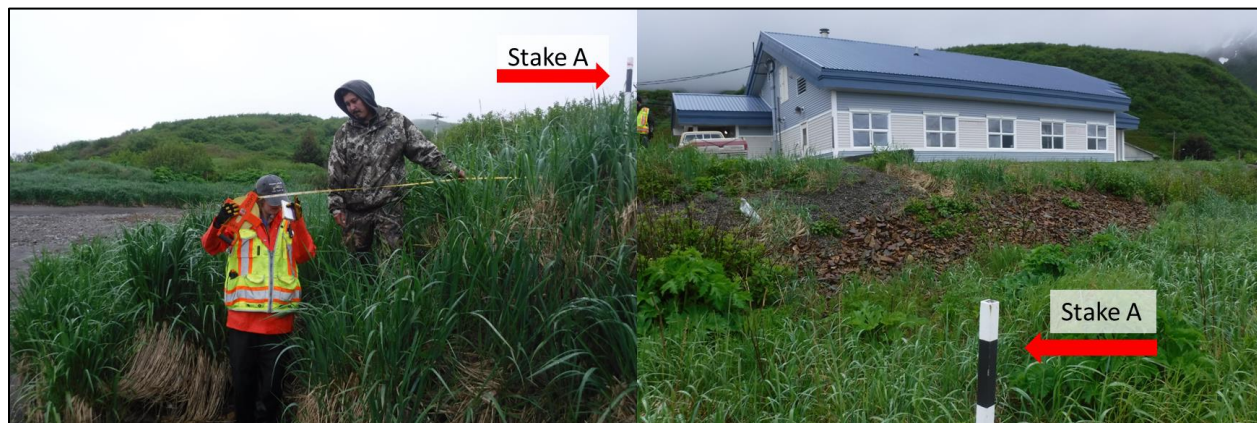
Figure 2.6 (Left) Chignik Bay environmental observer (Ed Krauss) and ACGL student (Jessie Christian) collecting stake ranging measurements at the Chignik Bay medical clinic erosion monitoring site. (Right) Stake A at transect 1, positioned in front of the Clinic on unconsolidated sediment.

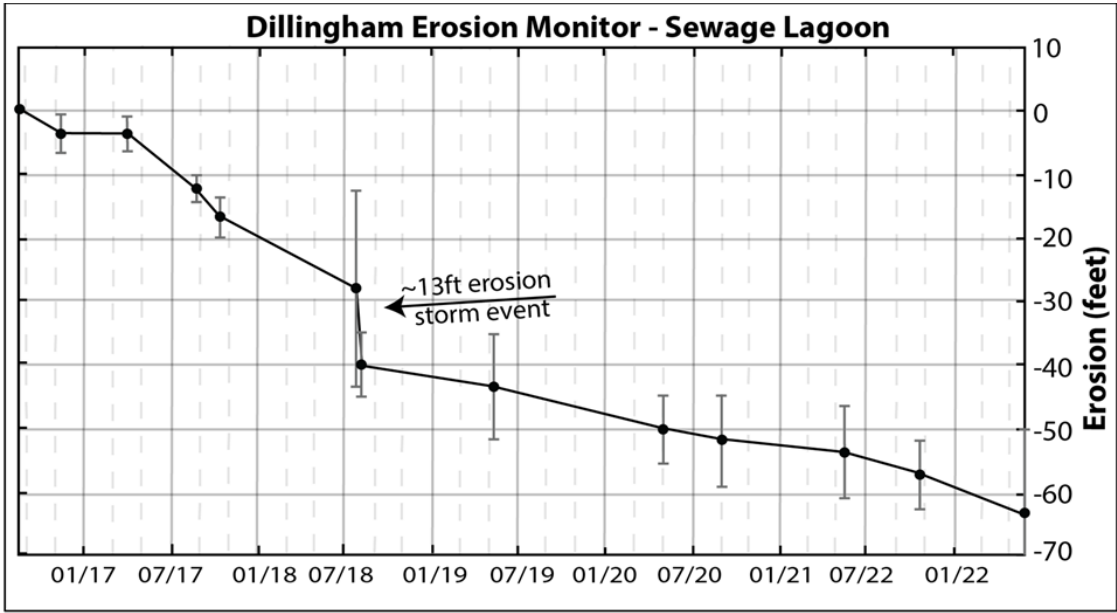
Figure 3.3 Averaged CBM stake site measurements at the Sewage Lagoon site in Dillingham, AK. Measurements were taken from 2016 to 2022 and are reported here in feet as they are delivered to community partners. The graph shows erosion distance over time. Notice the pre and post storm measurements in August 2018 that documented about 3.96 m (13 ft) of erosion in that single event.

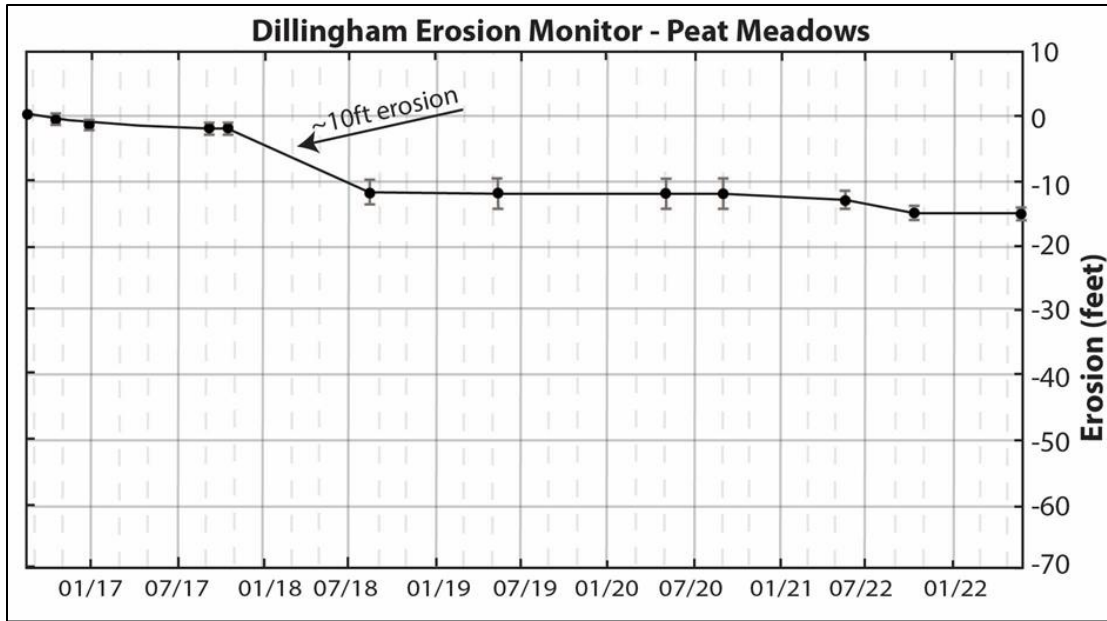
Figure 3.4 Averaged CBM stake site measurements at Peat Meadows site in Dillingham, AK. Data were taken from 2016 to 2022 and are reported here in feet as they are delivered to community partners. The graph shows erosion distance over time. The area has been relatively stable except for a sudden increase in 2018 with 3.05 m (10 ft) of erosion occurring over that year. Local observations indicate this increase in erosion was due to a series of extreme storm events.

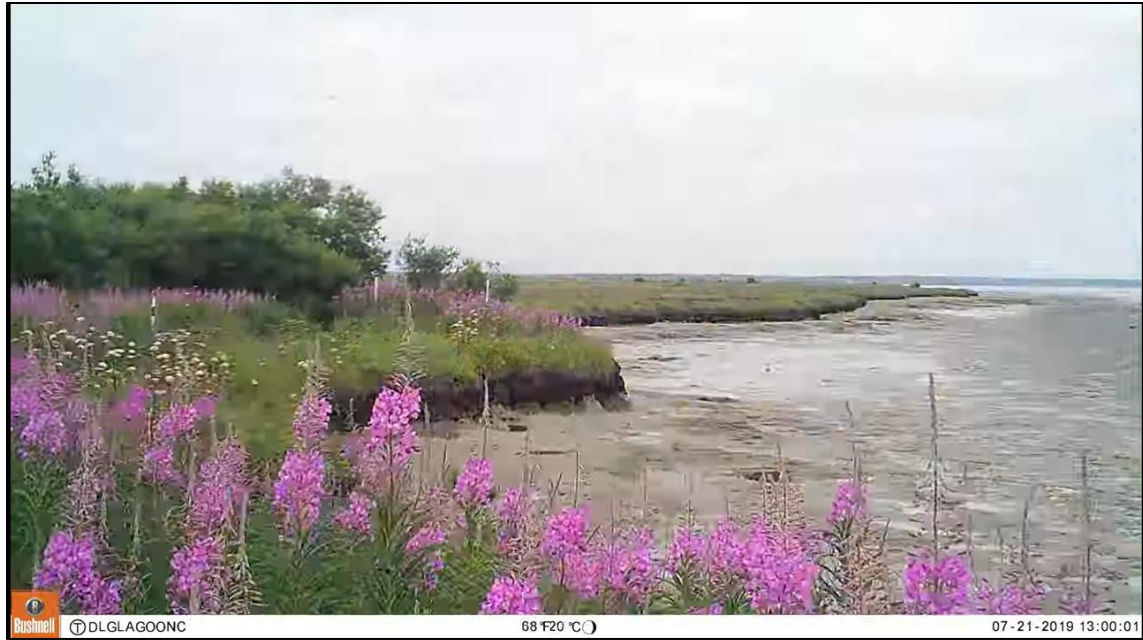
Figure 3.6 Time-lapse picture and compiled video of the Sewage Lagoon stake site. Notice white stakes in background. Images taken at Dillingham sewage lagoon from May 2019 to November 2019 make up a revealing video that documents wave action and erosion resulting from a single storm event. (URL: <https://youtu.be/M0zNXxNGhig>).

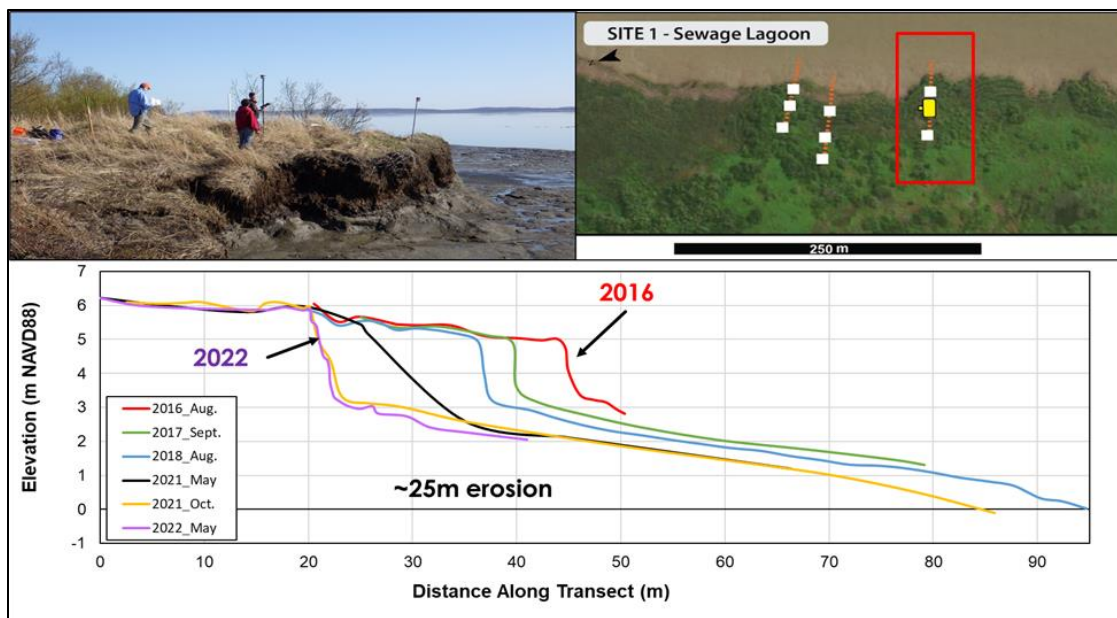
Figure 3.8 Coastal Profile 36 located at the sewage lagoon site in Dillingham, AK. (Top Left) On site image of the sewage lagoon site location. Environmental observer, Rene Roche, and ACGL scientists collecting coastal topographic profile at the location. (Top Right) Erosion monitoring site map for the Sewage Lagoon. The red box indicates which transect the coastal topographic profile was collected at. (Bottom) Data were taken from 2016 up to 2022. From 2016 (red) to 2022 (purple) there was approximately 25 m (82.0 ft) of erosion.

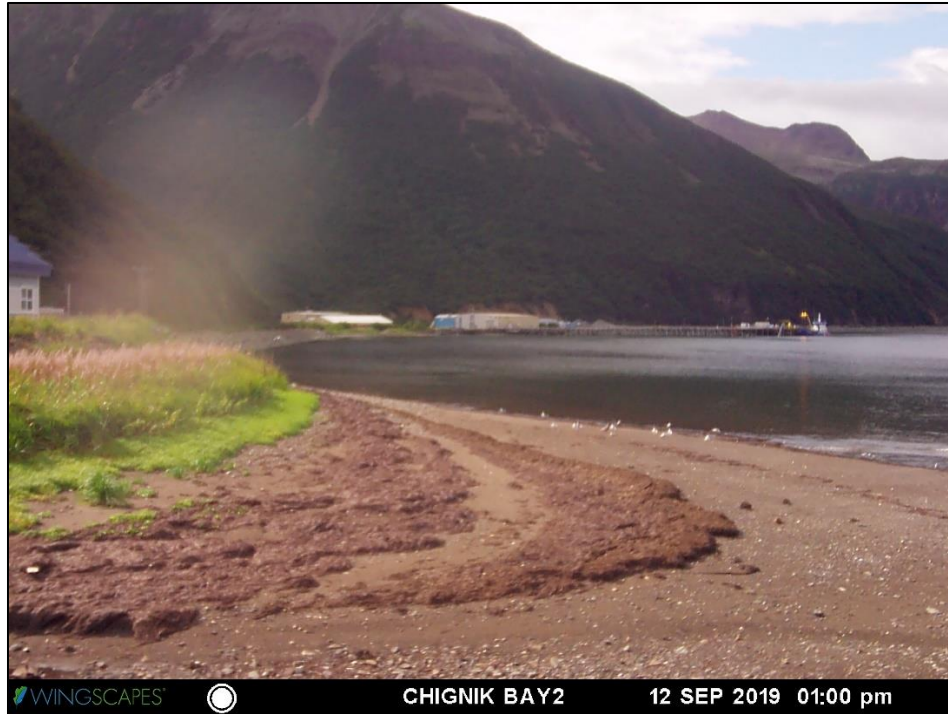
Figure 3.14 Time-lapse picture and compiled video of the clinic site. Images taken at Chignik Bay from June 2019 to May 2022. (URL: <https://youtu.be/3SjWLRm6vOw>).

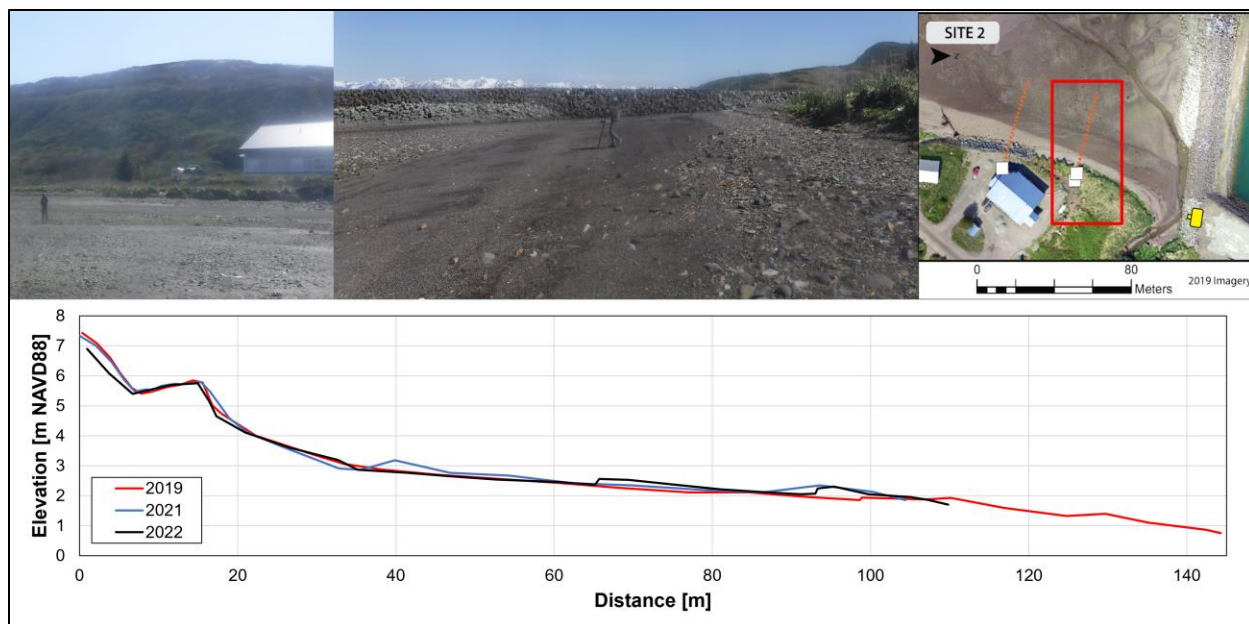
Figure 3.16 Coastal Profile 15 located in Chignik Bay, AK. (Top Left and Center) On site image of the sewage lagoon site location. ACGL scientists collecting coastal topographic profile at the medical clinic location. (Top Right) Erosion monitoring site map for the medical clinic. The red box indicates which transect the coastal topographic profile was collected at. (Bottom) Data were taken from 2019 up to 2022. From 2019 (red) to 2022 (black) there was approximately 1 m of erosion.

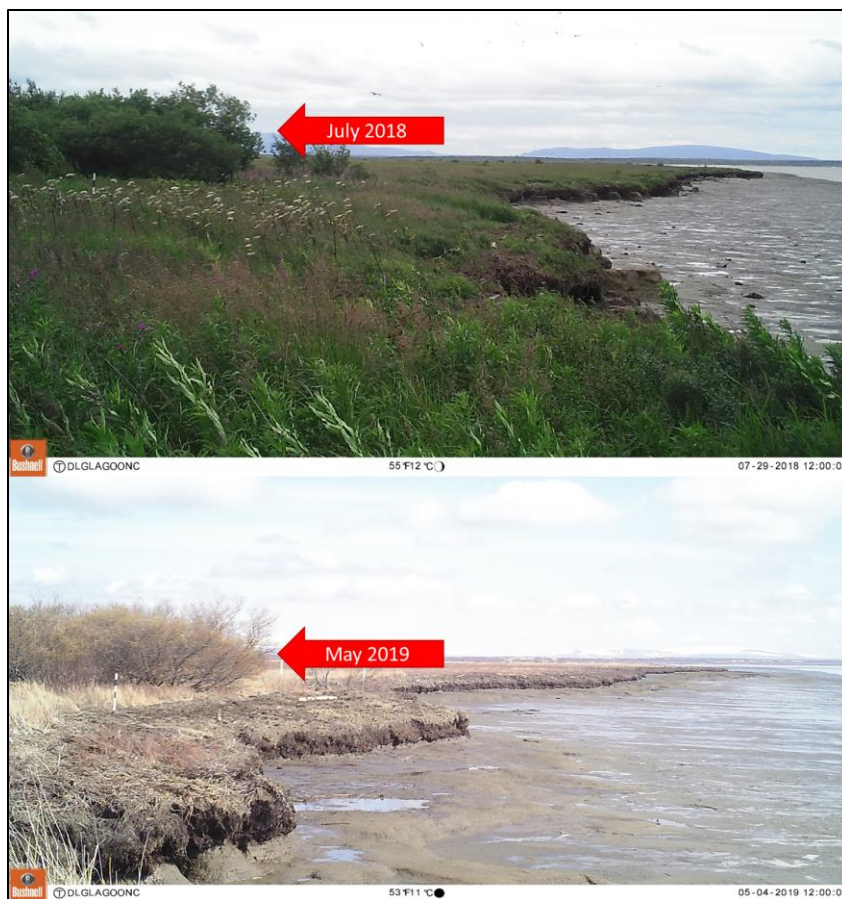
Figure 4.1 Images from time-lapse camera at Dillingham, AK sewage lagoon site. The top image was taken in July 2018. The bottom image was taken in May 2019. CBM measurements revealed 18 feet of erosion over the 10 months, with 13 feet being from one storm. Notice in the lower image the vegetation has been washed over during a recent storm event.

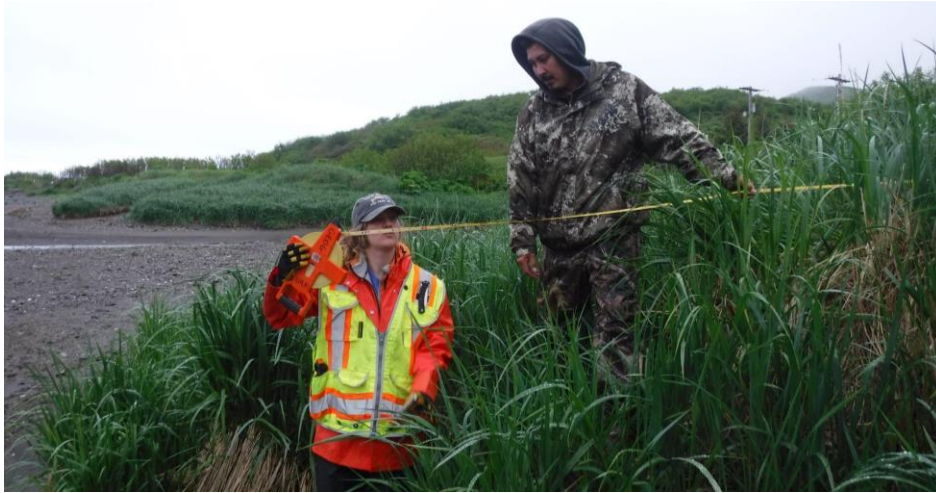
Figure 2. Example of measuring from a stake to an eroding bluff at Chignik Bay, AK.

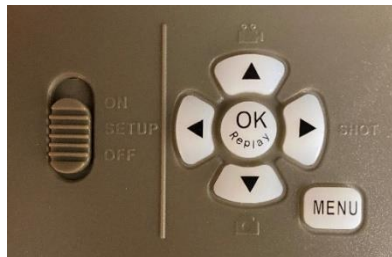
The adjacent image shows one type of camera configuration for the power and control panel. Depending on your camera this maybe be different. To the left of the line are the power options: **OFF**

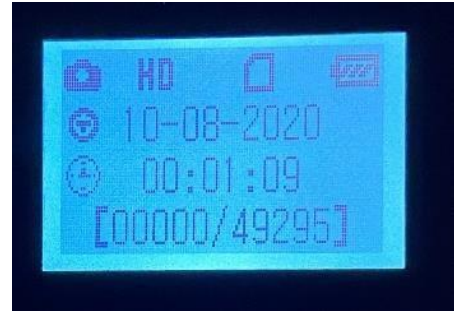
The adjacent image below is the home screen that should appear once you switch the camera to **SETUP** mode. The top right corner shows the battery level, the top right center shows that the SD card is inserted and recognized, the top left center will show the “Image Size” setting which should be set to “HD”, and the top left corner shows the “Mode” the device is set to: “Camera” mode will show the camera icon as seen above (make sure it is showing the camera), “Video” mode will show, “Hybrid” mode will show a camera with a +. Along the left side of the home screen there are two other icons; the “T” in a circle shows that “Time Stamp” is turned on. The analog clock shows that the field scan is on and set.

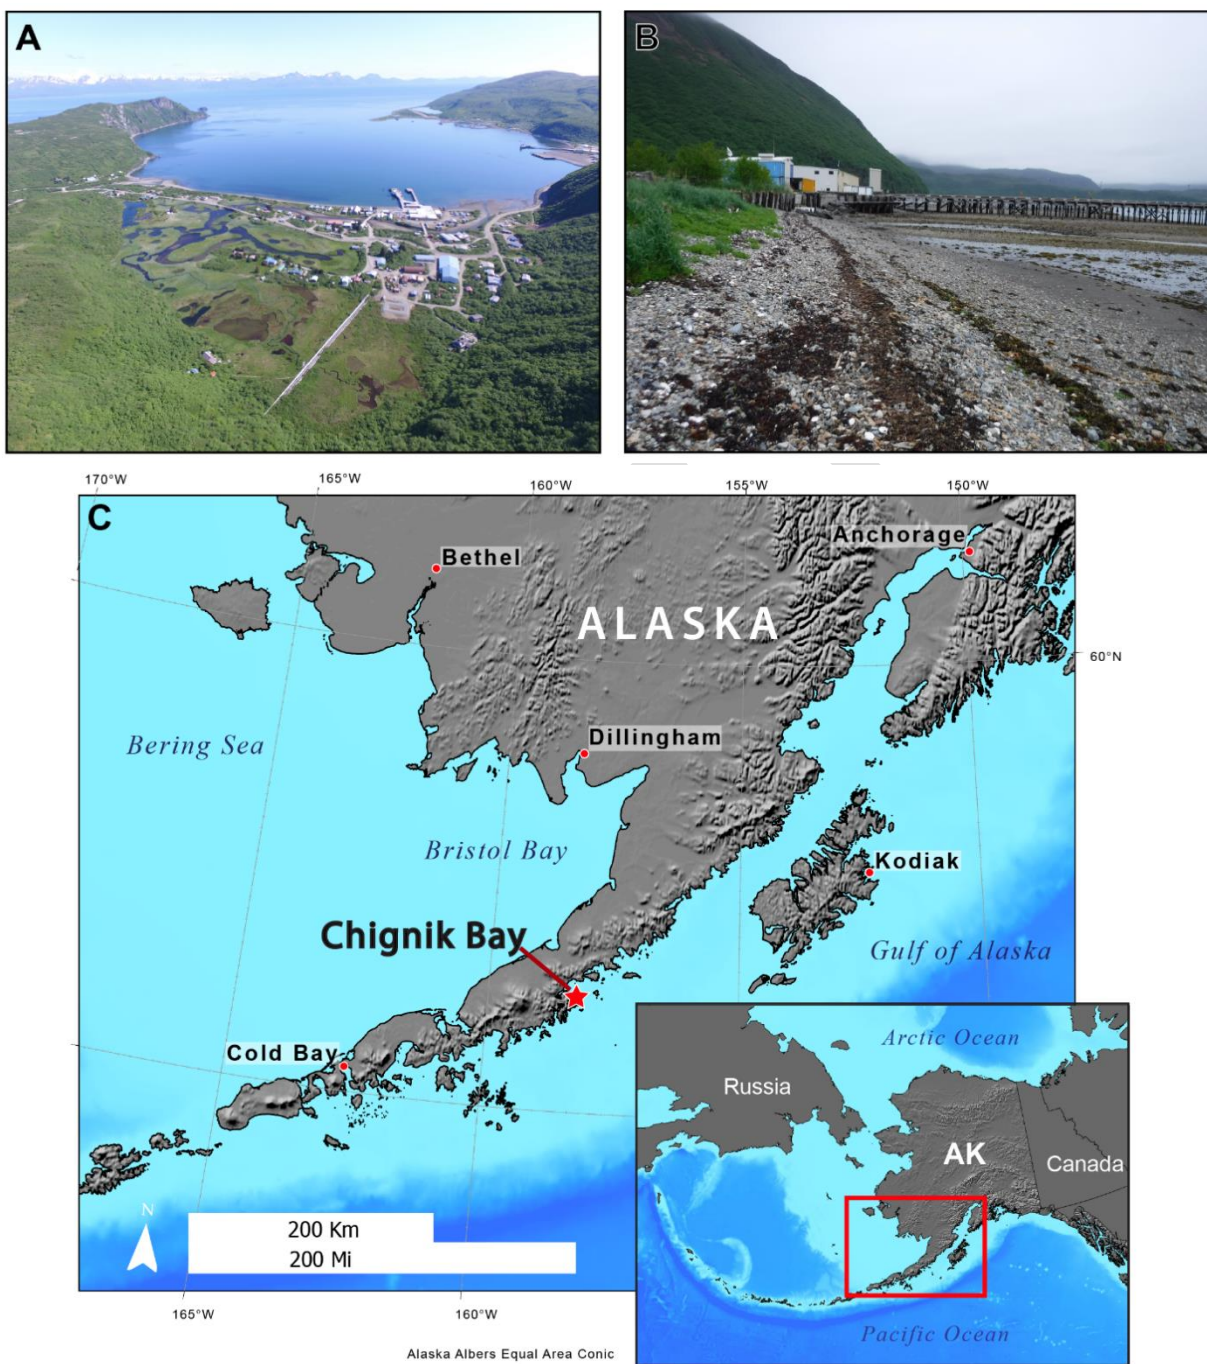
Figure 1. Regional context of the Chignik Bay, AK study site. (A) Aerial view of Chignik Bay. (B) Beach and cannery. (C) Regional map showing Chignik Bay's location in Alaska.

Chignik Bay is one of seventeen communities in the Lake and Peninsula Borough. It lies 724 km (450 mi) southwest of Anchorage and 418 km (260 mi) southwest of Kodiak (DCCED 2018) (**Figure 1**). The city comprises 11.7 square miles of land and 4.3 square miles of water (Chignik Bay Tribal Council 2019). Kalwak, the original village of the current land of Chignik Bay, was destroyed in the late 1700s during the Russian fur boom (Chignik Bay Tribal Council 2019). The word “Chignik” is a Sugpiak word for “big wind,” and the village of Chignik Bay was named after the body of water it overlooks. The community was established in the late 1800s as a fishing community and became an incorporated city in 1983 (DCCED 2018). Coal mining occurred from 1899 to 1915. The city is located at the head of Anchorage Bay, which itself is in the larger Chignik Bay.

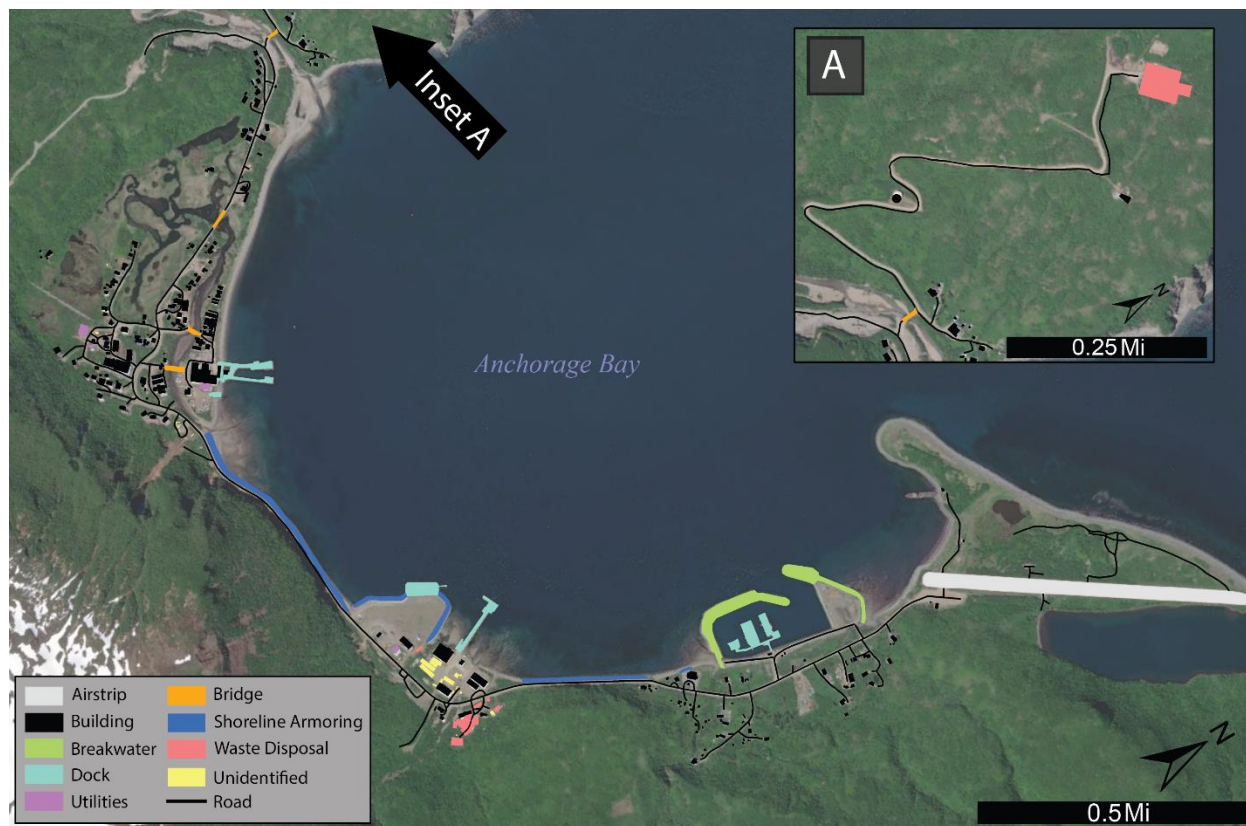
Figure 2. Map showing the building and utility infrastructure of Chignik Bay. (A) The extent of the community, (B) The waste disposal site. Data are displayed over ArcGIS base imagery provided by Esri.

There are several tank farms located around the community. There are three active tank farms: the east power plant tank farm, Trident tank farm, and the school tank farm. The east power plant tank farm contains six fuel tanks and is located 165 ft from Anchorage Bay (CIAP WEAR Trip Report, 2014). It acts as a fuel station for the community, and it supplies fuel to the east side power plant. The Trident tank farm contains eight fuel tanks and is located 60 ft from Anchorage Bay. It provides fuel for the Trident Seafoods Corporation (CIAP WEAR Trip Report, 2014). The school tank farm, located behind the school, provides fuel for the school. The site is located 1,200 ft from Anchorage Bay (CIAP WEAR Trip Report, 2014).

The city landfill has been in operation since 1996. It is unpermitted and only accepts municipal waste (CIAP WEAR Trip Report, 2014). This site is 1,000 ft from the west side of Anchorage Bay and 2,000 north of the main residential area (CIAP WEAR Trip Report, 2014). Indian creek holds a dam and a reservoir that treats water for all homes and the school. Piped sewage is held in community tanks and discharged through ocean outfall lines (CIAP WEAR Trip Report, 2014).

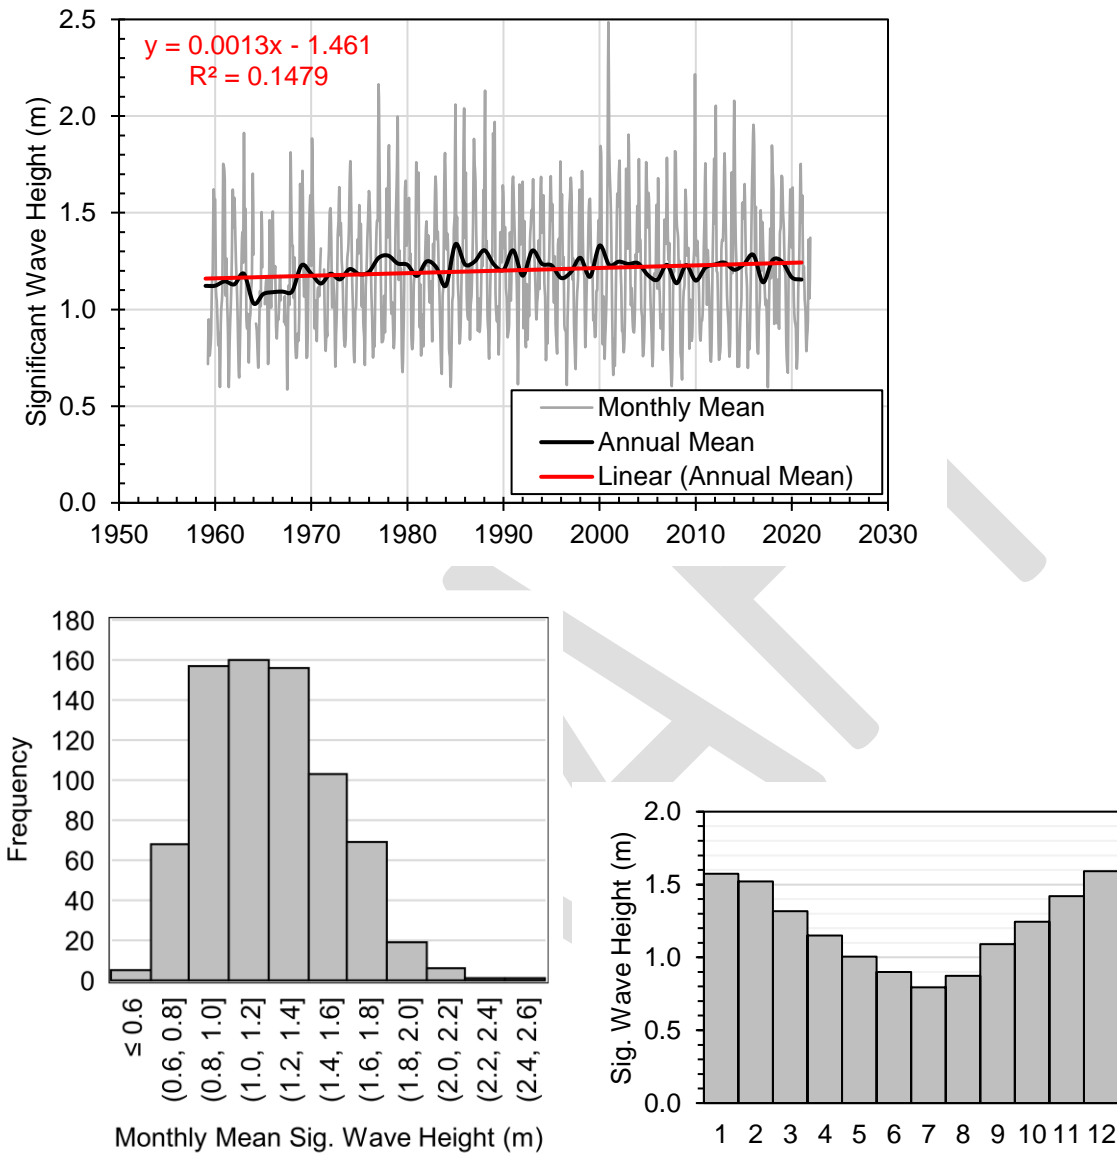
Figure 13. Significant wave height (SWH) statistics for Chignik Bay. (Top) Monthly (gray) and annual (black) mean SWH from 1959 through 2021. The linear regression of annual SWH (red) shows a slight increase but interannual variability is very high. (Bottom Left) Histogram of SWH shows the average is 1.20 m with SD 0.32 m. Values range between 0.5 to 2.6 m. (Bottom Right) Monthly mean SWH shows SWH is greatest in winter and lowest in summer.

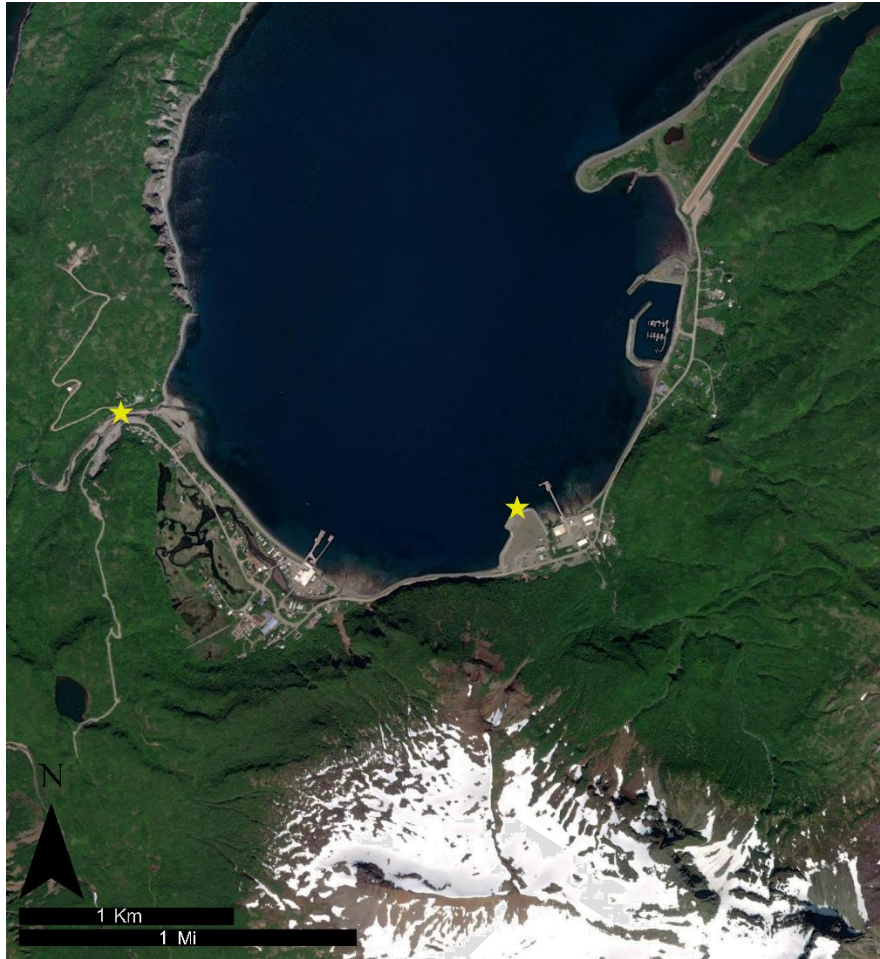
Figure 21. Map Chignik Bay water level gauges, represented by gold stars.

Two water level gauges were installed in Chignik Bay. One was installed on a dock overlooking Anchorage Bay and the other was installed on a bridge over Indian Creek (**Figure 20**).

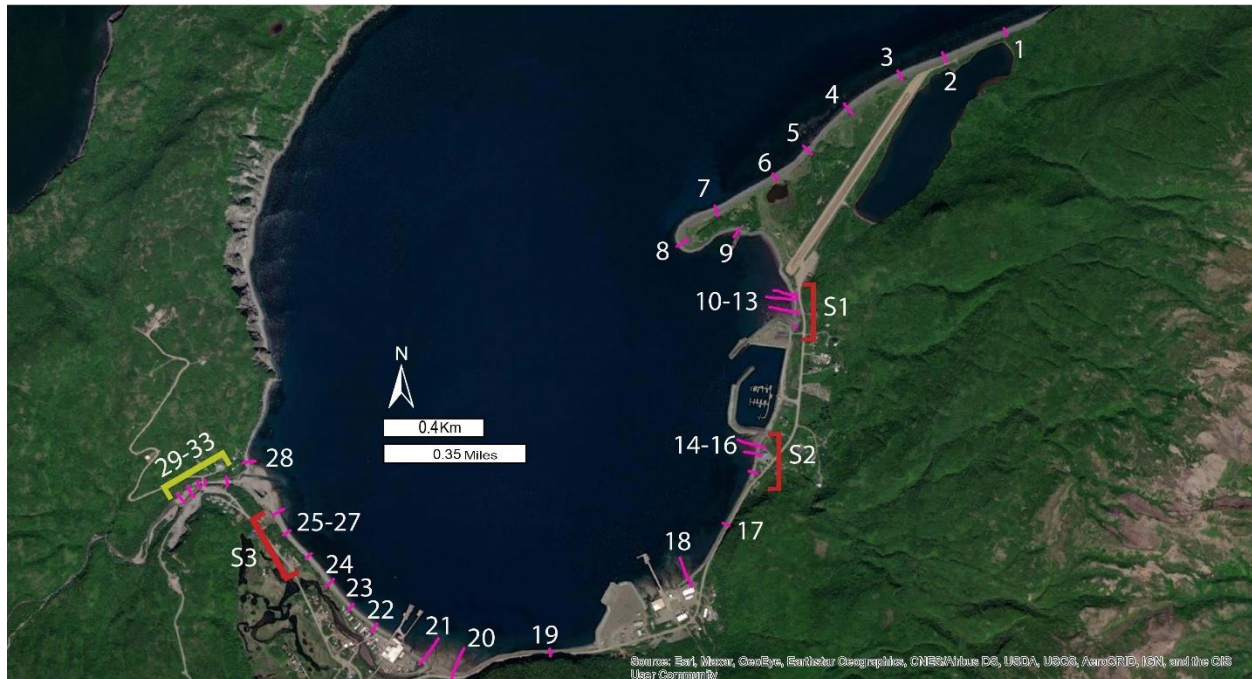
Figure 24. Map showing the location of each cross-shore elevation profile. Red brackets represent CBM sites. Yellow bracket represents cross-river elevation profiles.

Elevation profiles at Chignik Bay were collected by the ACGL along cross-shore transects at 33 locations in 2019, 2021, and 2022 (**Figure 24** & **Figure 25**). Representative coastal elevation profile

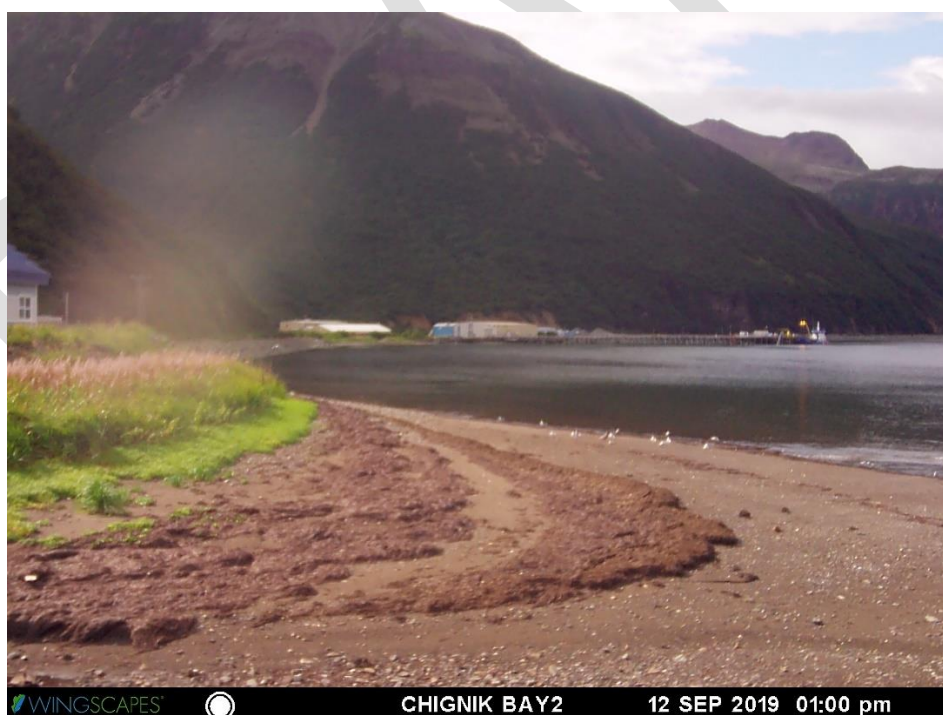
Figure 27. Time-lapse picture and compiled video of erosion monitoring site 2. Images taken at Chignik Bay from June 2019 to May 2020. (URL: <https://youtu.be/3SjWLRm6vOw>).

Time-lapse cameras were set up at two sites in May 2019 and data is currently being collected. The cameras were oriented perpendicular to a single profile at each site. Images were taken every hour and compiled into time-lapse videos (**Figure 26** & **Figure 27**). These datasets visually show change at each shoreline and can capture storm events. Erosion measurements were unable to be processed as the cameras were not secured tightly enough and the camera was frequently shifted out of place. Future site visits will require proper securing of these cameras.

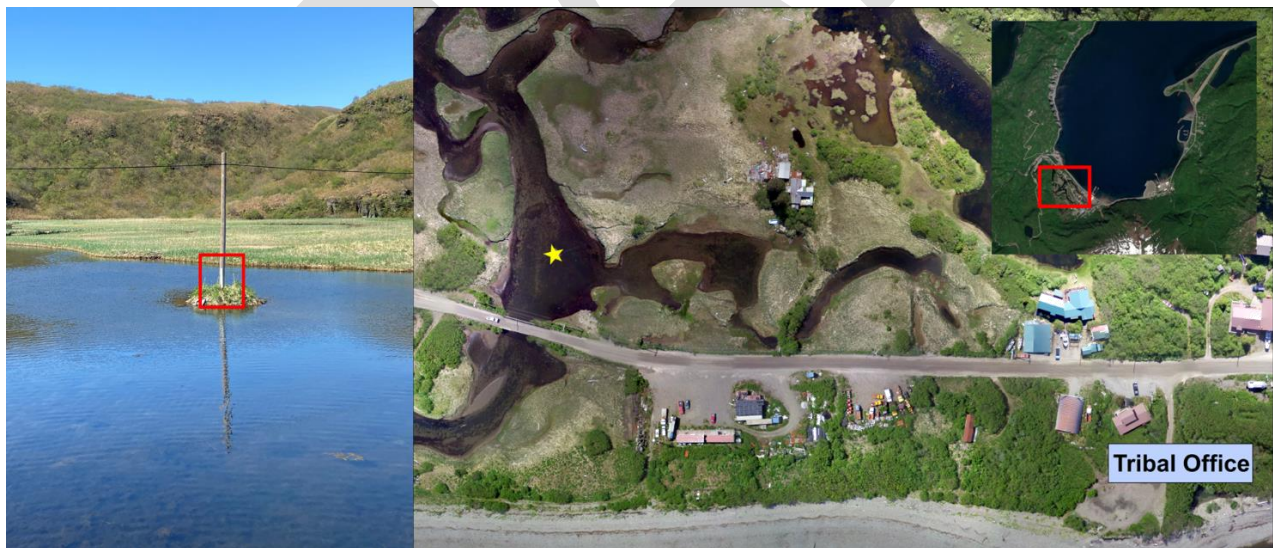
Figure 28. Location of tide staff installed May 2022. It was installed on a utility pole near the tribal office.

There is currently no flood hazard or exposure map for Chignik Bay. A flood map is created using a DEM, tidal datum connected to NAVD88, historical flood record, and impacts to infrastructure (Buzard et al., 2021). Chignik Bay has a DSM (**Figure 20**) and will receive a lidar-derived DTM. The tidal datum was connected to NAVD88 in this report's 2023 update (**Table 1**). The remaining components can be determined through GNSS surveying, community observations, and delineating infrastructure in imagery using GIS (Buzard et al., 2021a). With these components, flood maps can be created to show flood extent, severity, and likelihood. The maps would allow tide, storm, and tsunami forecasts to be related to infrastructure elevation. May 2022, a flood staff was installed on a utility pole in the flood plain of the community (**Figure 22**). This flood staff will allow residents to send in photos of flooding events. These measurements can be used to create flood extent maps.

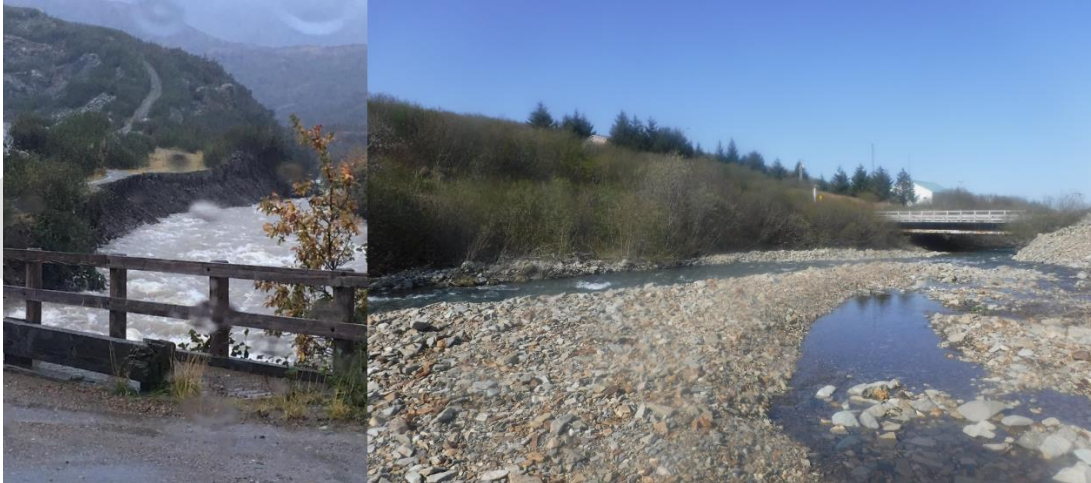
Figure 29. (Left) Photo taken by Jeanette Carlson standing on Indian Creek bridge during a flood in June. (Right) Photo taken by Jessie Christian on a calm day on a berm in Indian Creek with bridge in background.

Local anecdotal input has pointed to erosion of the bank under the Indian creek bridge connecting the community to their tsunami evacuation route and waste disposal site. High water events from storms cause the majority of erosion according to local residents (**Figure 29**). A water level gauge was installed in 2022 and baseline data has been collected for future monitoring efforts.

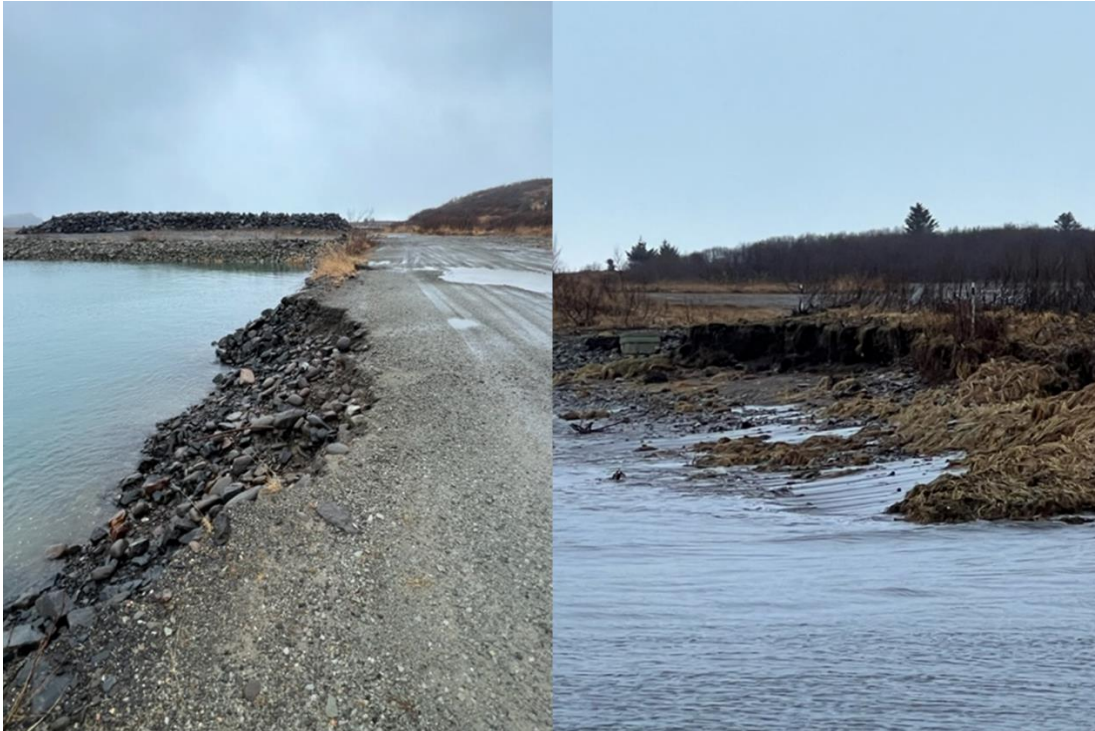
Figure 30. Photos taken by Andrew Anderson (Left) Main Road after December 2022 storm. (Right) Community Monitoring site located by airport after December 2022 storm.

Unarmored sections of the bluff fronting the main road by the air strip are eroding. When the road is obstructed, access to the airport get cut off and transportation to and from the village slows. Coastal profiles and CBM measurements show the bluff has eroded approximately 1ft over 4 years. Residents shared information and photos of a large storm in December 2022 that

caused a large amount of erosion (**Figure 30**). Baseline data has been collected in the area for future monitoring efforts.

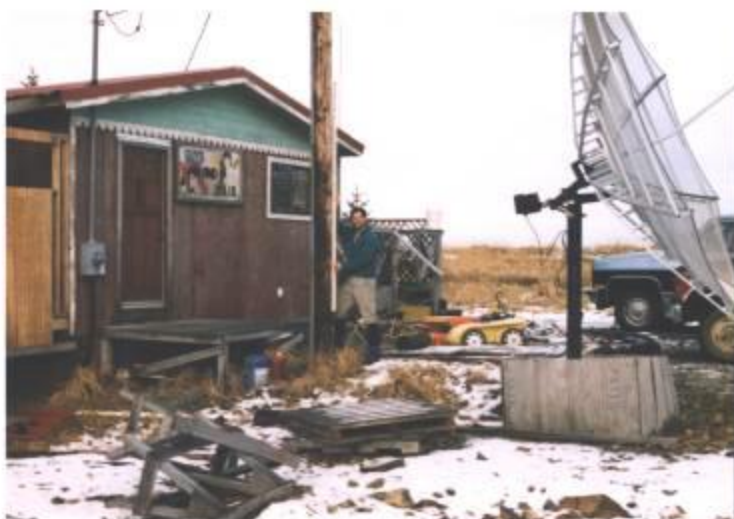
Temporary bench mark on the power pole at Harold Skonberg's house.

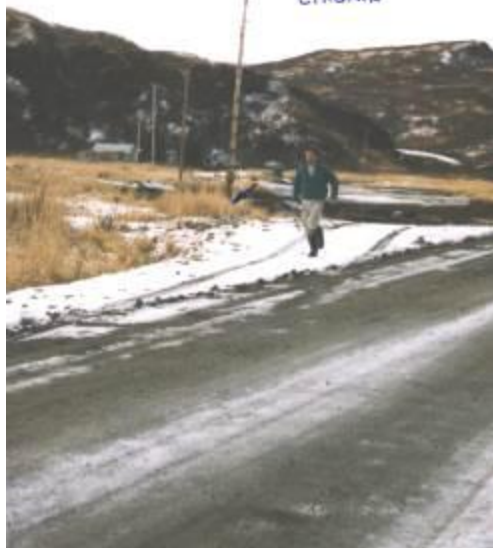
TBM ON POLE
AT BRIDGE 6
W. 3RD AVE.
CHIGNIK
