# CLIMATE RESILIENCY ACTION PLAN

CHIGNIK BAY TRIBAL COUNCIL  
Chignik Bay, Alaska

FINAL (Revision 0)

Bristol Project No. 3222067

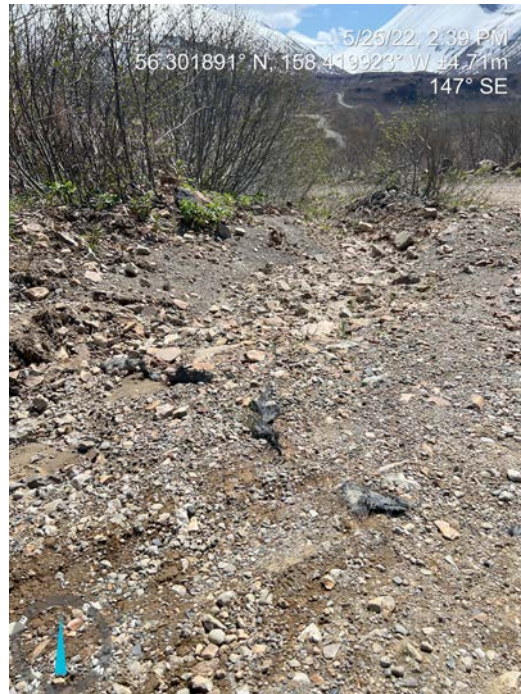
Alternative locations:	N/A
Other Notes:	*after bridge heading to dump, left hand side, deep trenching from runoff (6' wide, 2' deep) * (a) washout exposing large rock, sharp corner * (b) carry ditch around corner * (c) ditch work needed *PVC culvert 6" wide

Exposed Geotextile

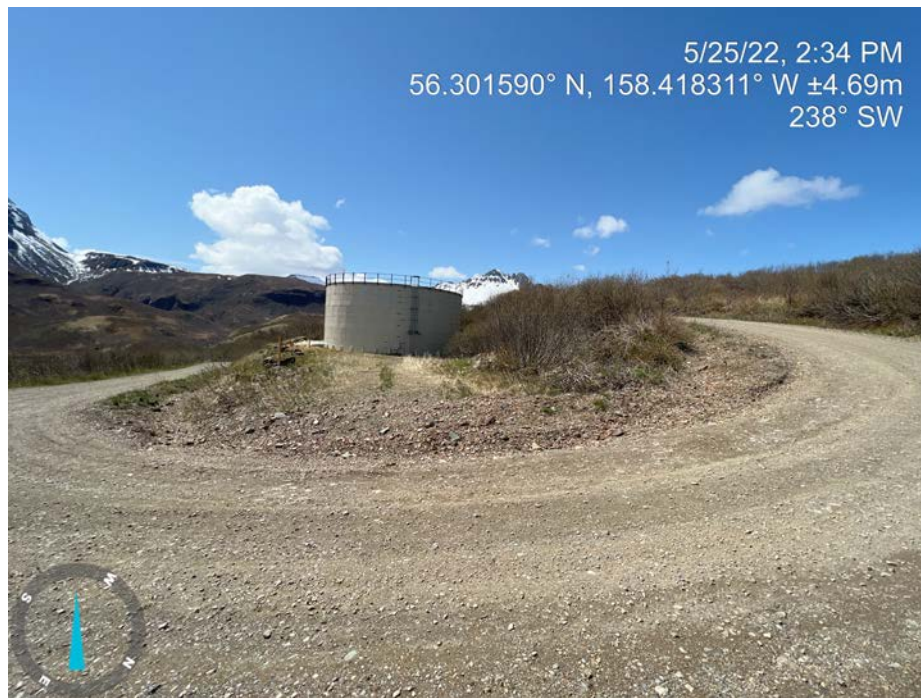
Lack of Ditching Around Bends  
1 of 2

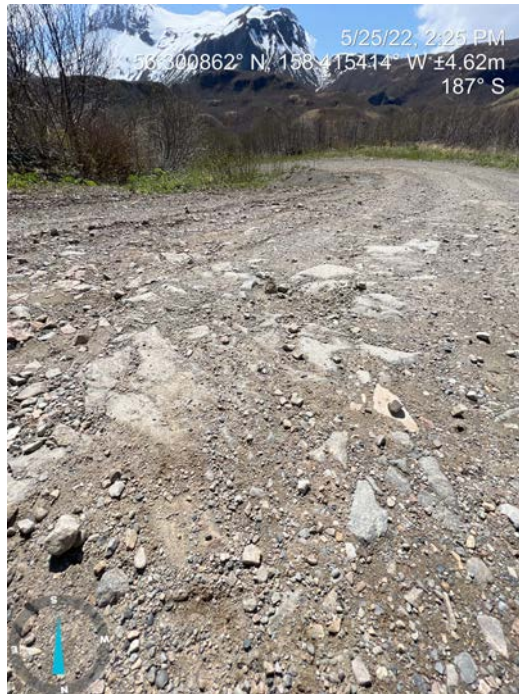
Runoff Washing Away Fines Exposing Larger Rock

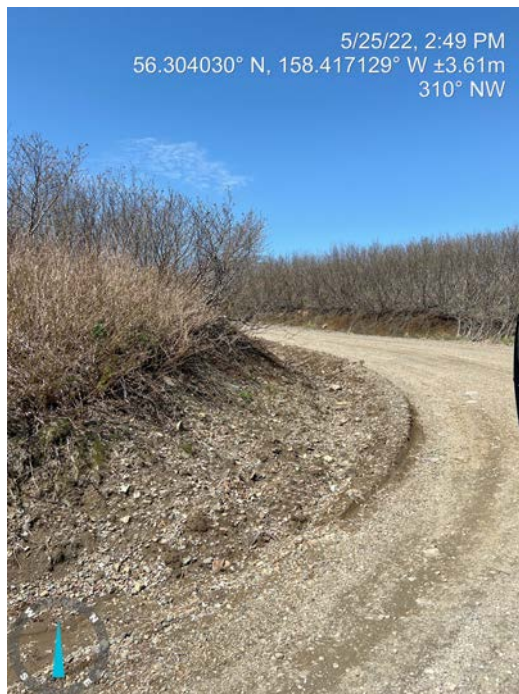
Washed Out Ditching Around Bend  
2 of 2

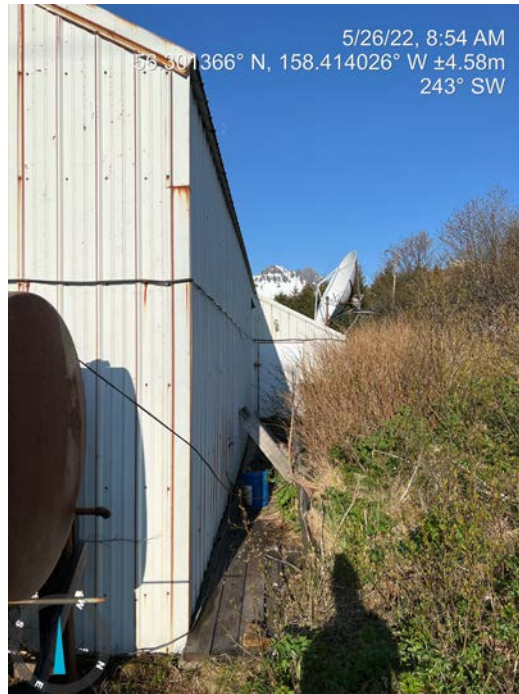
East Back Side

Defend in place strategies:	N/A
Alternative locations:	N/A
Other Notes:	*Metal siding *Wood retaining wall in back - leaning *Unstable staircases

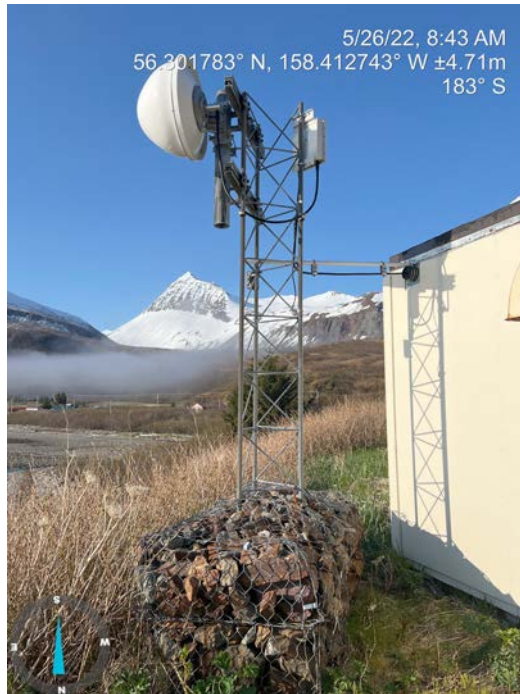
Infrastructure Name:	5 - ACS Satellite / Building
Location (lat & long):	56.301733, -158.412804
Owner (Commercial, Residential, or Public):	Commercial, ACS & AT&T
Function:	ACS Telephone, AT&T Satellite
Dimensions:	20.5' x 8.5'
Date Constructed:	
Age (years):	
Foundation Type:	Metal Skid
Condition:	Good
Utilities (water, sewer, electric, communications, gas, heating oil):	Communications
Prone to flooding?	No
Prone to erosion?	Some erosion on bluff edge
Prone to landslide/avalanche?	No
Drainage problems?	No
Cause of Failure (if any, date issue started):	N/A
Proposed facility improvements:	N/A
Defend in place strategies:	Monitor erosion of bluff edge
Alternative locations:	Move further away from bluff edge when needed
Other Notes:	*On edge of bluff *Anchored down *Lots of old equipment stored outside near facility

Bluff Edge

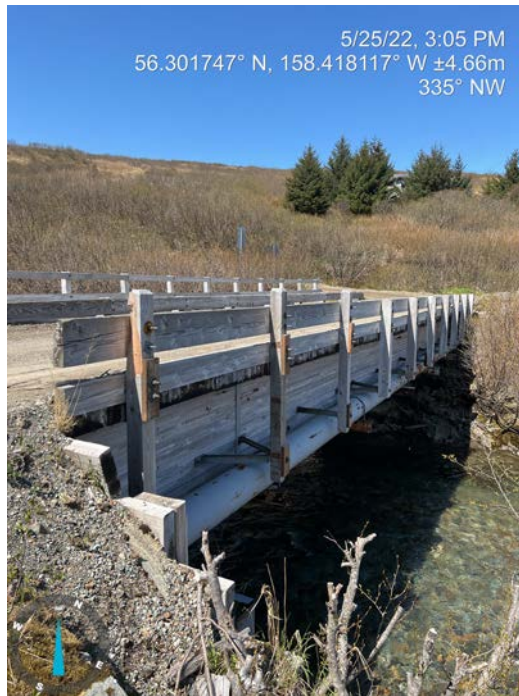
North Abutment

Infrastructure Name:	6A - Indian Creek Bridge
Location (lat & long):	56.300603, -158.415371
Owner (Commercial, Residential, or Public):	Public, City of Chignik
Function:	Tsunami Evacuation Route
Dimensions:	72' long, 15' wide (vehicle), 7' (pedestrian)
Date Constructed:	1985
Age (years):	37
Foundation Type:	*Wood decking and wing walls *metal/wood/rock abutments (one side of the deck is resting on the
Condition:	*See most current survey done by the State after last big earthquake. *Unsatisfactory (decking may be ok but abutments need updated
Utilities (water, sewer, electric, communications, gas, heating oil):	Water/Sewer???
Prone to flooding?	Located in flood zone
Prone to erosion?	Yes
Prone to landslide/avalanche?	No
Drainage problems?	*far side connection (Dump Rd), has erosion due to runoff. *Fines are deposited on deck of bridge *Culvert draining and hitting wingwall of bridge *Drainage and erosion on both ends of bridge along wingwalls

Cause of Failure (if any, date issue started):	Erosion at abutments, wear and tear from vehicle traffic
Proposed facility improvements:	Replace bridge structure components as needed
Defend in place strategies:	Stabilize areas of erosion
Alternative locations:	N/A
Other Notes:	*Wood surface decking worn down on side closest to quarry. *Some wood posts and rub rails are cracked on the surface

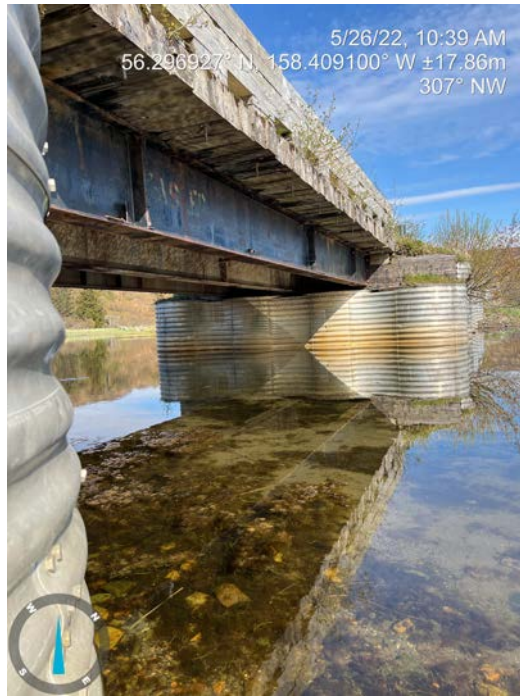
Abutment

Infrastructure Name:	6B - Chignik Creek Bridge
Location (lat & long):	56.296927, -158.409100
Owner (Commercial, Residential, or Public):	City of Chignik
Function:	Tsunami Evacuation Route
Dimensions:	20' wide x 51' long
Date Constructed:	2002
Age (years):	20
Foundation Type:	*Culvert w/ earth filled (vertical culvert) *Wood wing walls
Condition:	*Wood decking worn *Wood Railing worn *Metal guardrail good except bullnoses need repaired/replaced
Utilities (water, sewer, electric, communications, gas, heating oil):	Lighting/power
Prone to flooding?	Located in flood zone
Prone to erosion?	Some erosion on embankments and near wing walls
Prone to landslide/avalanche?	No
Drainage problems?	No
Cause of Failure (if any, date issue started):	
Proposed facility improvements:	*Wing wall, wood & metal guardrails, and decking need replaced
Defend in place strategies:	N/A
Alternative locations:	N/A
Other Notes:	*14" depth due to grading along guardrails *Road narrows (1 lane) *guardrail on either side of bridge

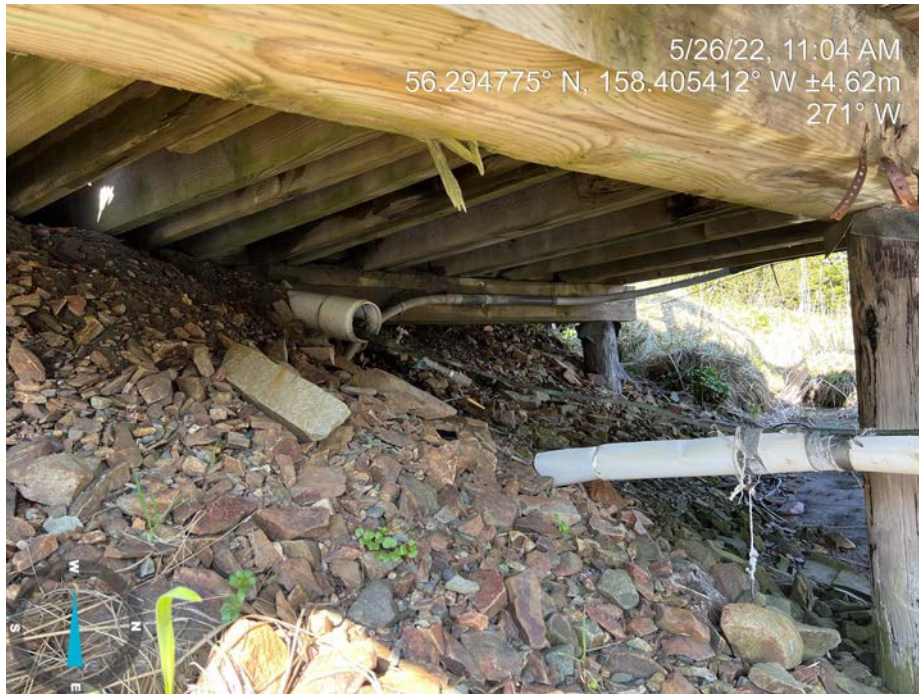
Abutment

Infrastructure Name:	6C - Trident Bridge
Location (lat & long):	56.294860, -158.405574
Owner (Commercial, Residential, or Public):	Commercial, Trident
Function:	Transportation
Dimensions:	13.5' wide x 115' long
Date Constructed:	
Age (years):	
Foundation Type:	Piles, one end rests on natural ground
Condition:	*Some loose boards *Loose approach
Utilities (water, sewer, electric, communications, gas, heating oil):	Electric, water
Prone to flooding?	Located in flood zone
Prone to erosion?	Piles prone to ocean surges
Prone to landslide/avalanche?	No
Drainage problems?	No
Cause of Failure (if any, date issue started):	Piles prone to wood rot, loose decking
Proposed facility improvements:	*New decking and approaches *Waterproofing on piles
Defend in place strategies:	N/A
Alternative locations:	N/A
Other Notes:	*Bridge crosses portion of the former Indian Creek (is not cut off from main flow with the construction of the Anderson Rd) *Still gets tidal waters *Mostly Pedestrian Use (visually saw 2 vehicles use it)

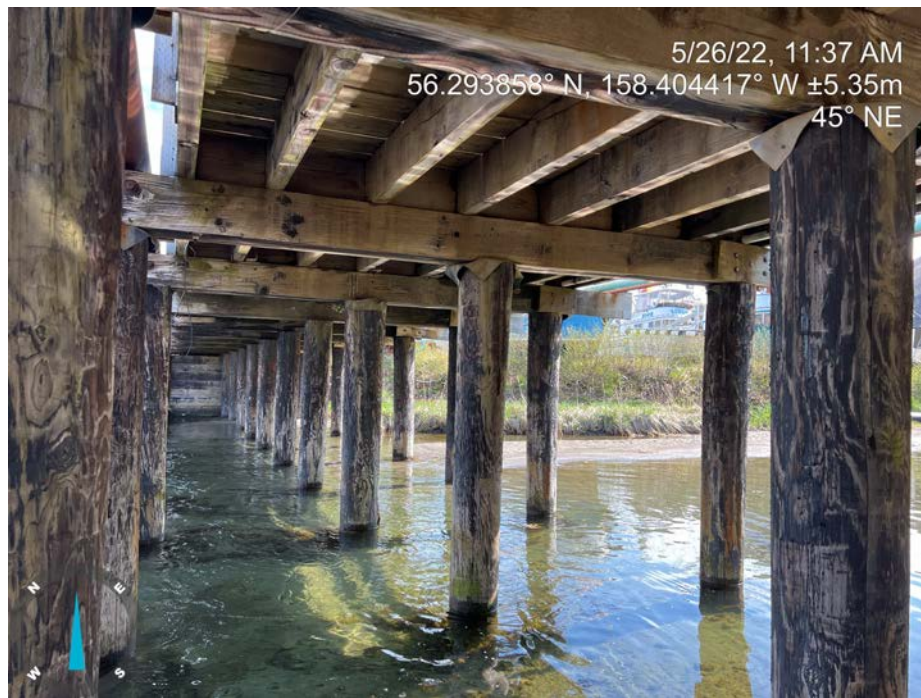
Piles  
1 of 3

Infrastructure Name:	6D - Trident Bridge
Location (lat & long):	56.293735, -158.404669
Owner (Commercial, Residential, or Public):	Commercial, Trident
Function:	Transportation
Dimensions:	14' wide x 196' long (~100' creek width)
Date Constructed:	
Age (years):	
Foundation Type:	*Wood piles and wing wall, decking and rails *Resting on natural ground
Condition:	*Loose and cracked boards on decking *One side of rail loose
Utilities (water, sewer, electric, communications, gas, heating oil):	Water
Prone to flooding?	Located in flood zone
Prone to erosion?	Piles prone to ocean surges
Prone to landslide/avalanche?	No
Drainage problems?	No
Cause of Failure (if any, date issue started):	Piles prone to wood rot, loose decking
Proposed facility improvements:	*New decking and approaches *Waterproofing on piles
Defend in place strategies:	N/A
Alternative locations:	N/A
Other Notes:	*Water pipe w/ outflow into creek attached to bridge *Used to haul large quantities of freight

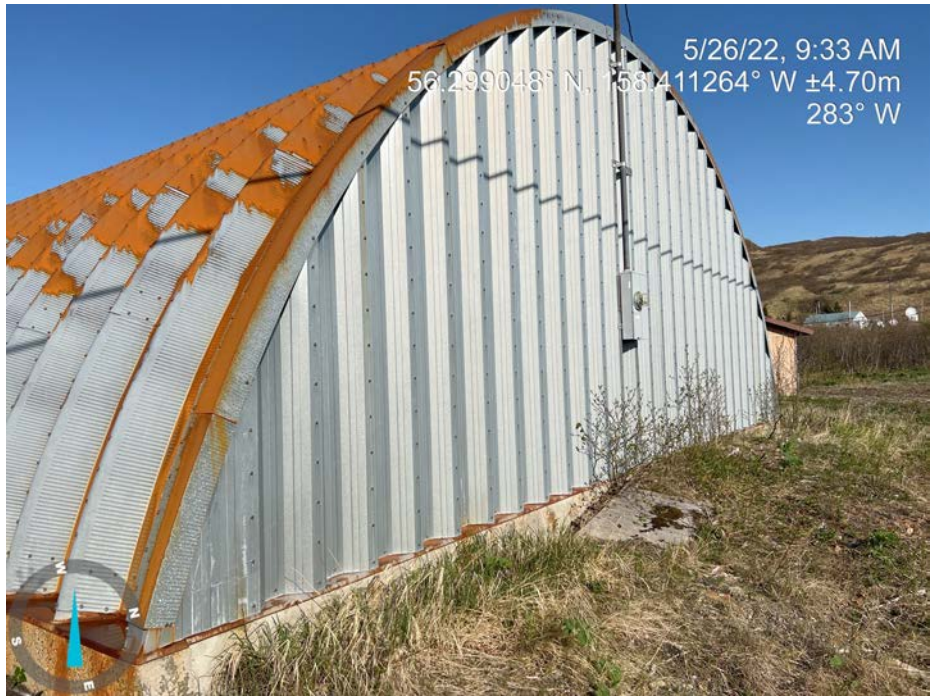
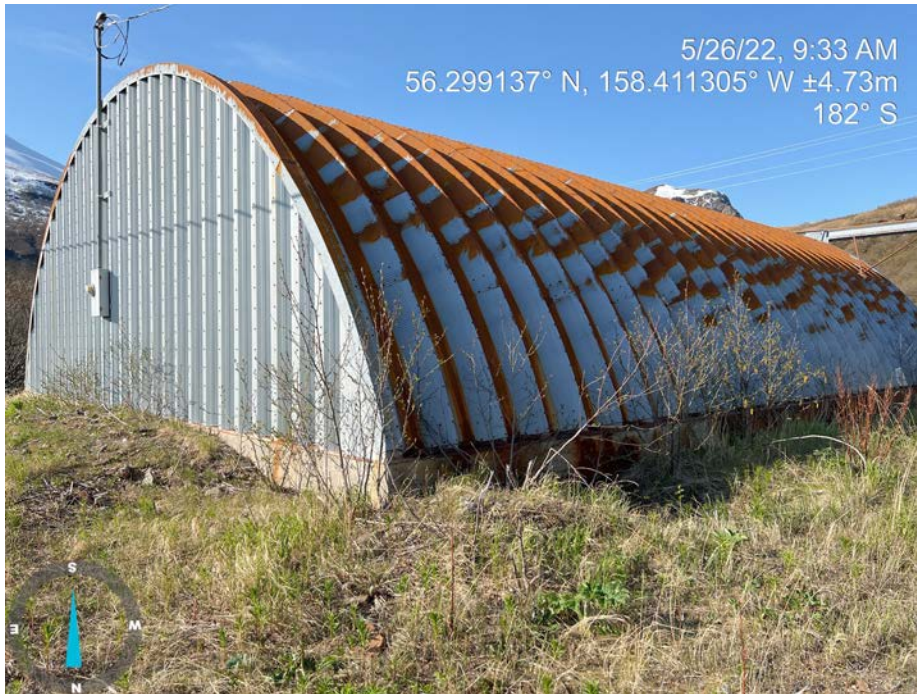
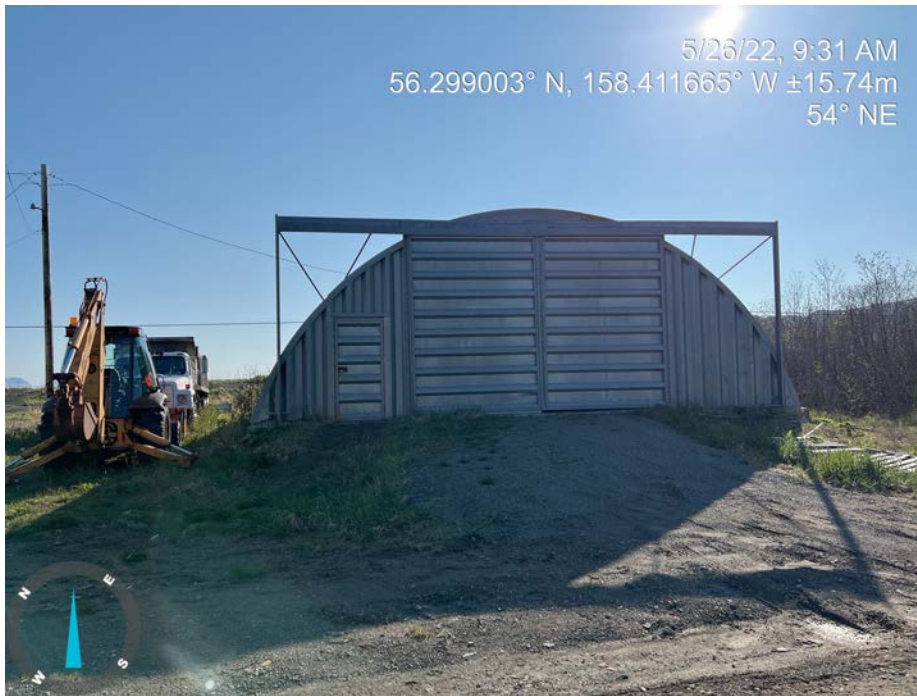
Infrastructure Name:	9 - Tribal Shop
Location (lat & long):	56.299003, -158.411665
Owner (Commercial, Residential, or Public):	Public, Tribe
Function:	Equipment & Material Storage for Projects
Dimensions:	39.5' x 60'
Date Constructed:	2001
Age (years):	21
Foundation Type:	Concrete slab on grade 16" concrete thickness with some pitting
Condition:	Good condition w/ minor foundation pitting Rusted metal dome
Utilities (water, sewer, electric, communications, gas, heating oil):	Electric
Prone to flooding?	Located in flood zone
Prone to erosion?	No
Prone to landslide/avalanche?	No
Drainage problems?	No
Cause of Failure (if any, date issue started):	Rusted metal dome
Proposed facility improvements:	Paint dome to prevent further dome deterioration & rust
Defend in place strategies:	N/A
Alternative locations:	N/A
Other Notes:	*Metal Dome

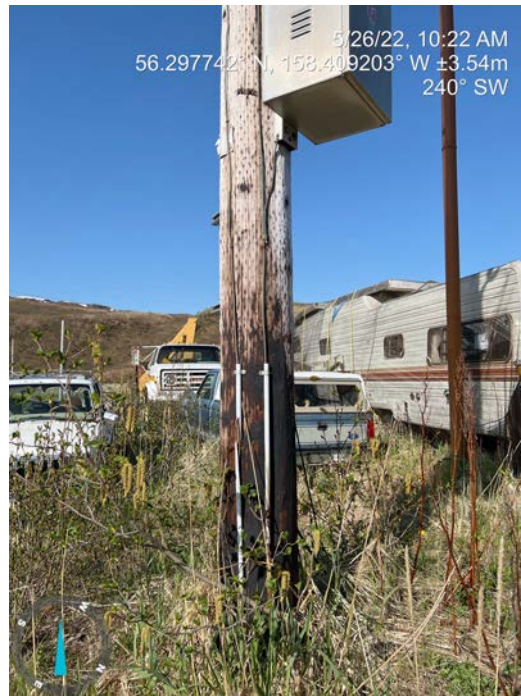
Pole Foundation  
1 of 2

Infrastructure Name:	10 - Tsunami Siren
Location (lat & long):	56.297742, -158.409203
Owner (Commercial, Residential, or Public):	Public
Function:	Tsunami Warning
Dimensions:	
Date Constructed:	
Age (years):	
Foundation Type:	Pole in Concrete
Condition:	Good
Utilities (water, sewer, electric, communications, gas, heating oil):	Electric
Prone to flooding?	Located in flood zone
Prone to erosion?	No
Prone to landslide/avalanche?	No
Drainage problems?	No
Cause of Failure (if any, date issue started):	N/A
Proposed facility improvements:	Louder siren and/or install multiple sirens along community
Defend in place strategies:	N/A
Alternative locations:	N/A
Other Notes:	*Berm on back side *Only half of community can hear this. Not sufficient for whole community.

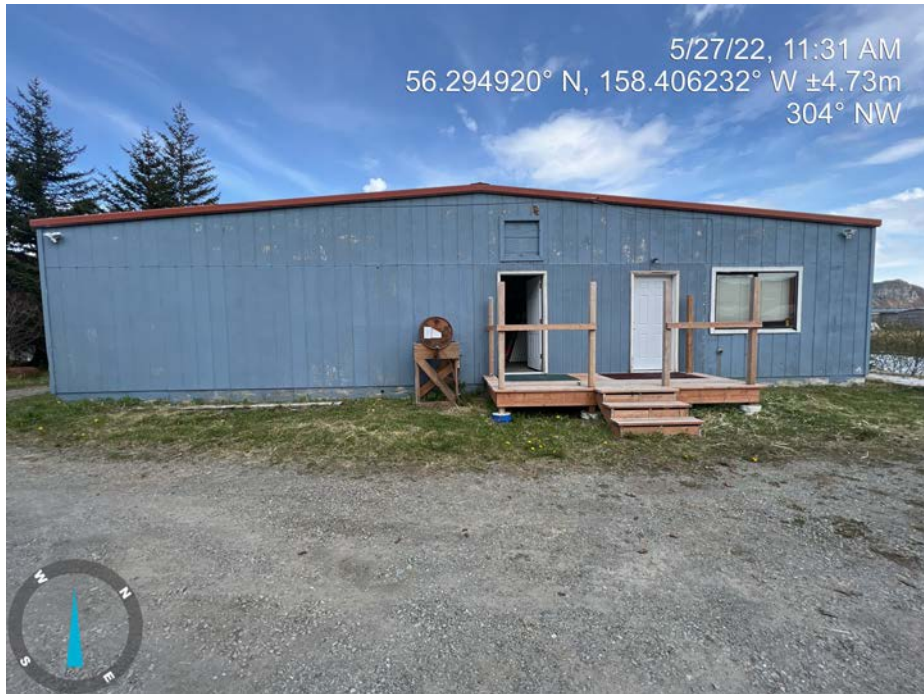
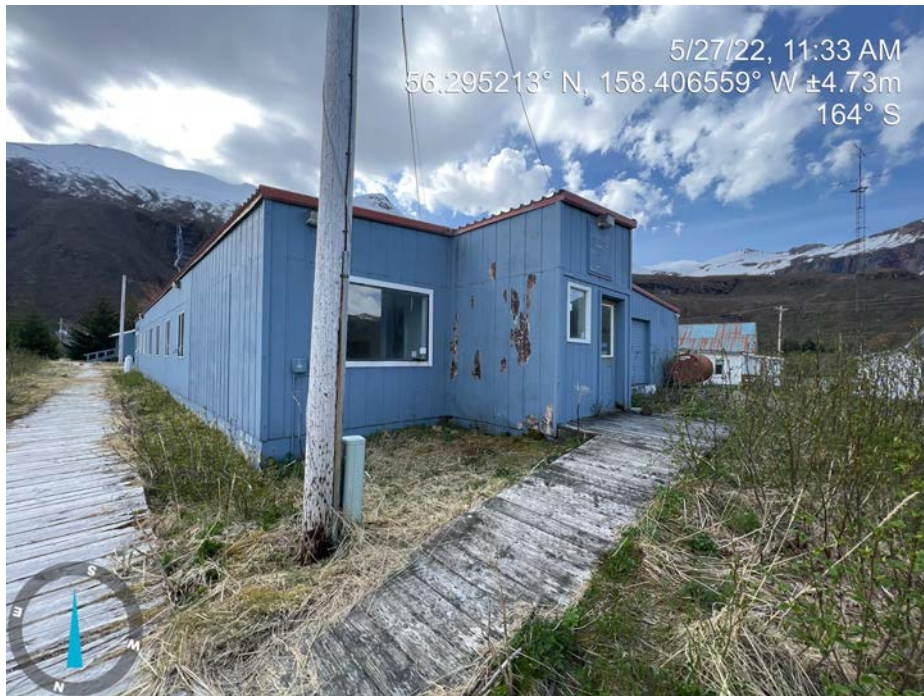
Infrastructure Name:	12 - Far West Bunkhouse
Location (lat & long):	56.295213, -158.406559
Owner (Commercial, Residential, or Public):	Commercial, Far West
Function:	Housing
Dimensions:	57' x 97'
Date Constructed:	
Age (years):	
Foundation Type:	Unsure but has wood skirting at a minimum
Condition:	Good w/ some minor repairs needed
Utilities (water, sewer, electric, communications, gas, heating oil):	electric, propane, heating oil
Prone to flooding?	Located in the flood zone
Prone to erosion?	No visual evidence
Prone to landslide/avalanche?	No visual evidence
Drainage problems?	No visual evidence
Cause of Failure (if any, date issue started):	Old structure
Proposed facility improvements:	*New windows *Update/repair broken siding
Defend in place strategies:	N/A
Alternative locations:	N/A
Other Notes:	*T1/11 siding - some broken sections *Some insulation (plastic) is exposed to the elements

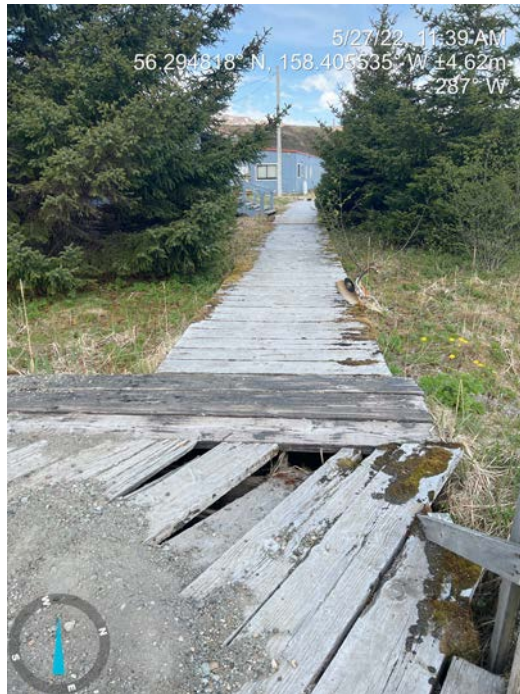
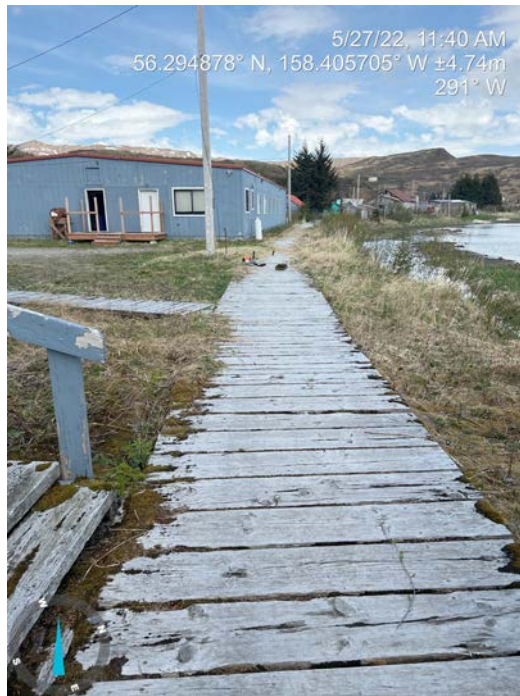
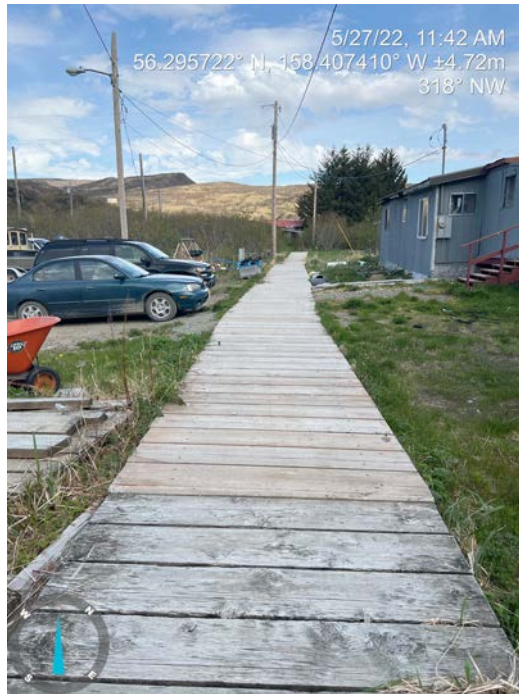
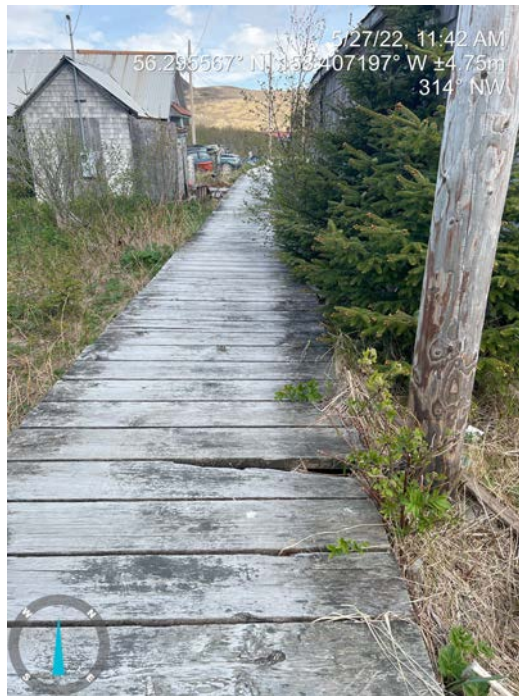
Infrastructure Name:	13 - Boardwalk
Location (lat & long):	56.294905, -158.405752
Owner (Commercial, Residential, or Public):	Public, City of Chignik
Function:	Pedestrian Use
Dimensions:	*6' wide *680' long (old boardwalk), 188' (newer boardwalk)
Date Constructed:	
Age (years):	
Foundation Type:	timber sleepers
Condition:	Most is good. A few boards are damaged and need replaced. There's a new section. Bridge 7C approach needs replaced.
Utilities (water, sewer, electric, communications, gas, heating oil):	N/A
Prone to flooding?	Located in flood zone
Prone to erosion?	No visual evidence
Prone to landslide/avalanche?	No visual evidence
Drainage problems?	No visual evidence
Cause of Failure (if any, date issue started):	Old structure
Proposed facility improvements:	*Replace approach near bridge 7C *Replace broken boards as needed
Defend in place strategies:	N/A
Alternative locations:	N/A
Other Notes:

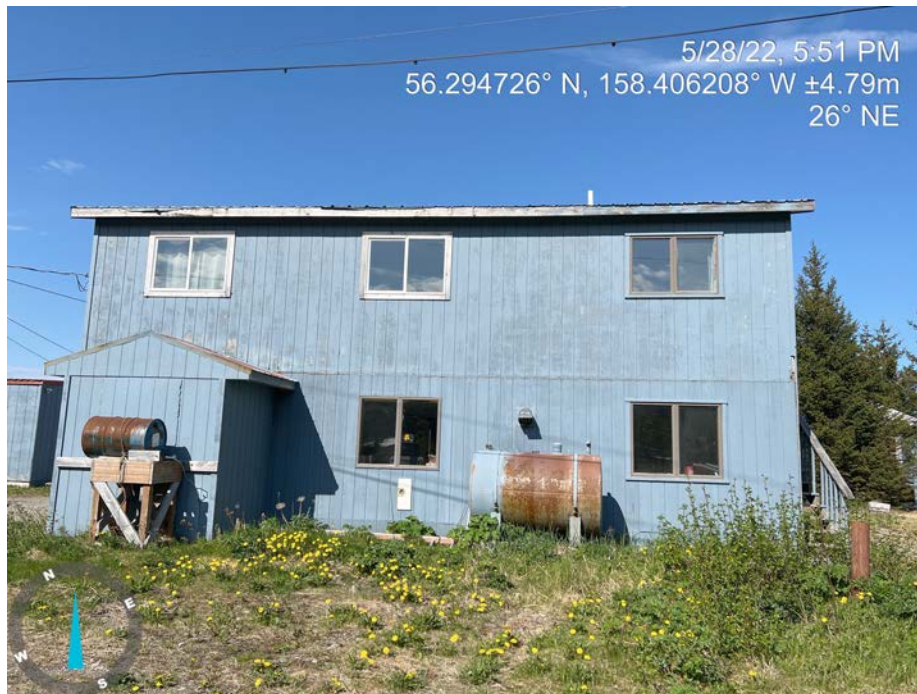
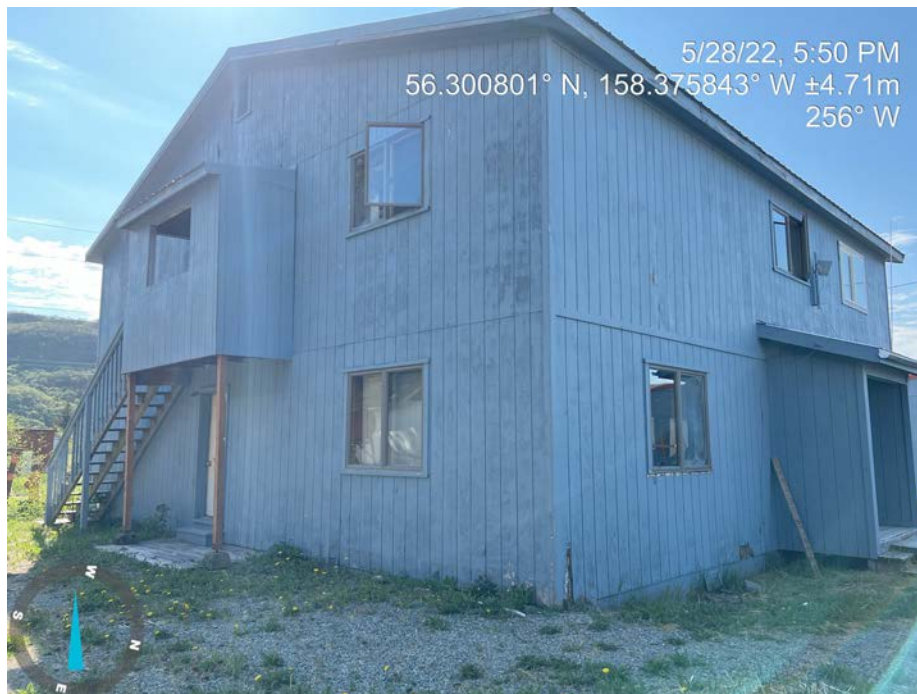
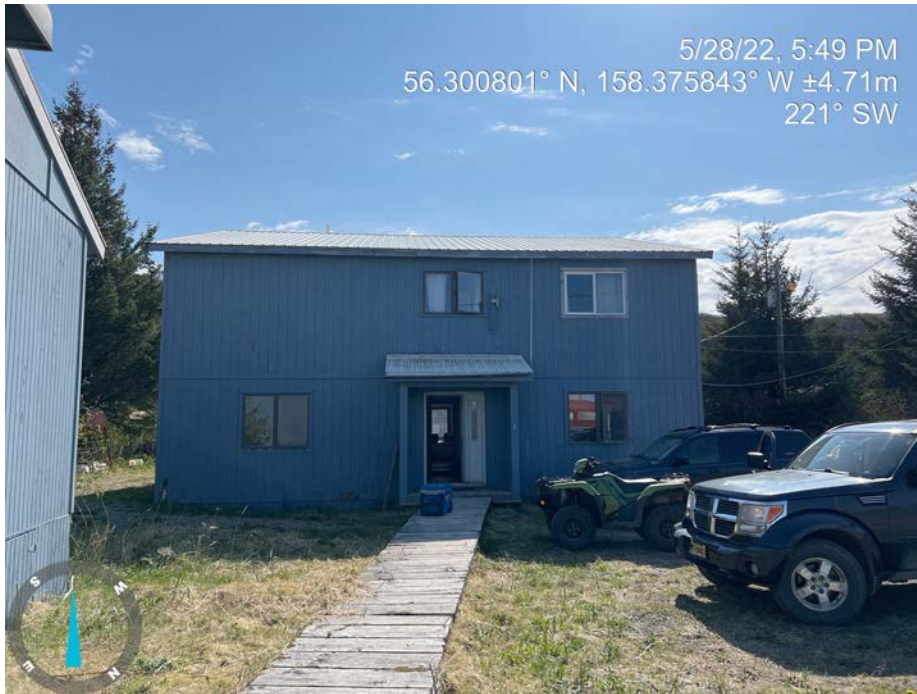
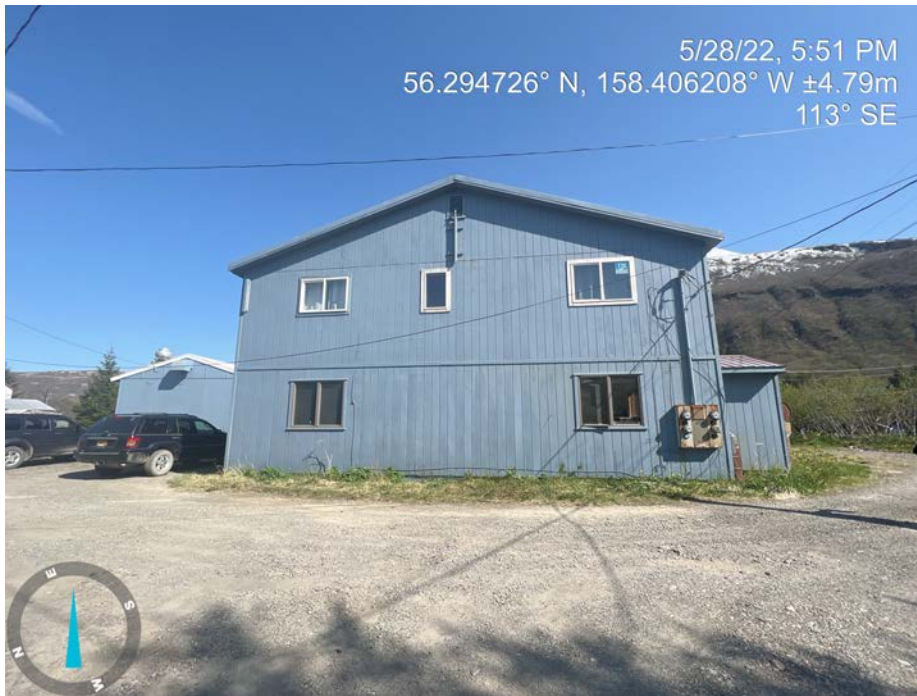
Infrastructure Name:	14 - Far West Apartment
Location (lat & long):	56.294726, -158.406208
Owner (Commercial, Residential, or Public):	Far West Corporation
Function:	Lodging
Dimensions:	41' x 41'
Date Constructed:	
Age (years):	
Foundation Type:	Wood
Condition:	Okay
Utilities (water, sewer, electric, communications, gas, heating oil):	electric, fuel tank
Prone to flooding?	Located in flood zone
Prone to erosion?	No visual evidence
Prone to landslide/avalanche?	No visual evidence
Drainage problems?	No visual evidence
Cause of Failure (if any, date issue started):	Old structure
Proposed facility improvements:	Siding needs to be replaced to repair holes in several locations
Defend in place strategies:	N/A
Alternative locations:	N/A
Other Notes:

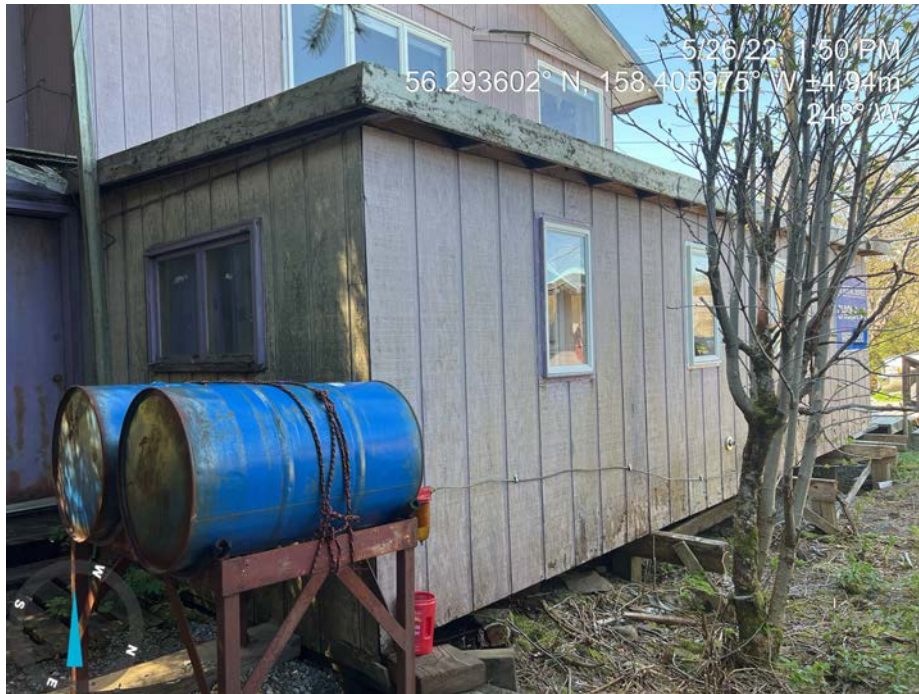
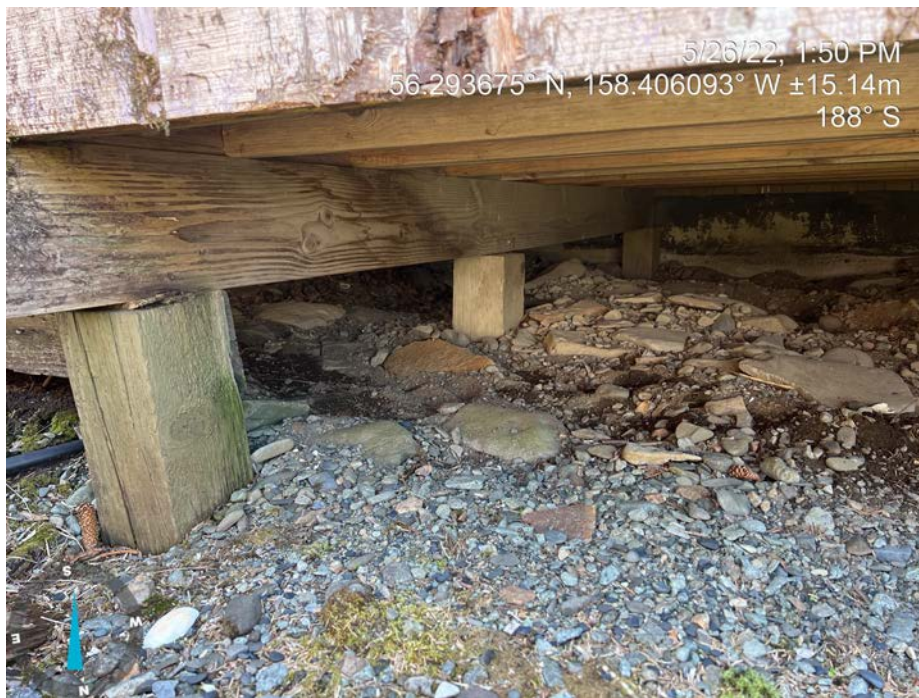
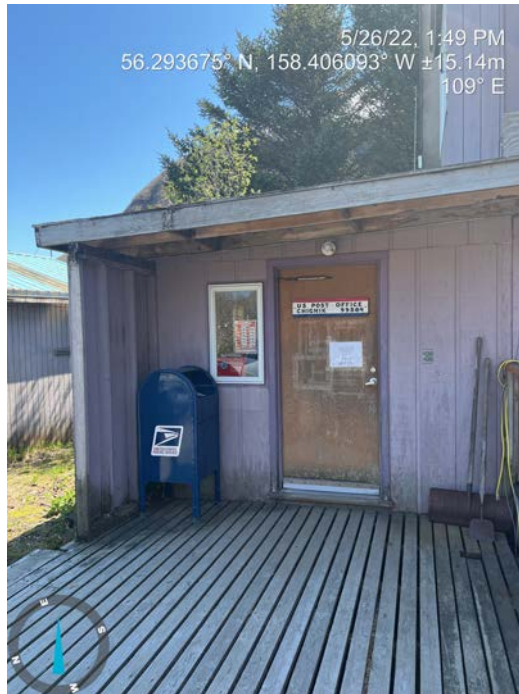
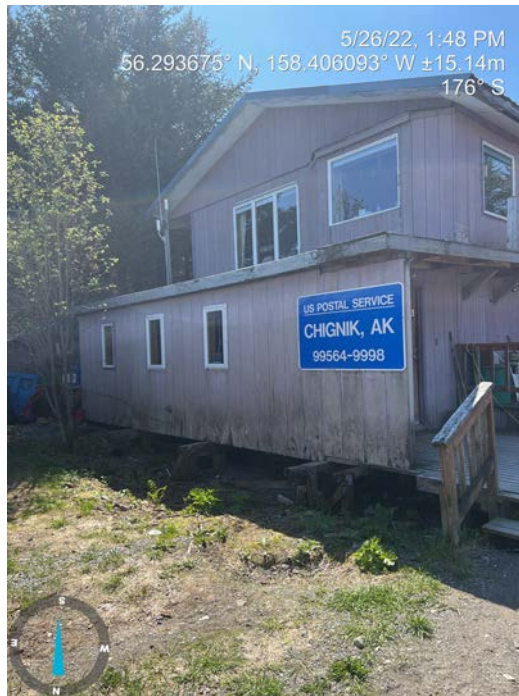
Infrastructure Name:	15 - Post Office
Location (lat & long):	56.293602, -158.405975
Owner (Commercial, Residential, or Public):	Public, Federal Government
Function:	Mail
Dimensions:	Building addition/extension
Date Constructed:	
Age (years):	
Foundation Type:	Wood piling?
Condition:	Wood siding (old)
Utilities (water, sewer, electric, communications, gas, heating oil):	Heating oil, electric
Prone to flooding?	No visual evidence
Prone to erosion?	No visual evidence
Prone to landslide/avalanche?	No visual evidence
Drainage problems?	No visual evidence
Cause of Failure (if any, date issue started):	Some wood foundation supports seem old/rotten
Proposed facility improvements:	Add more wood foundation supports as needed
Defend in place strategies:	N/A
Alternative locations:	N/A
Other Notes:	*Home built on slope of hill *Small extension of residential home

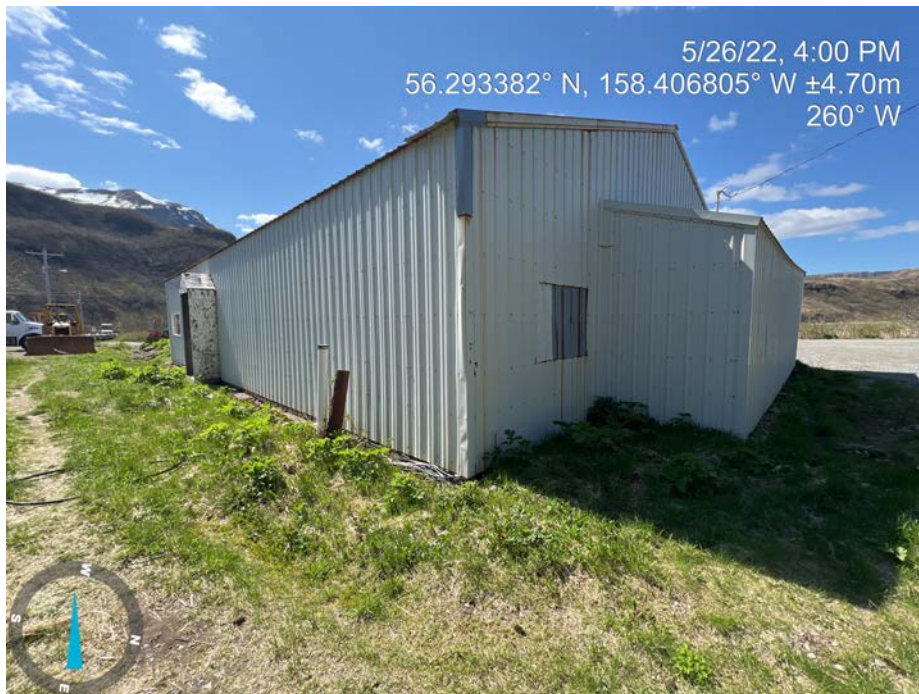
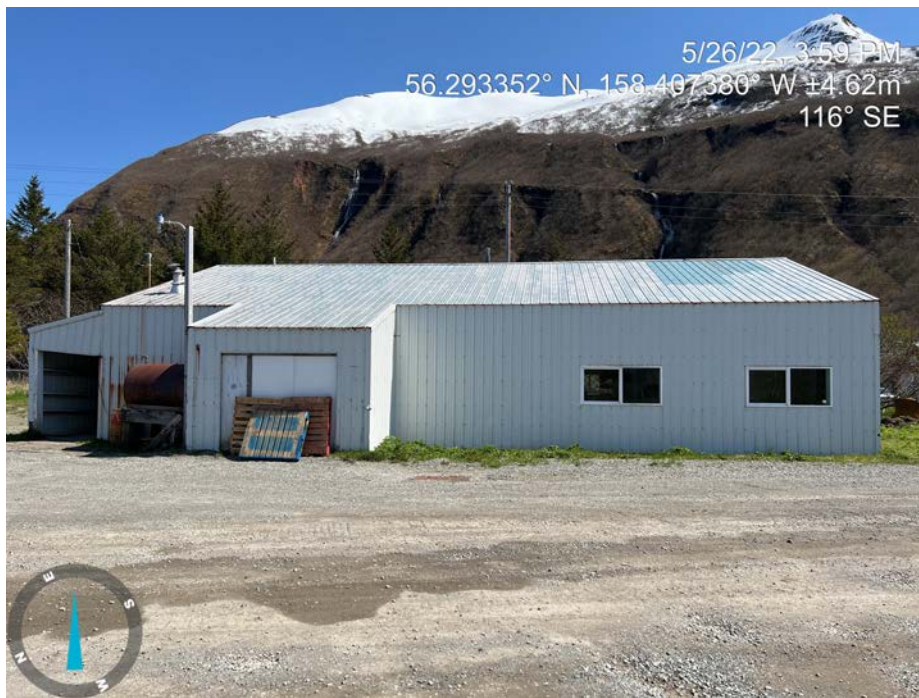
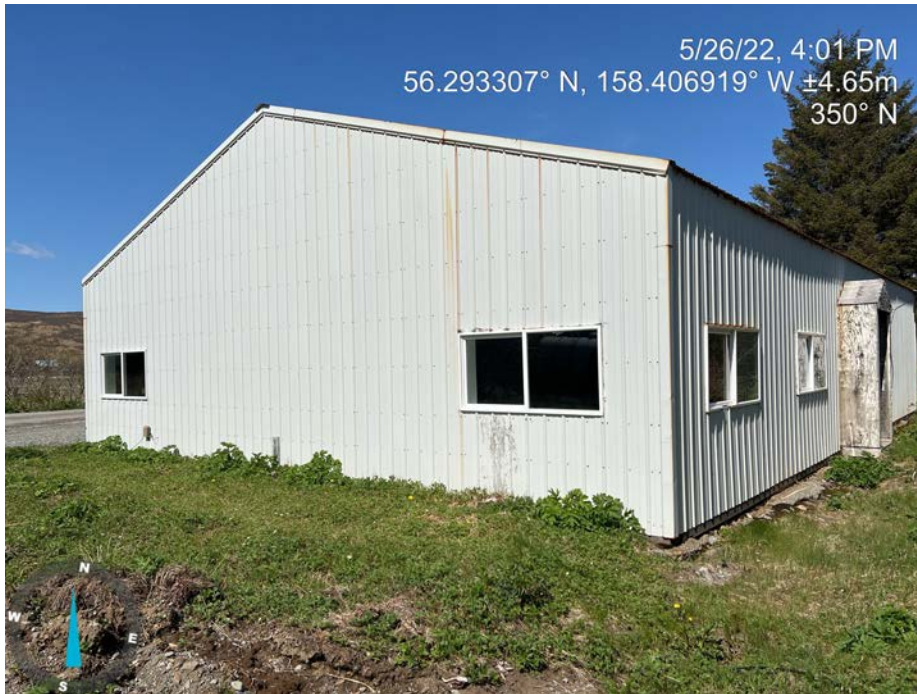
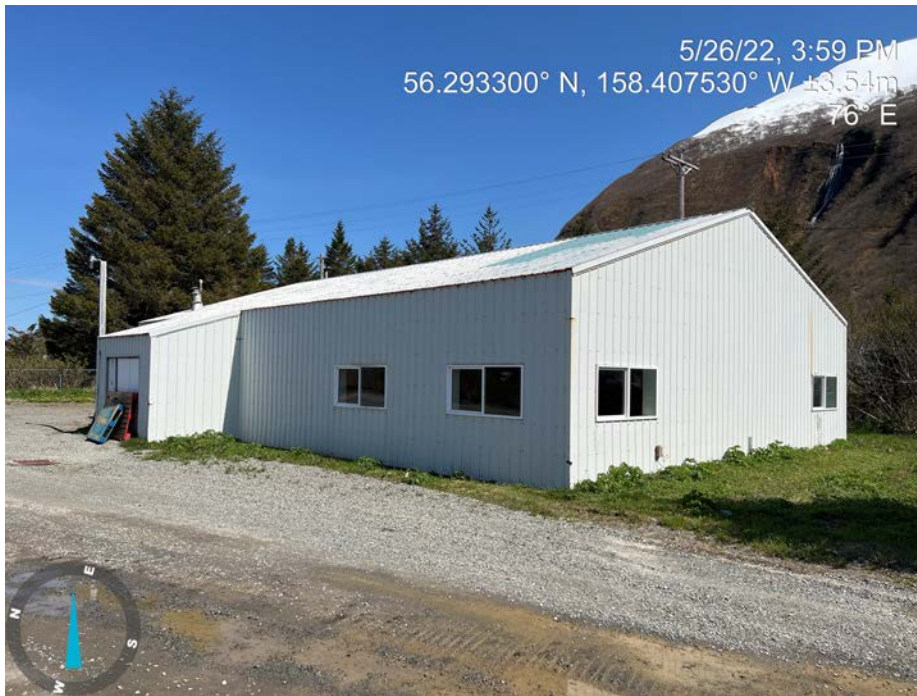
Infrastructure Name:	16 - Community Hall
Location (lat & long):	56.293484, -158.407086
Owner (Commercial, Residential, or Public):	Public, City of Chignik
Function:	Public gathering, some groceries for sale, game hall
Dimensions:	61.5' x 40'
Date Constructed:	
Age (years):	
Foundation Type:	*Wood beams, concrete planks
Condition:	Good
Utilities (water, sewer, electric, communications, gas, heating oil):	Electric, heating oil, water
Prone to flooding?	No visual evidence
Prone to erosion?	No visual evidence
Prone to landslide/avalanche?	No visual evidence
Drainage problems?	No visual evidence
Cause of Failure (if any, date issue started):	No visual evidence
Proposed facility improvements:	N/A
Defend in place strategies:	N/A
Alternative locations:	N/A
Other Notes:	*Metal siding / roof *Trench of some sort on the back side (unsure of cause)

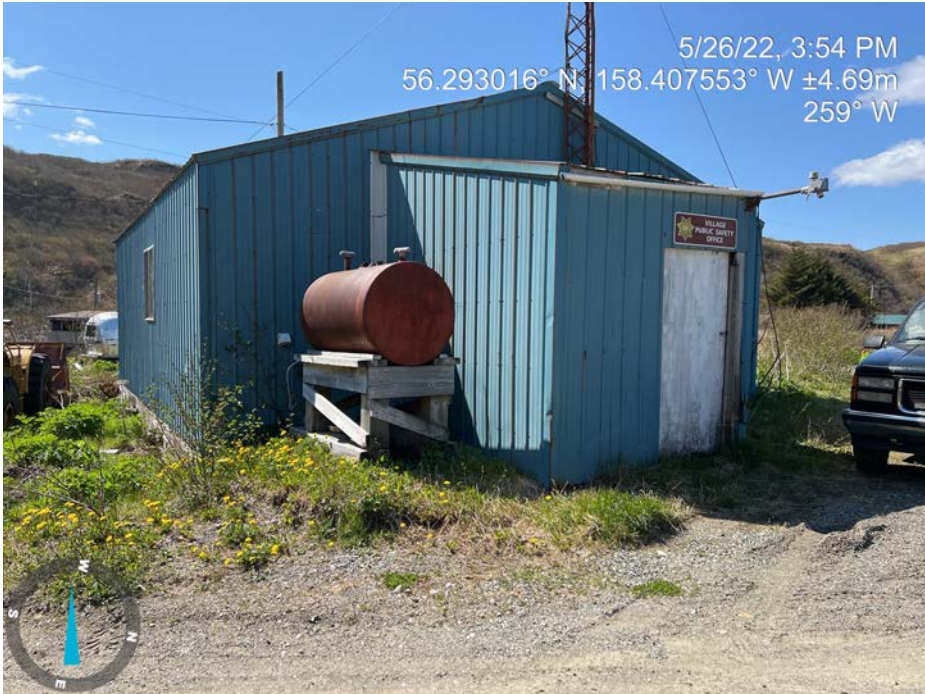
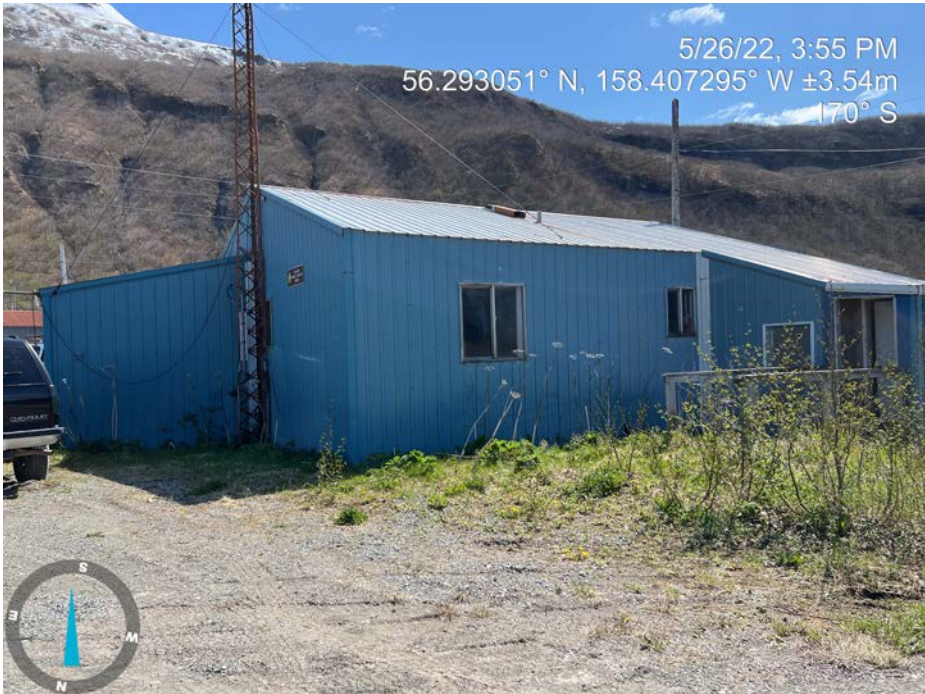
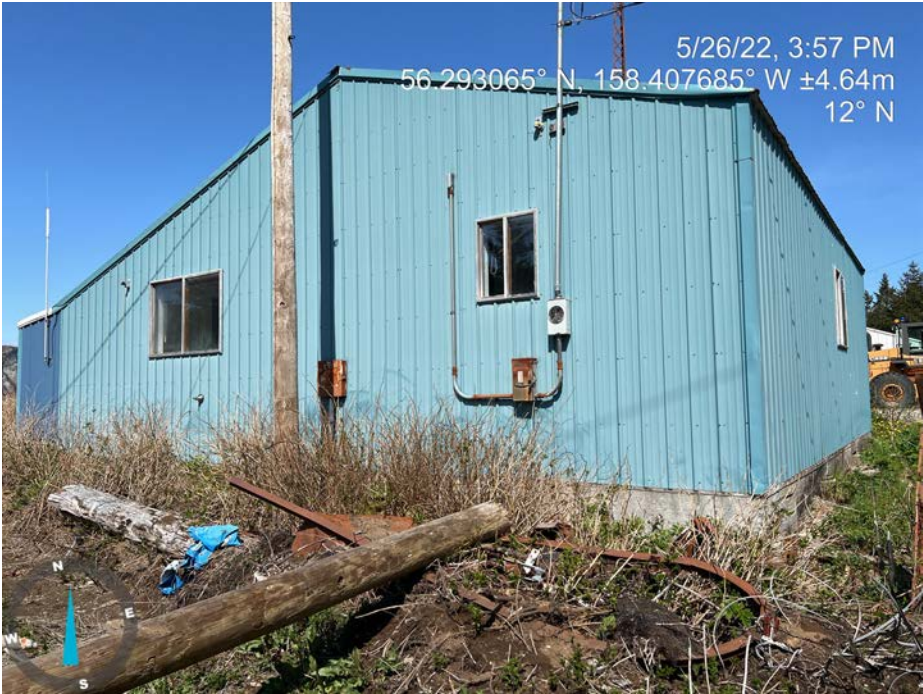
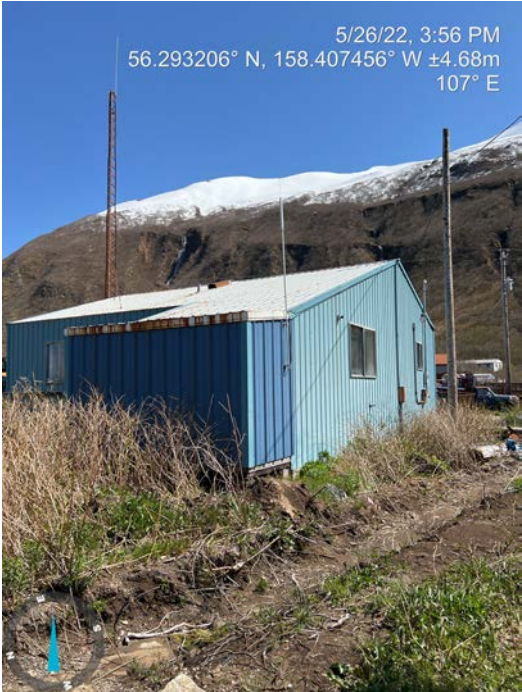
Infrastructure Name:	17 - Public Safety Apartment/Office/Equipment
Location (lat & long):	56.293175, -158.407565
Owner (Commercial, Residential, or Public):	Public, City of Chignik
Function:	Storage, no longer used for housing
Dimensions:	
Date Constructed:	
Age (years):	
Foundation Type:	Wood
Condition:	Poor
Utilities (water, sewer, electric, communications, gas, heating oil):	No visual evidence
Prone to flooding?	No visual evidence
Prone to erosion?	No visual evidence
Prone to landslide/avalanche?	No visual evidence
Drainage problems?	No visual evidence
Cause of Failure (if any, date issue started):	Old/dated structure
Proposed facility improvements:	N/A
Defend in place strategies:	N/A
Alternative locations:	Dispose of structure before it becomes a hazard
Other Notes:	*Old building *Tribe says it needs to be torn down *Metal siding / roof
