# CLIMATE RESILIENCY ACTION PLAN

CHIGNIK BAY TRIBAL COUNCIL  
Chignik Bay, Alaska

FINAL (Revision 0)

Bristol Project No. 3222067

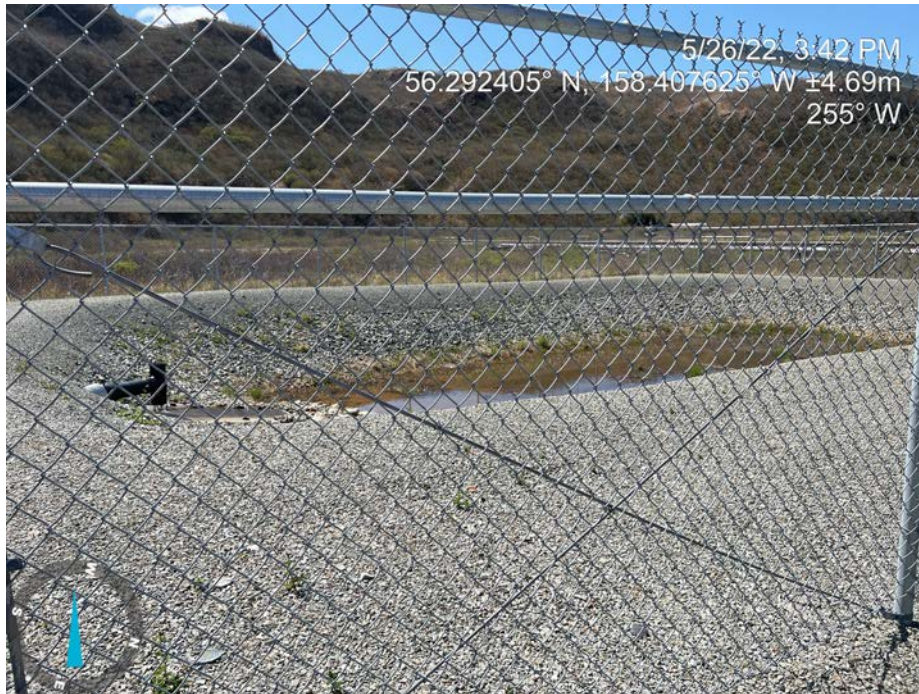
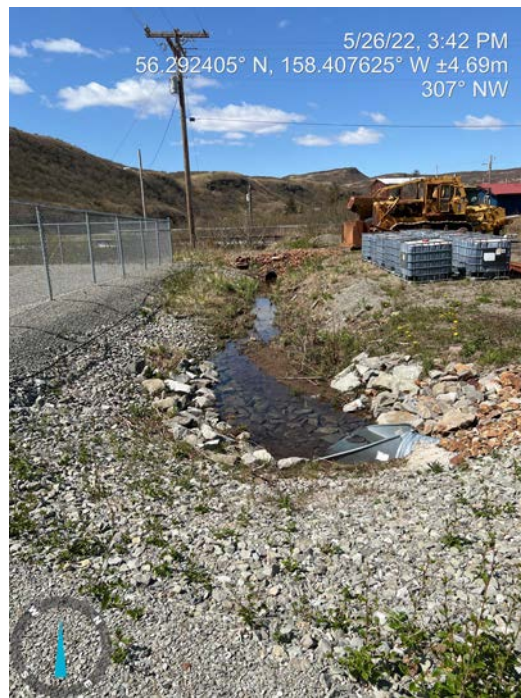
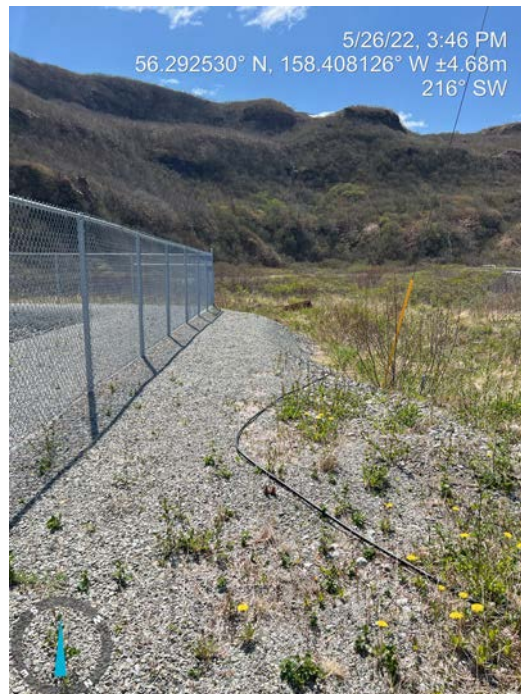
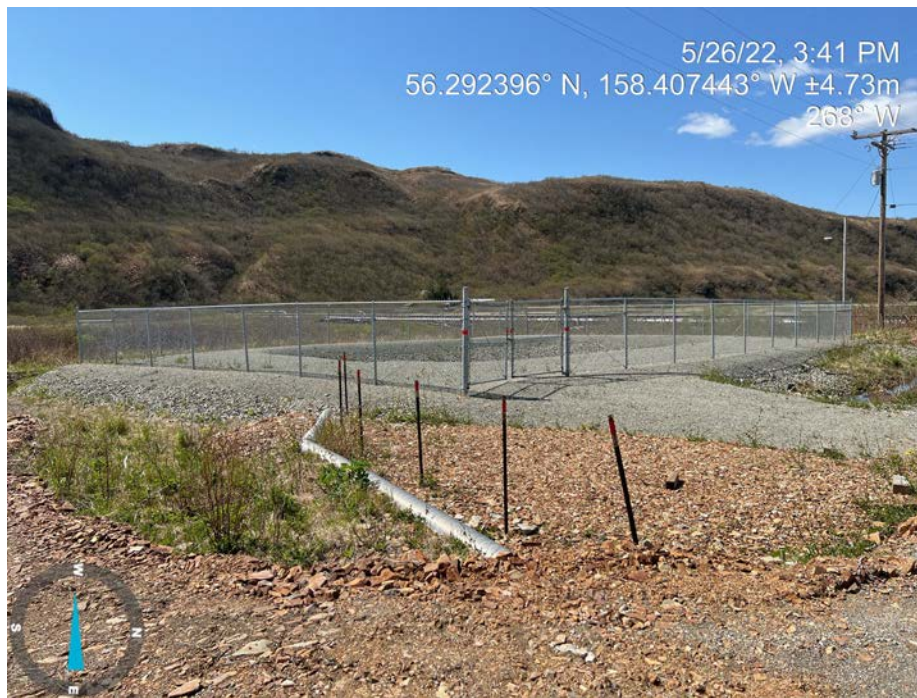
Infrastructure Name:	18 - Water Treatment Plant Backwash Lagoon
Location (lat & long):	56.292432, -158.407997
Owner (Commercial, Residential, or Public):	Public, City of Chignik (ANTHC)
Function:	Water Treatment
Dimensions:	65' x 94.5'
Date Constructed:	
Age (years):	
Foundation Type:	
Condition:	Good
Utilities (water, sewer, electric, communications, gas, heating oil):	Water
Prone to flooding?	No visual evidence *some evidence of marsh around perimeter
Prone to erosion?	No visual evidence
Prone to landslide/avalanche?	No visual evidence
Drainage problems?	No visual evidence
Cause of Failure (if any, date issue started):	No visual evidence
Proposed facility improvements:	Improve drainage around lagoon with adequate ditching
Defend in place strategies:	N/A
Alternative locations:	N/A
Other Notes:	*Gravel pad embankment *Fenced off

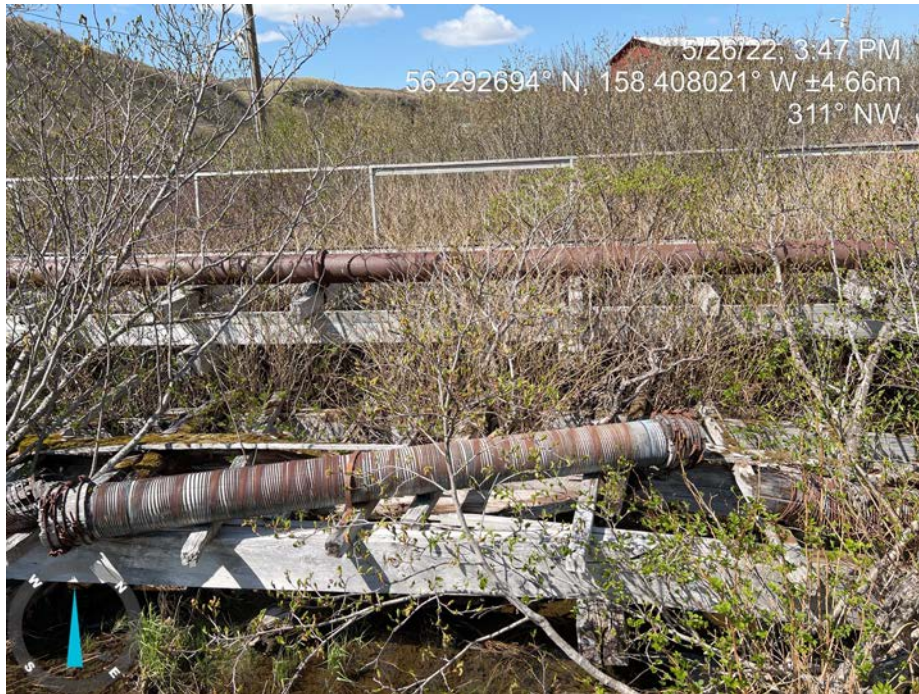
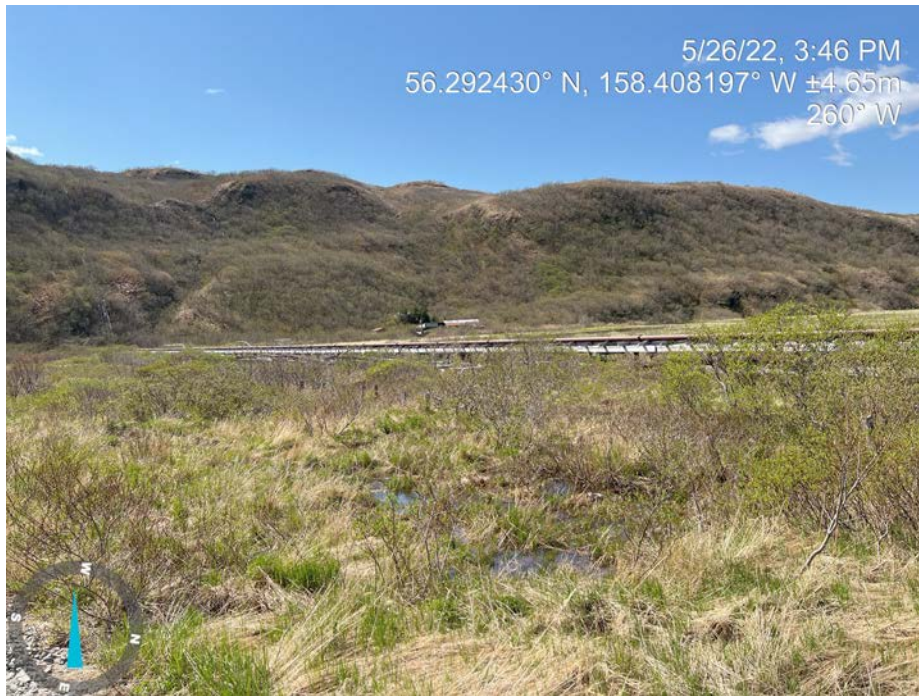
Infrastructure Name:	19 - Water Trestle
Location (lat & long):	56.291922, -158.411178
Owner (Commercial, Residential, or Public):	Public, City of Chignik
Function:	Water Supply
Dimensions:	
Date Constructed:	
Age (years):	
Foundation Type:	Trestle
Condition:	Poor
Utilities (water, sewer, electric, communications, gas, heating oil):	Water
Prone to flooding?	No
Prone to erosion?	Yes
Prone to landslide/avalanche?	Yes
Drainage problems?	Yes
Cause of Failure (if any, date issue started):	Leaks from old pipe, wood trestle in poor condition, ice build up on trestle and pipe in winter
Proposed facility improvements:	Replace trestle, replace water line
Defend in place strategies:	N/A
Alternative locations:	N/A
Other Notes:	*Trestle is old and wood is rotting. Not safe to climb anymore. *Water pipe as broken several times over the past years.

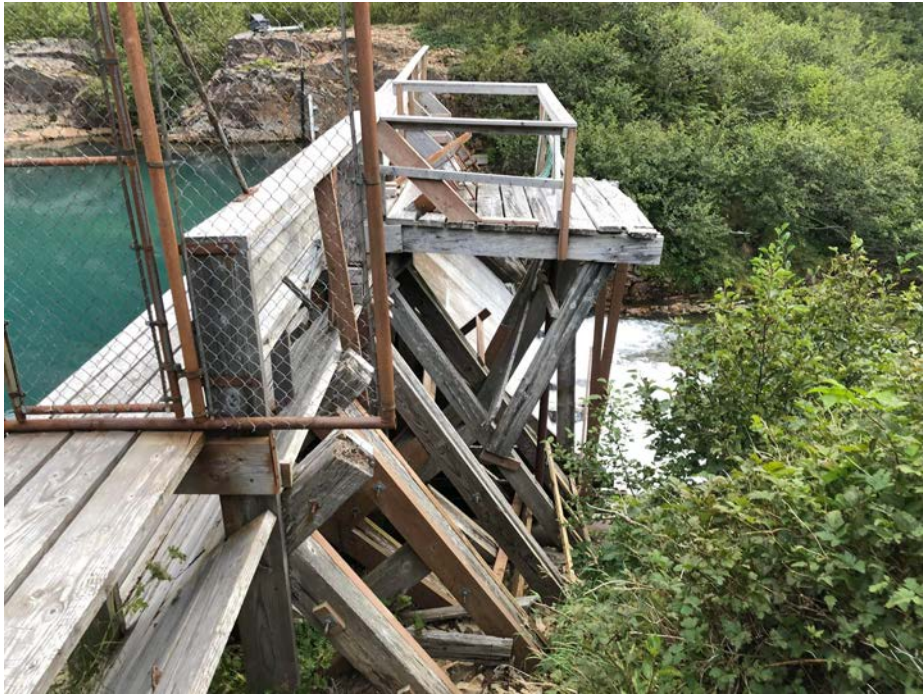
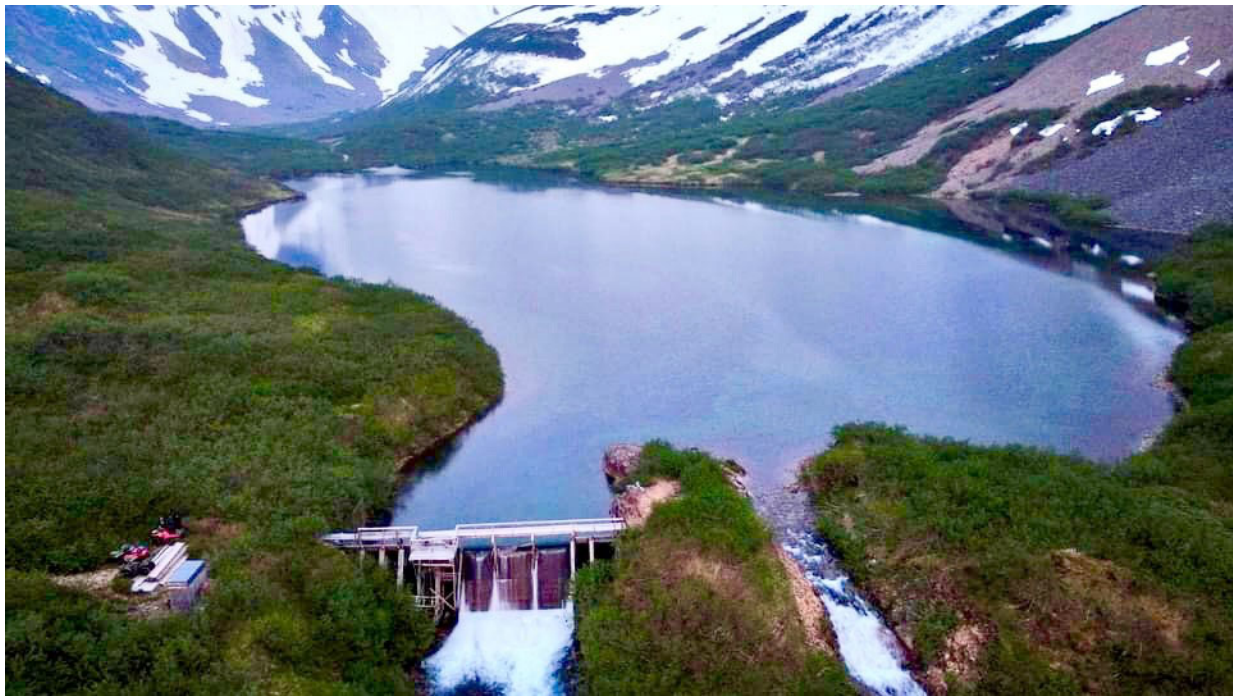
Infrastructure Name:	20 - Indian Lake Dam
Location (lat & long):	56.280065, -158.413964
Owner (Commercial, Residential, or Public):	
Function:	Water Intake for Raw Water Line
Dimensions:	
Date Constructed:	1940
Age (years):	82
Foundation Type:	Dam
Condition:	Unsatisfactory
Utilities (water, sewer, electric, communications, gas, heating oil):	Water
Prone to flooding?	No
Prone to erosion?	Yes
Prone to landslide/avalanche?	No
Drainage problems?	Yes
Cause of Failure (if any, date issue started):	
Proposed facility improvements:	
Defend in place strategies:	
Alternative locations:	
Other Notes:	* Refacing needed *Can still see the old wood piping *City currently working to finish road to dam (3/4 way complete)

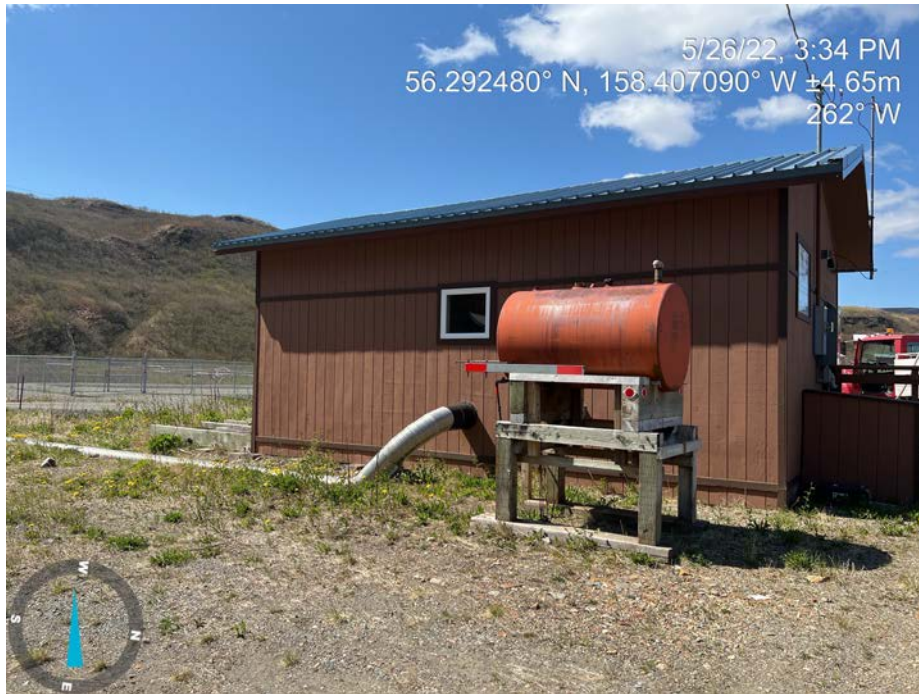
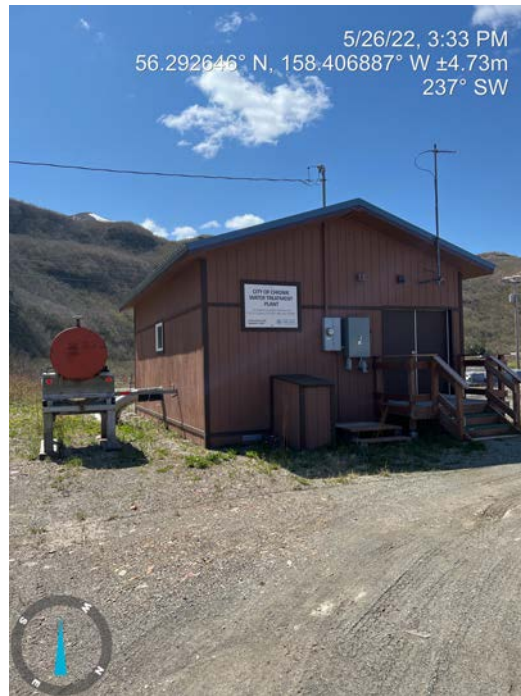
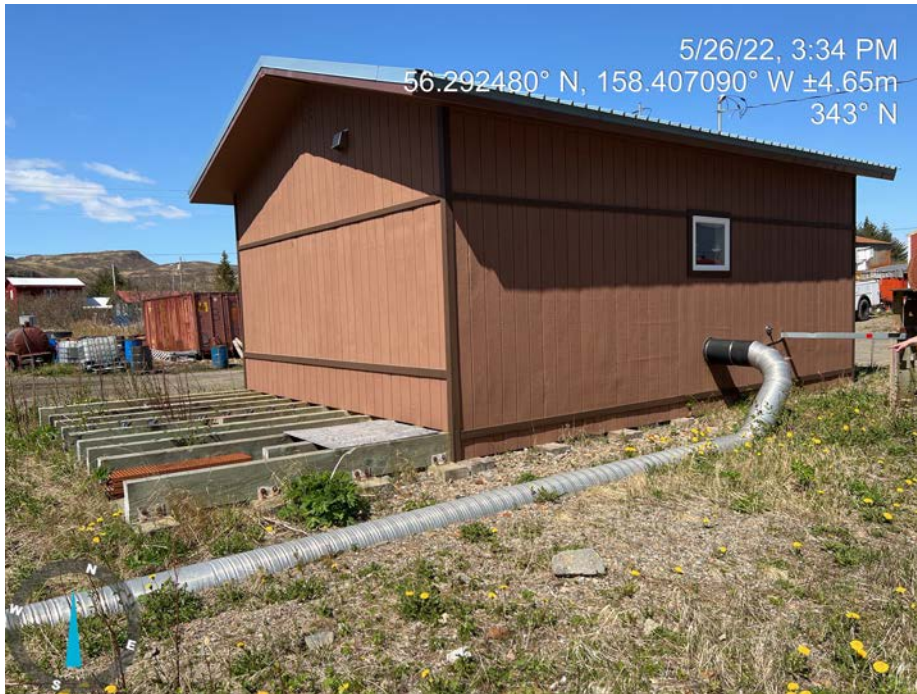
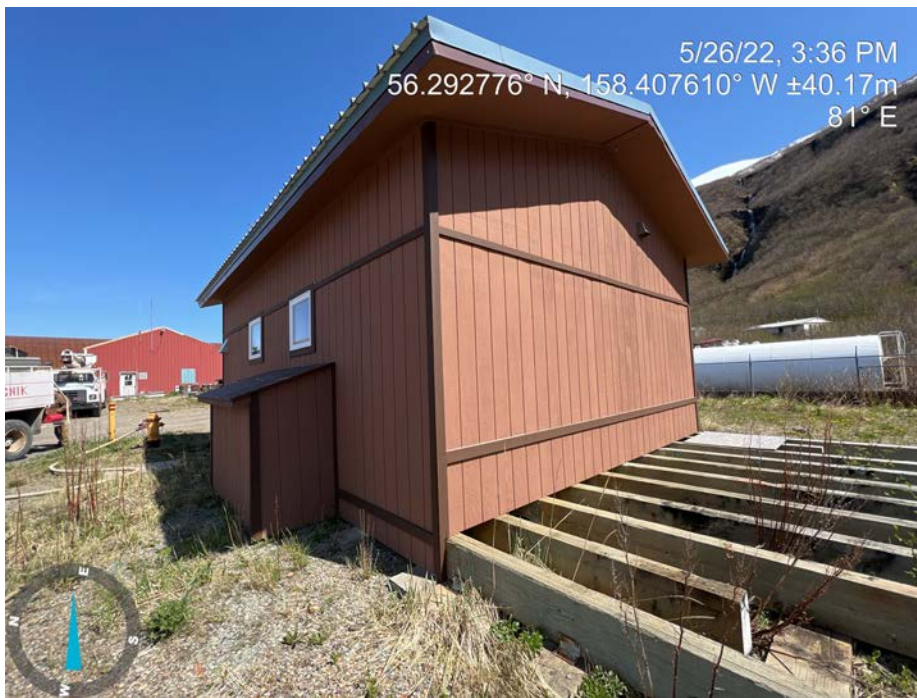
Infrastructure Name:	21 - Water Treatment Plant
Location (lat & long):	56.292622, -158.407251
Owner (Commercial, Residential, or Public):	Public, City of Chignik (ANTHC)
Function:	Water Treatment
Dimensions:	20.5' x 29'
Date Constructed:	*Constructed in 1987 *Updated in 2018
Age (years):	4
Foundation Type:	Wood
Condition:	Good (Like new)
Utilities (water, sewer, electric, communications, gas, heating oil):	Water, electric, gas
Prone to flooding?	No visual evidence
Prone to erosion?	No visual evidence
Prone to landslide/avalanche?	No visual evidence
Drainage problems?	No visual evidence
Cause of Failure (if any, date issue started):	N/A
Proposed facility improvements:	N/A
Defend in place strategies:	N/A
Alternative locations:	N/A
Other Notes:	*Wood T1/11 siding *Metal roof

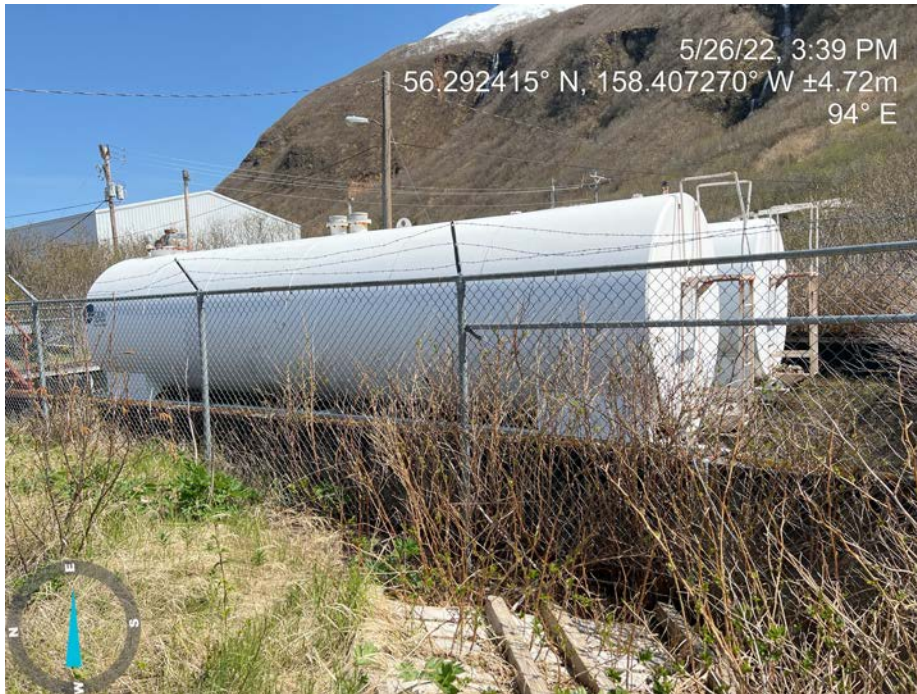
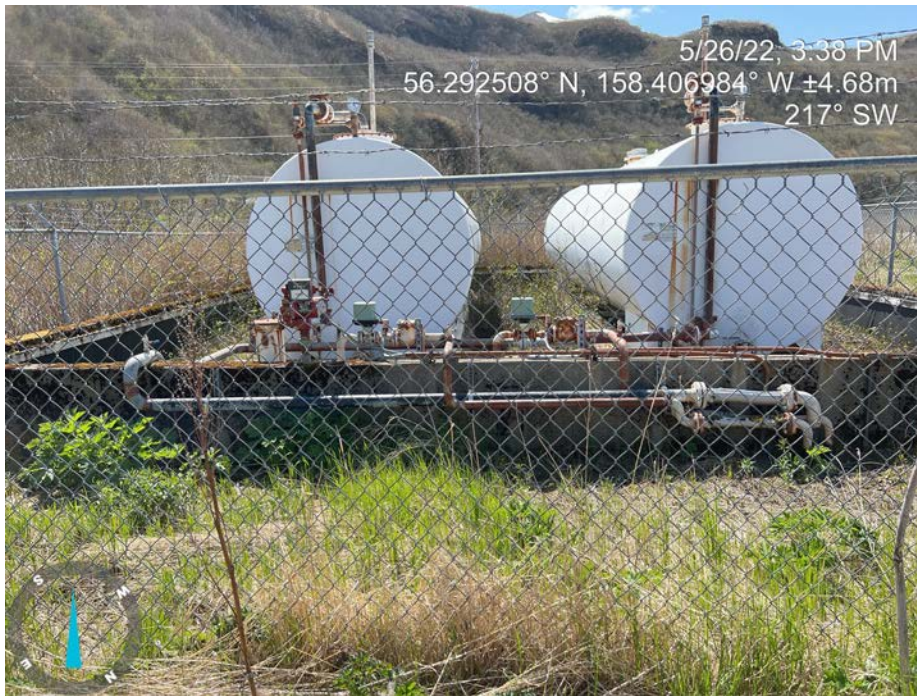
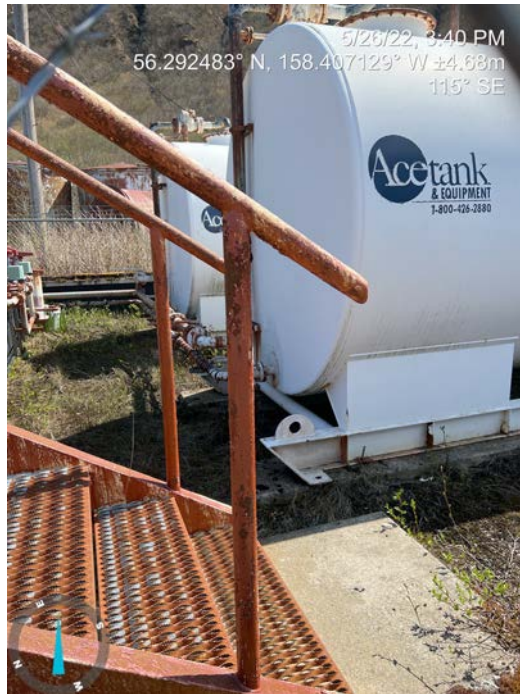
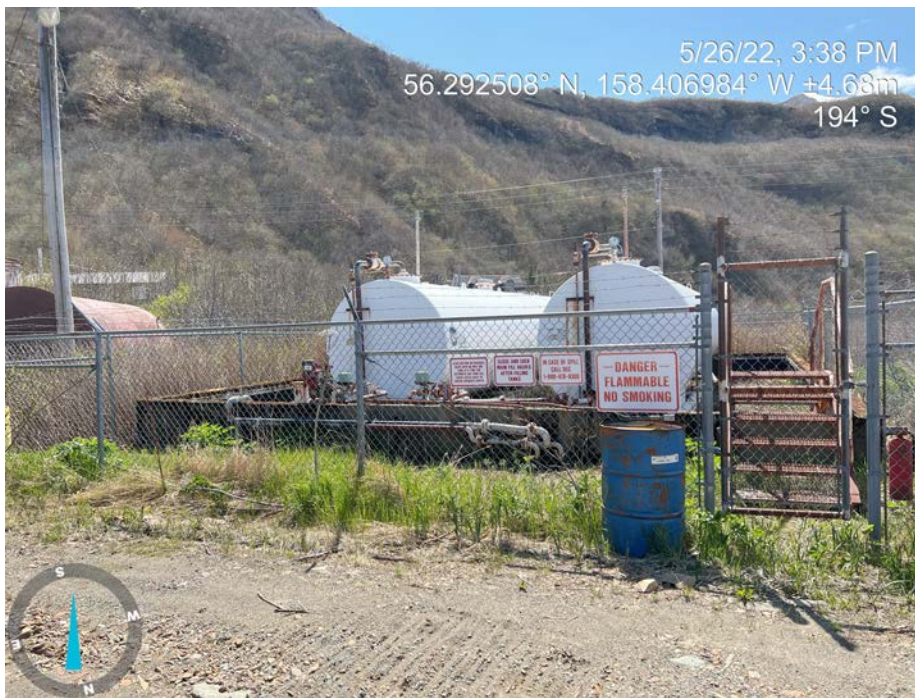
Infrastructure Name:	22 - School Tank Farm
Location (lat & long):	56.292416, -158.407089
Owner (Commercial, Residential, or Public):	Public, Lake and Peninsula School District
Function:	Fuel Supply
Dimensions:	
Date Constructed:	
Age (years):	
Foundation Type:	Metal skid on concrete planks
Condition:	Good
Utilities (water, sewer, electric, communications, gas, heating oil):	Gas, electric
Prone to flooding?	No visual evidence
Prone to erosion?	No visual evidence
Prone to landslide/avalanche?	No visual evidence
Drainage problems?	No visual evidence
Cause of Failure (if any, date issue started):	N/A
Proposed facility improvements:	N/A
Defend in place strategies:	N/A
Alternative locations:	N/A
Other Notes:	*Containment - concrete lined w/ black material

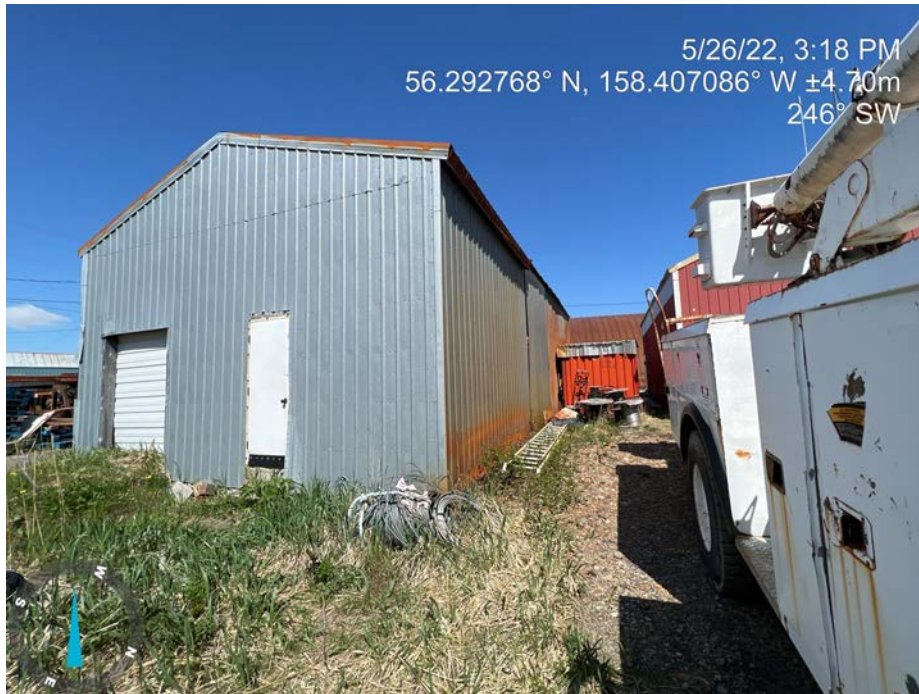
Infrastructure Name:	23 - Storage Unit
Location (lat & long):	56.292830, -158.406744
Owner (Commercial, Residential, or Public):	Public, City of Chignik
Function:	Storage
Dimensions:	49' x 25'
Date Constructed:	
Age (years):	
Foundation Type:	Concrete slab on grade
Condition:	*Good w/minor issues at corners *Minor siding needs
Utilities (water, sewer, electric, communications, gas, heating oil):	Electric, gas
Prone to flooding?	No visual evidence
Prone to erosion?	No visual evidence
Prone to landslide/avalanche?	No visual evidence
Drainage problems?	No visual evidence
Cause of Failure (if any, date issue started):	Minor siding damage
Proposed facility improvements:	Replace/patch siding and roofing as needed
Defend in place strategies:	N/A
Alternative locations:	N/A
Other Notes:	*Metal building *3,000 gal fuel tank (empty)

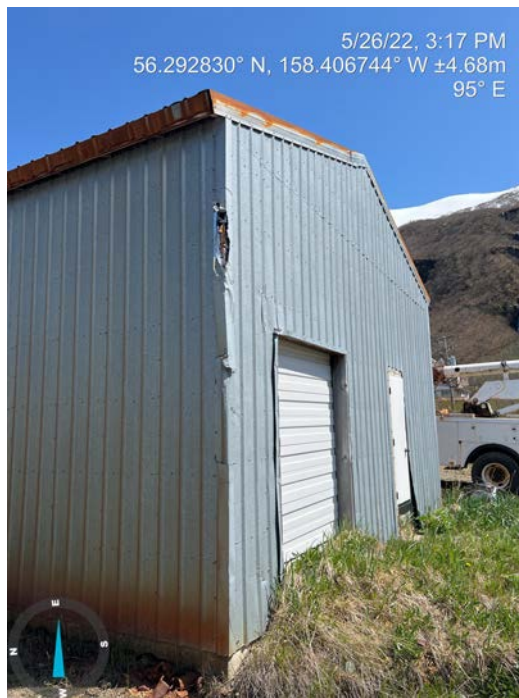
Damaged Siding  
1 of 2

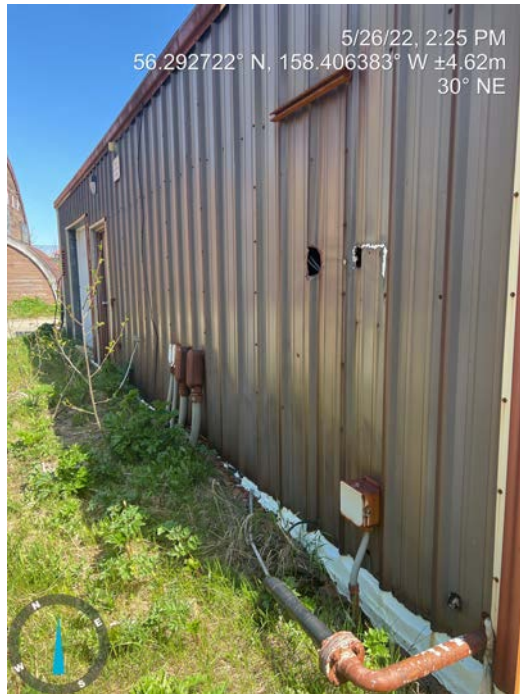
Infrastructure Name:	26 - School Generator
Location (lat & long):	56.292722, -158.406383
Owner (Commercial, Residential, or Public):	Public, Lake and Peninsula School District
Function:	Power
Dimensions:	
Date Constructed:	
Age (years):	
Foundation Type:	Concrete slab on grade
Condition:	Good
Utilities (water, sewer, electric, communications, gas, heating oil):	Electric, gas
Prone to flooding?	No visual evidence
Prone to erosion?	No visual evidence
Prone to landslide/avalanche?	No visual evidence
Drainage problems?	No visual evidence
Cause of Failure (if any, date issue started):	N/A
Proposed facility improvements:	N/A
Defend in place strategies:	N/A
Alternative locations:	N/A
Other Notes:	*Metal siding w/ a few holes

Damaged Siding

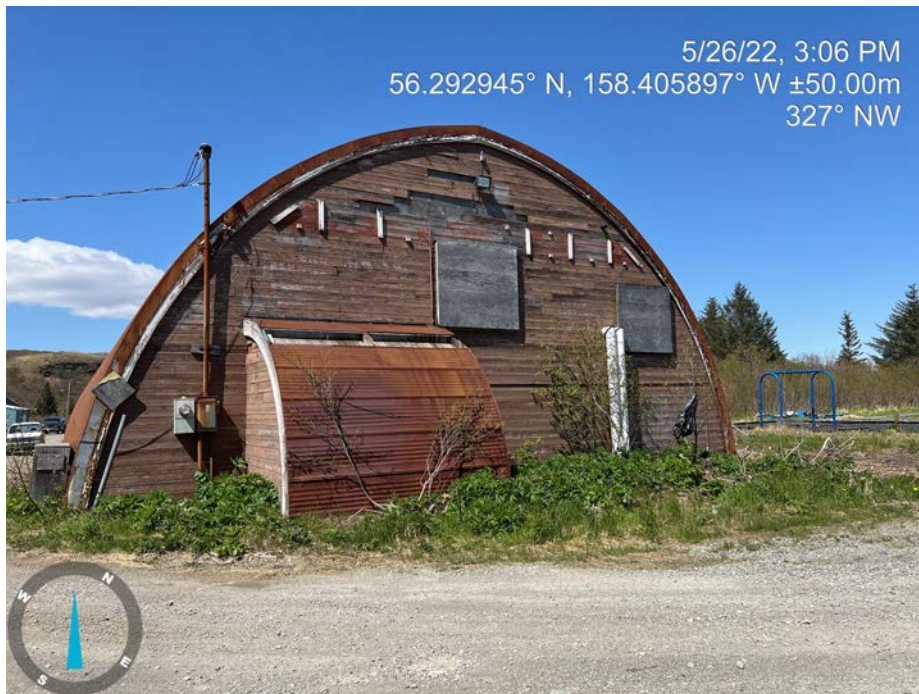
Infrastructure Name:	27 - City Shop / Equipment
Location (lat & long):	56.292904, -158.406444
Owner (Commercial, Residential, or Public):	Public, City of Chignik
Function:	Workspace / Equipment/ Tools
Dimensions:	52' x 103'
Date Constructed:	
Age (years):	
Foundation Type:	Concrete slab on grade
Condition:	*Wood ends (worn) *Metal siding (rusted, bent, torn)
Utilities (water, sewer, electric, communications, gas, heating oil):	Electric, gas
Prone to flooding?	No visual evidence
Prone to erosion?	No visual evidence
Prone to landslide/avalanche?	No visual evidence
Drainage problems?	No visual evidence
Cause of Failure (if any, date issue started):	Rust
Proposed facility improvements:	*Patch/replace metal dome & wood ends
Defend in place strategies:	N/A
Alternative locations:	N/A
Other Notes:	*Old *Double metal layer with wood between (circular) *Concrete foundation broken (visual from one side)

Damaged Exterior Dome  
1 of 2

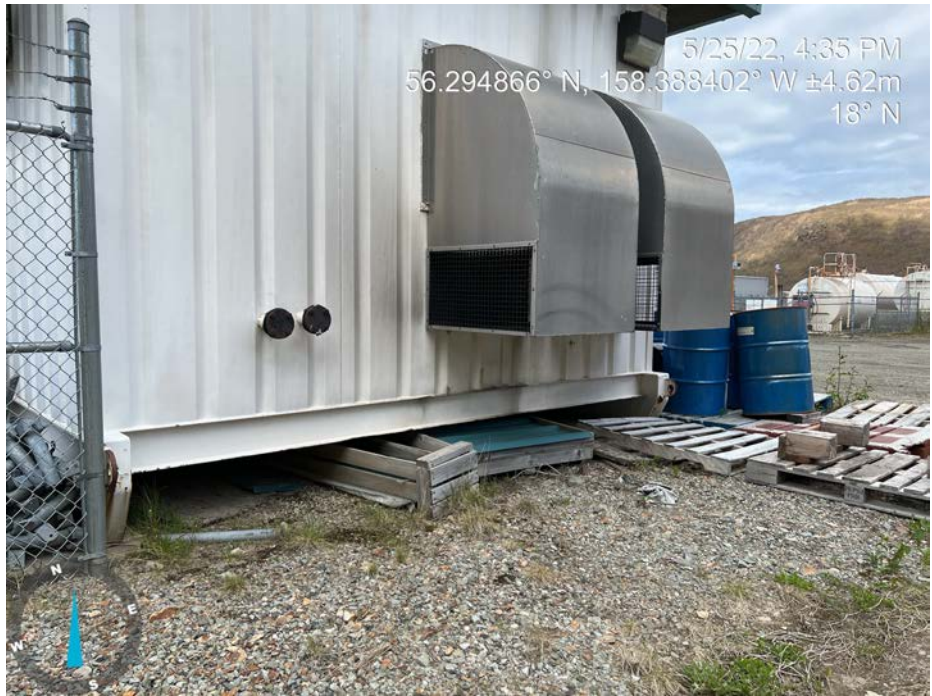
Metal Skid Foundation

Infrastructure Name:	30 - City Generator Building
Location (lat & long):	56.294866, -158.388402
Owner (Commercial, Residential, or Public):	Public, City of Chignik
Function:	Power Generation
Dimensions:	40' x 15.5'
Date Constructed:	2008
Age (years):	14
Foundation Type:	Metal Skid
Condition:	Good
Utilities (water, sewer, electric, communications, gas, heating oil):	heating oil, electric
Prone to flooding?	No
Prone to erosion?	No
Prone to landslide/avalanche?	landslides/avalanches have happened in past and have come close to hitting building
Drainage problems?	No
Cause of Failure (if any, date issue started):	N/A
Proposed facility improvements:	N/A
Defend in place strategies:	N/A
Alternative locations:	Move further away from base of landslide area towards shoreline and build gravel pad to safe flood elevation
Other Notes:	*Empty barrels next to building

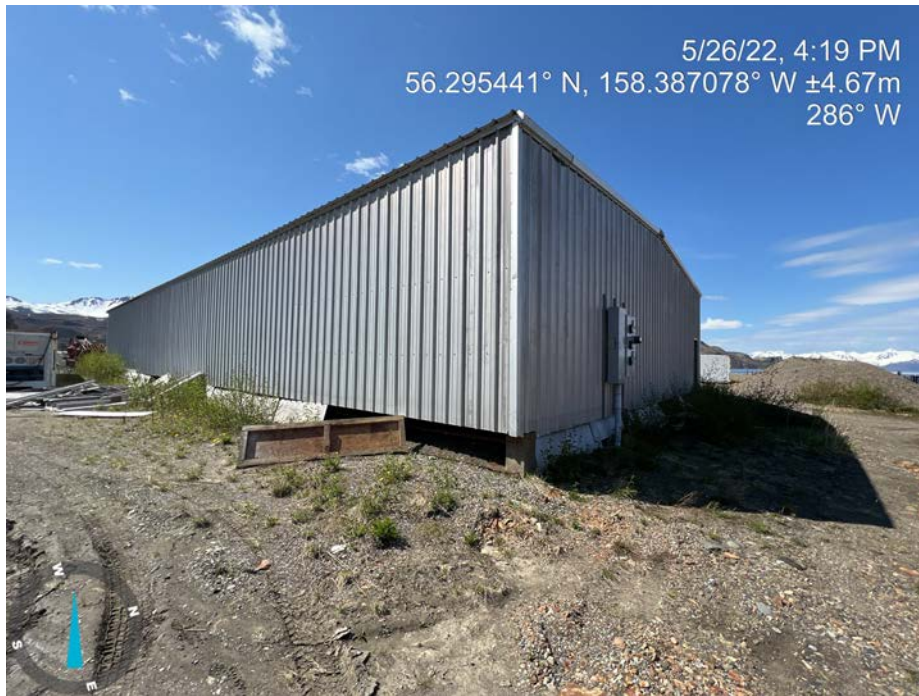
Infrastructure Name:	33 - Subsistence Building
Location (lat & long):	56.295545, -158.387627
Owner (Commercial, Residential, or Public):	Public, City of Chignik
Function:	Subsistence Use
Dimensions:	51' x 121'
Date Constructed:	2005
Age (years):	17
Foundation Type:	Concrete pad (broken up with rebar exposed) *rebar can be seen in foundation on both sides of building
Condition:	Foundation not in good repair, building not closed to elements
Utilities (water, sewer, electric, communications, gas, heating oil):	Electric, water, gas
Prone to flooding?	No visual evidence
Prone to erosion?	No visual evidence
Prone to landslide/avalanche?	No visual evidence
Drainage problems?	No visual evidence
Cause of Failure (if any, date issue started):	No visual evidence
Proposed facility improvements:	*Reinforce concrete floor *Enclose foundation (new skirt around building)
Defend in place strategies:	N/A
Alternative locations:	N/A

Damaged Concrete Foundation

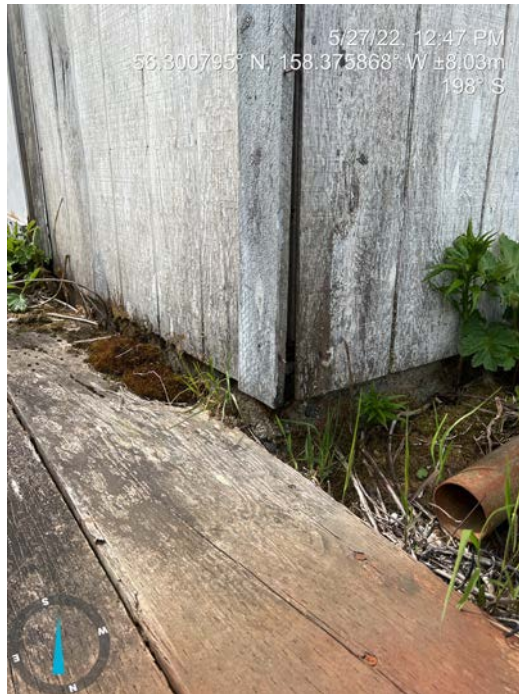
Foundation

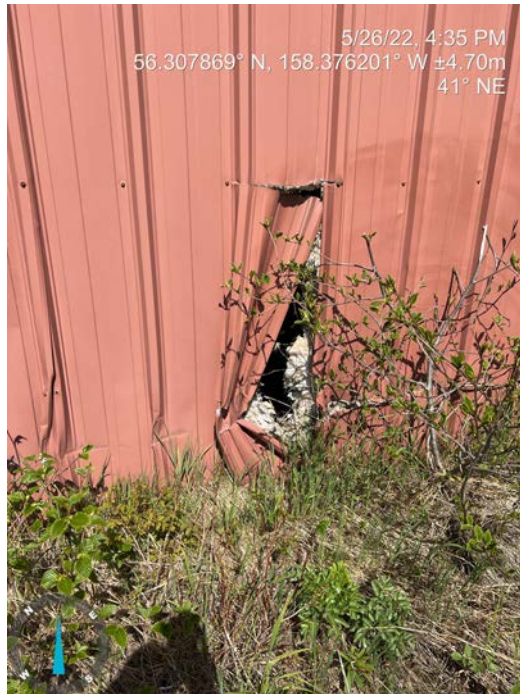
Damaged Siding

Infrastructure Name:	39 - Airport Maintenance Building
Location (lat & long):	56.307901, -158.376091
Owner (Commercial, Residential, or Public):	Public, Alaska Department of Transportation & Public Facilities
Function:	House maintenance equipment used for the runway
Dimensions:	47' x 24.5'
Date Constructed:	
Age (years):	
Foundation Type:	Concrete pad
Condition:	Good
Utilities (water, sewer, electric, communications, gas, heating oil):	
Prone to flooding?	Located in flood zone
Prone to erosion?	Yes
Prone to landslide/avalanche?	No
Drainage problems?	No
Cause of Failure (if any, date issue started):	N/A
Proposed facility improvements:	*Minor siding repairs needed. *New door needed to hold out elements.
Defend in place strategies:	N/A
Alternative locations:	N/A
Other Notes:

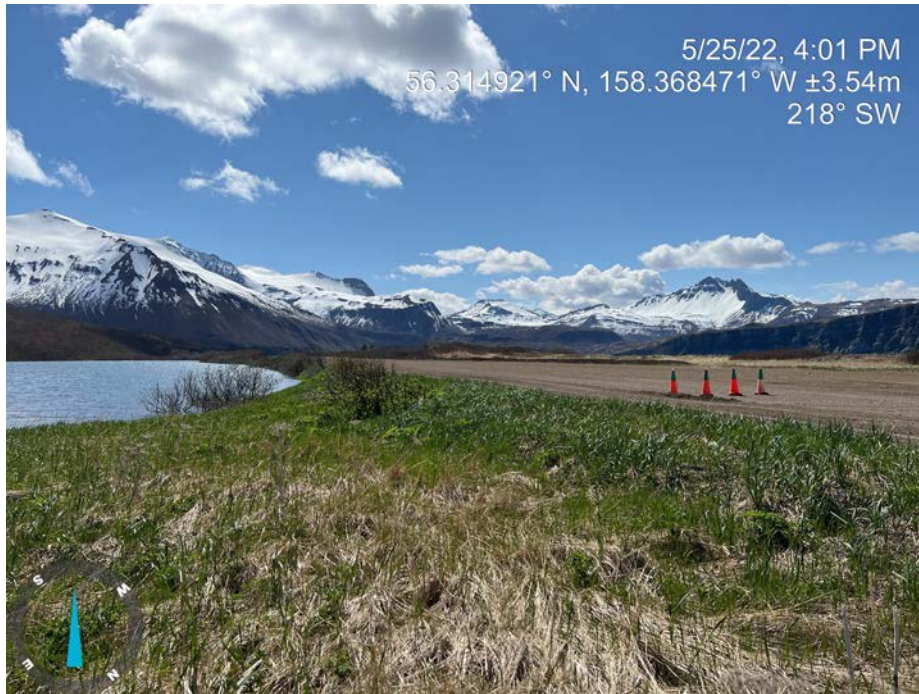
Airport Lake

Alternative locations:	N/A
Other Notes:	*Armor rock at ocean end is smooth with consistent sizes *Rock at the Bay side is more jagged and varying sizes *Lake is located on one side *Runway is soft during spring months due to permafrost melt. *Two airplane crashes in the past 2 years due to mud and rock on runway

Infrastructure Name:	40 - Airport
Location (lat & long):	56.308029, -158.377692
Owner (Commercial, Residential, or Public):	Public, Alaska Department of Transportation & Public Facilities
Function:	Takeoff and Landing of Aircraft
Dimensions:	~2,600' long by 60' wide
Date Constructed:	1968
Age (years):	54
Foundation Type:	Gravel
Condition:	*can become soft in the spring due to permafrost melt and unsatisfactory surface course material
Utilities (water, sewer, electric, communications, gas, heating oil):	
Prone to flooding?	Located in flood zone
Prone to erosion?	Yes, at end of airport runway
Prone to landslide/avalanche?	No
Drainage problems?	Yes
Cause of Failure (if any, date issue started):	Unsatisfactory surface course material, lack of armor rock protecting embankments
Proposed facility improvements:	*Install runway lights *Extend runway into ocean side
Defend in place strategies:	Add armor rock where needed, replace surface course with satisfactory material

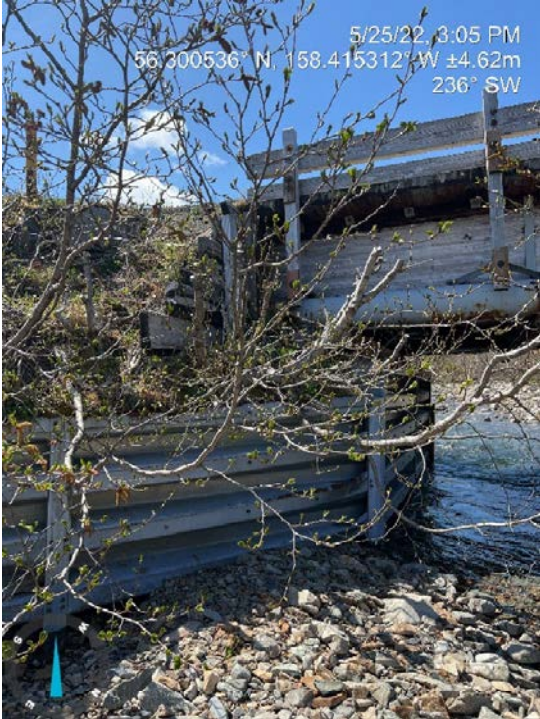
Bank erosion is present along both bridge abutments. The north side upstream bank is eroding into the channel where the stream bends sharply. Erosion can be observed on either side of the abutments at both ends of the bridge. Residents have reported seeing multiple high-water events in Indian Creek causing significant erosion along the bridge abutments.

*South Side Abutment*

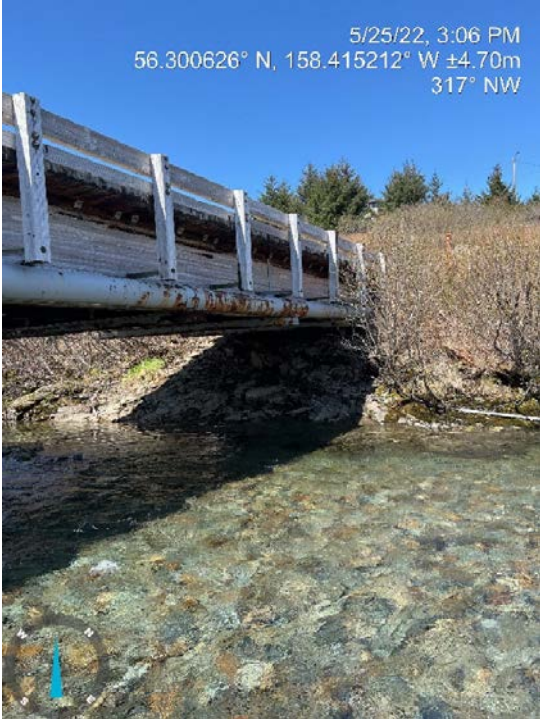
*North Side Abutment*

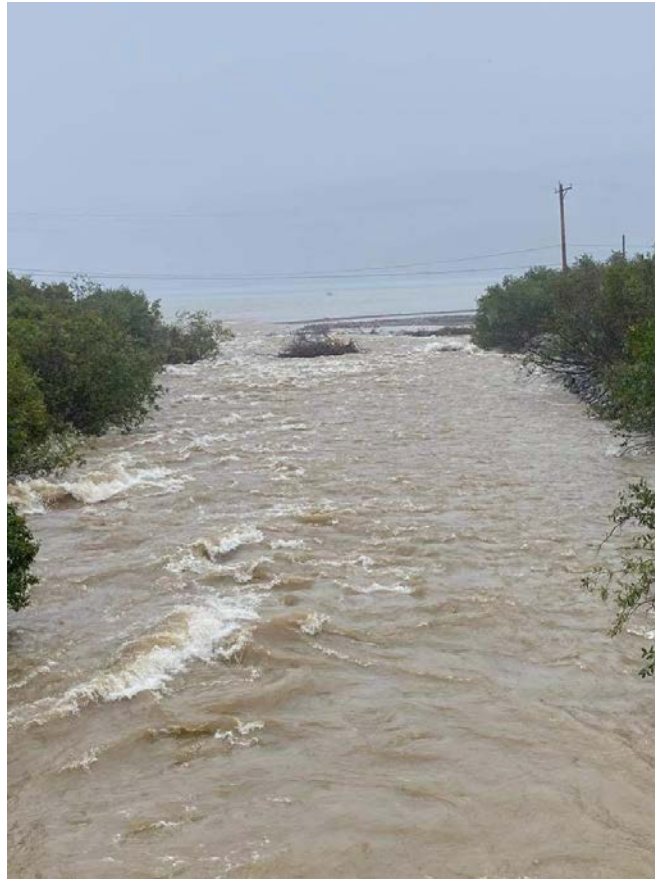
*Downstream of Indian Creek Bridge*

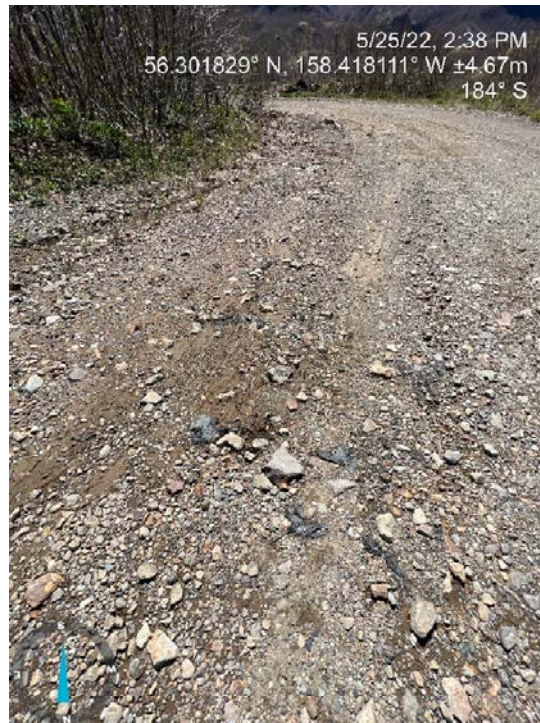
*Exposed Geotextile*

- Constructing ditches along road and adding cobbles or riprap where needed to withstand the erosive forces.
- Placing additional culverts where needed.
- Increase the road width where possible.
- Increase the number of pullouts on the single lane road, and increase the size of the pullouts.
- Add guardrails around the pull outs as warranted.
- Clear brush and alders along the sides of the road to improve visibility and eliminate blind spots at corners.

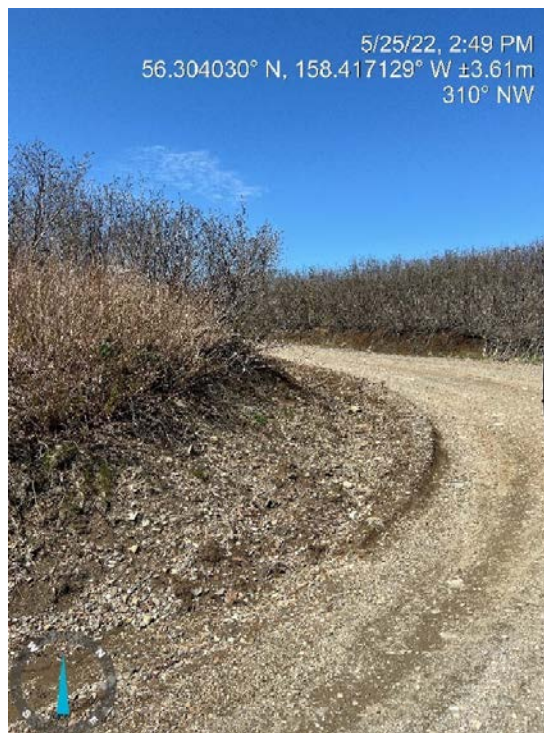
*Washed Out Ditching Around Bend*

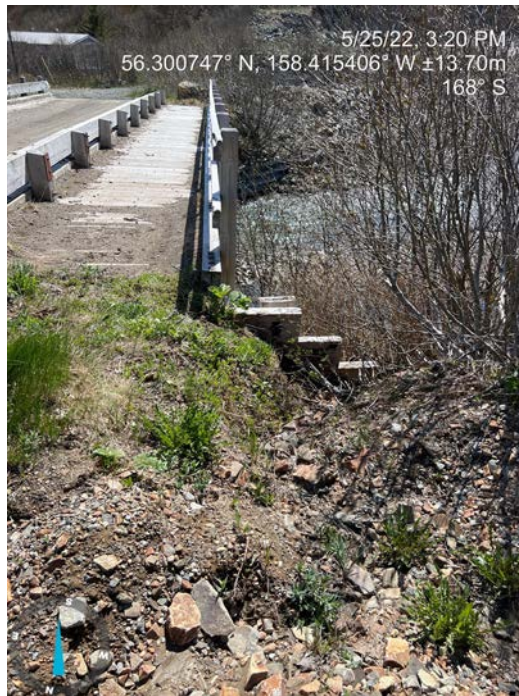
Erosion at South Abutment Wood Wing Wall

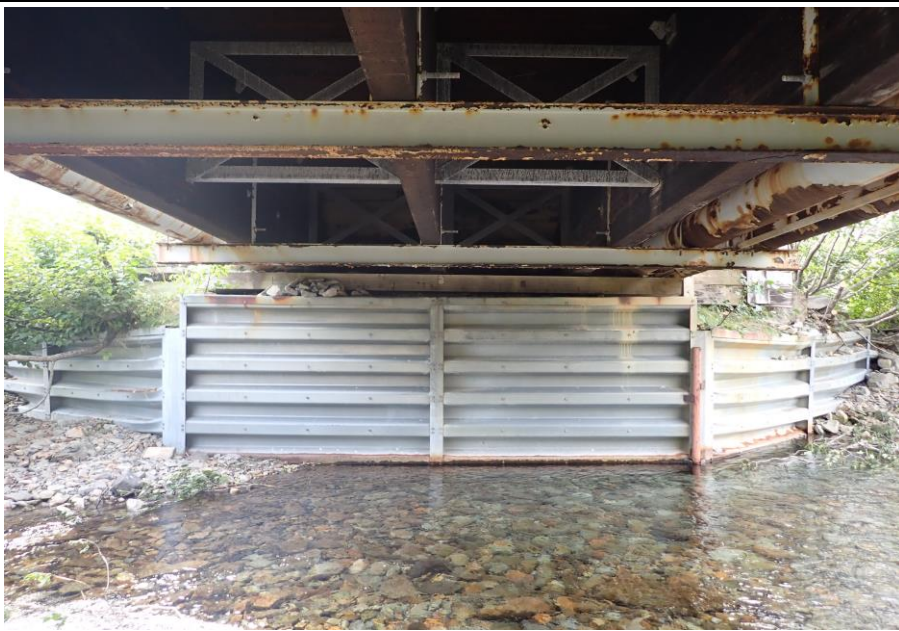
Bridge No.	1764	Br. Name	Indian Creek	Date	09/21/22
Inspector	David McAdoo / Javier De Leon		Frame	11	
NE Abutment			File	P9210434.jpg

<i>Priority</i>	<i>Description</i>	<i>Quantity</i>	<i>Work Needed</i>
High	Substructure-Repair (EA)	1	Re-establish full contact between NE timber mud sill and abutment fill. Repair binwall.
High	Substructure-Repair (EA)	1	Remove and replace the spalled concrete from US side of the FE abutment cap.
Medium	Deck-Resurface (SF)	80	Replace running planks.
Medium	Bridge Rail-Repair (LF)	6	Replace worn and splintered end rail sections (16 feet 10 inches) at both NE sides and both FE sides. Replace split timber posts. Replace damaged rub rail.
Medium	Misc-Install Sign (EA)	6	Install name place signs at each end of the bridge. Install object markers at each corner of the bridge.
Medium	Channel-Repair Washouts / Erosion (EA)	1	Develop project to stabilize NE US bank.

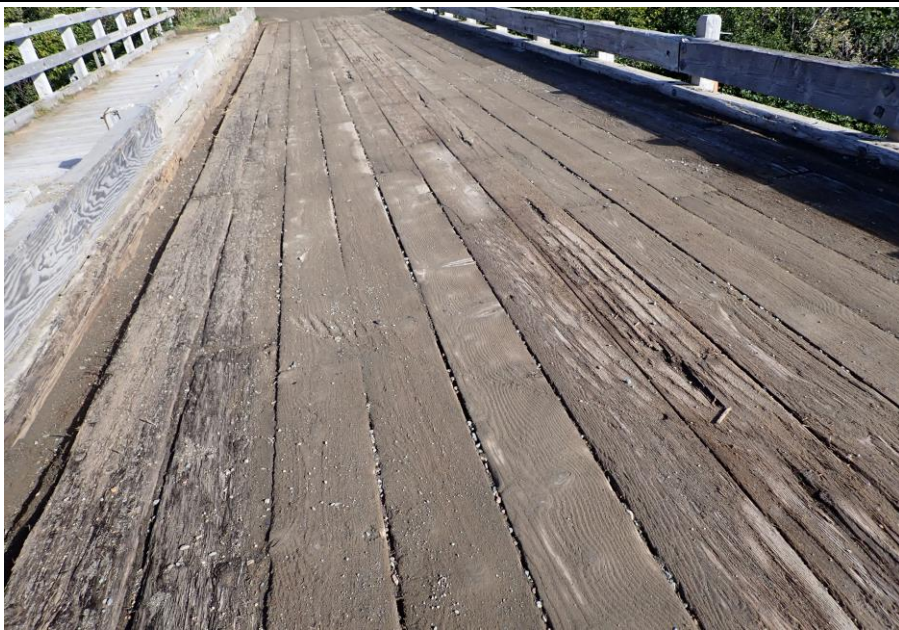
Bridge No.	1764	Br. Name	Indian Creek	Date	09/21/22
Inspector	David McAdoo / Javier De Leon		Frame	19	
Wearing Surface, Typ.			File	P9210408.jpg

<i>Element</i>	<i>Description</i>	<i>Observations</i>
31	Timber Deck	Running plank spikes are driven through the deck and protrude from the soffit and girder bays at the FE.
> 510	Wearing Surfaces	NE DS running planks worn away, a 4-foot by 2-foot section. Running planks in other locations worn, split and checked. Hardware is exposed and bent over at the NE of the deck.
111	Timber Open Girder/Beam	Girder 1 US face, timber preservative is discolored in a few places. Girder 1 has horizontal splits along the DS Face about half way-up and along the girder from midspan to the FE. Girder 2 has horizontal splits along the US Face about half way-up and along the girder from the NE to midspan. Girder 3 DS face, timber preservative is discolored from exposure. Utility hangers bolted to girders are rusty.
218	Other Abutments	NE abutment has timber mud sill and timber backwall. Timber mud is sill undermined 12 to 14 inches along full length. At the ends, the timber mud sill is undermined 3-feet. Steel binwalls retain soil to support the mud sill. The binwall us rusted out at streamline at NE. Binwalls are bent and twisted at NE DS and NE US corners.  FE abutment has concrete footing and timber backwall. The concrete footing is soft, spalled and deteriorated at FE US side near exterior girder bearing for about 9-feet. The FE US bearing plate has lost approximately 2-inches of bearing area around the edges. The concrete footing is soft, spalled, and deteriorated under Bay 2 around the post tensioning rods in the concrete.  Top of both timber backwalls tilt away from bridge. Gap is present but no loss of material visible at FE. Definite loss of material at NE.

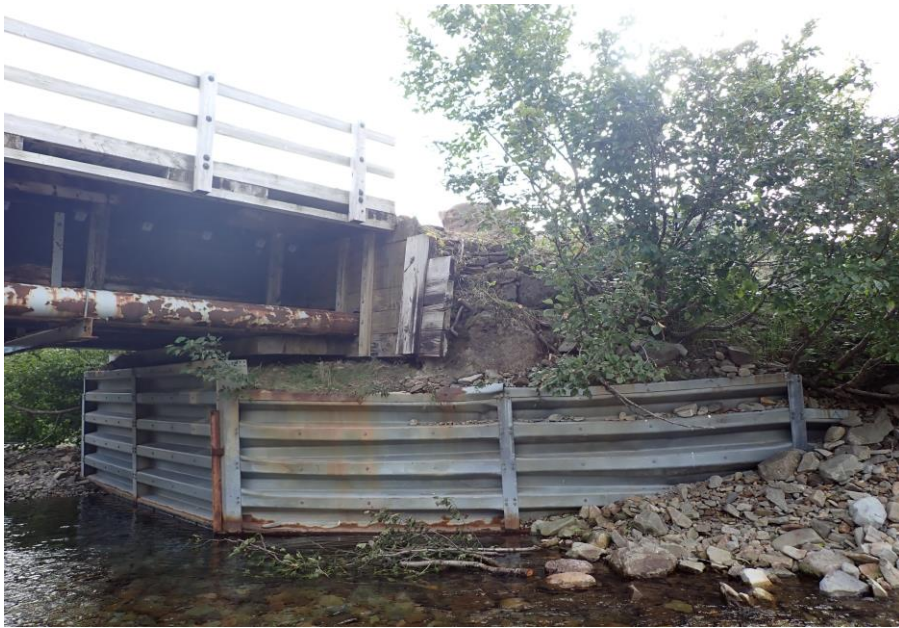
Bridge No. 1764 Br. Name Indian Creek Date 09/21/22  
 Inspector David McAdoo / Javier De Leon Frame 21  
 NE US Backwall Separation File P9210436.jpg

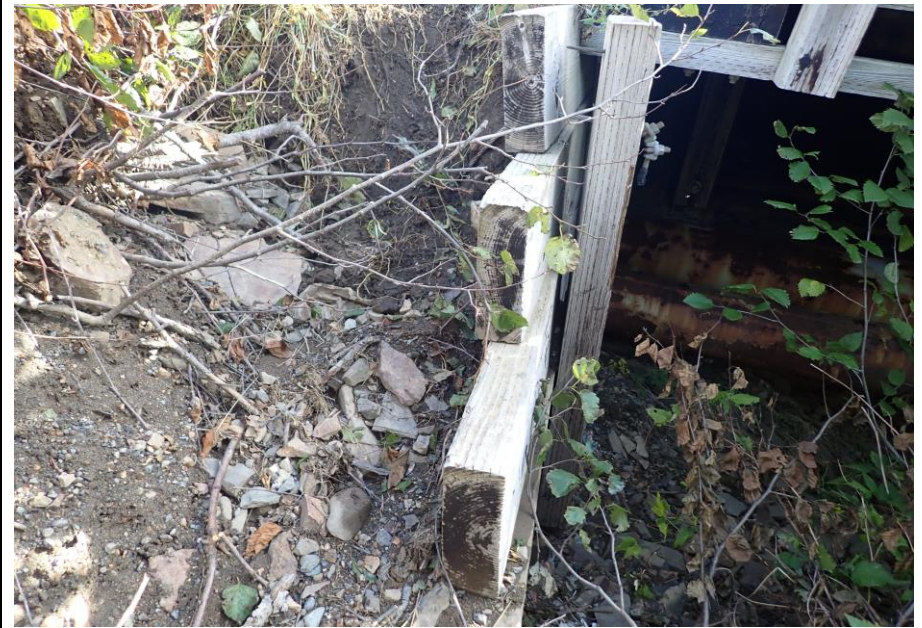
Bridge No. 1764 Br. Name Indian Creek Date 09/21/22  
 Inspector David McAdoo / Javier De Leon Frame 22  
 FE US Backwall Separation File P9210423.jpg
