# CLIMATE RESILIENCY ACTION PLAN

CHIGNIK BAY TRIBAL COUNCIL  
Chignik Bay, Alaska

FINAL (Revision 0)

Bristol Project No. 3222067

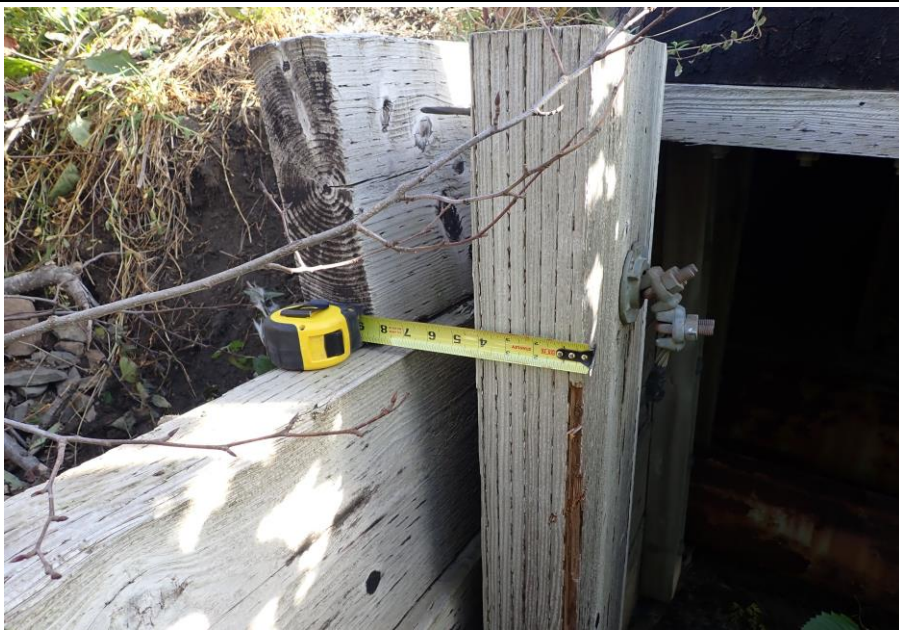
Bridge No. 1764 Br. Name Indian Creek Date 09/21/22  
 Inspector David McAdoo / Javier De Leon Frame 23  
 FE US Backwall Separation File P9210424.jpg

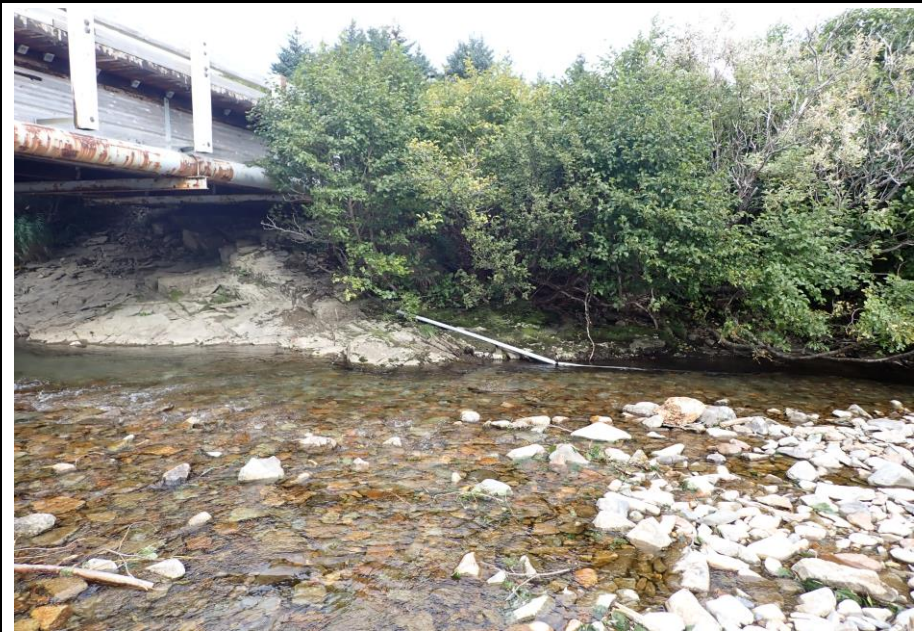
Bridge No. 1764 Br. Name Indian Creek Date 09/21/22  
 Inspector David McAdoo / Javier De Leon Frame 27  
 Looking Through FE US Culvert File P9210422.jpg

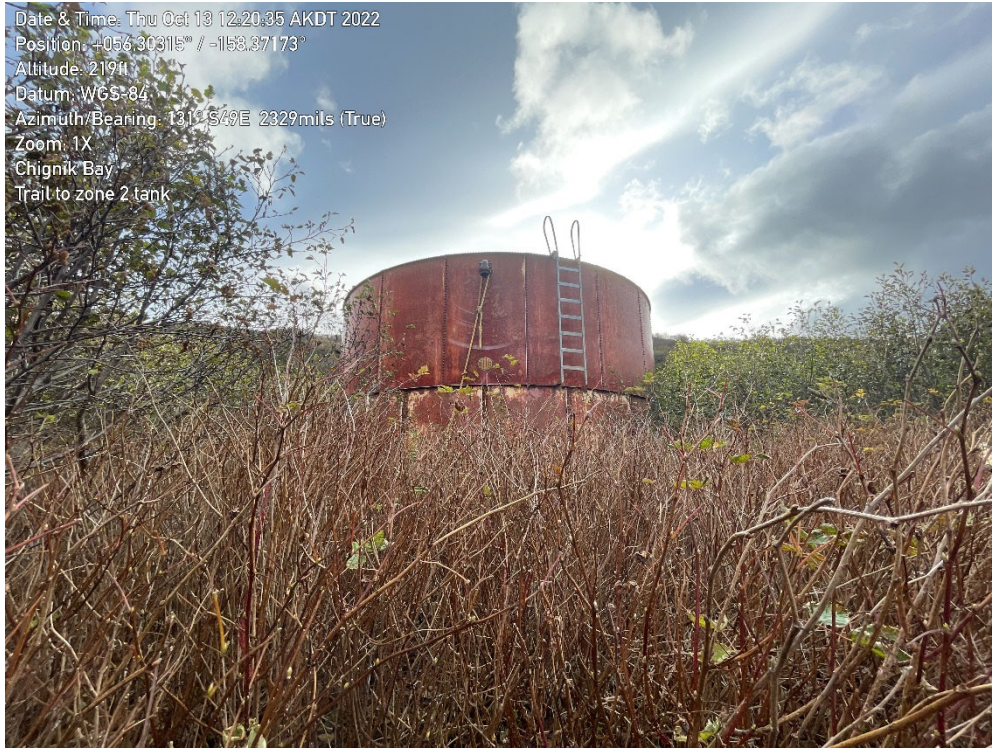
*Old East Side Water Storage Tank*

storage tank would give residents a safe and warm place to stay during tsunami evacuations if residents did not have time to travel across town to the west side tsunami shelter. If the east side old water storage tank's condition was found to not be suitable for this function, it could be removed, and its foundation incorporated into the new tsunami shelter. This project would provide access to safe shelter for the entire Community in the event of a tsunami.

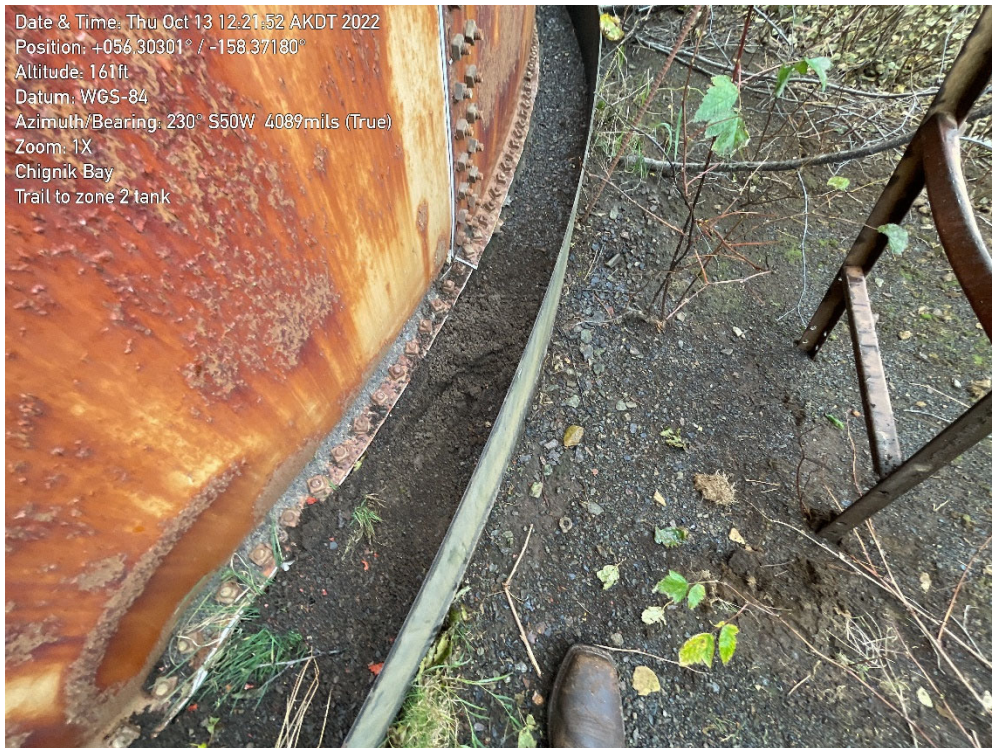
*Old East Side Water Storage Tank Foundation*

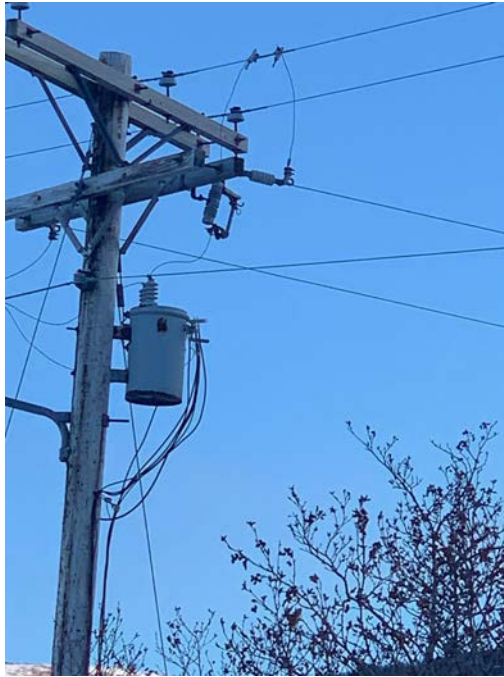
1 - Rusted Transformer

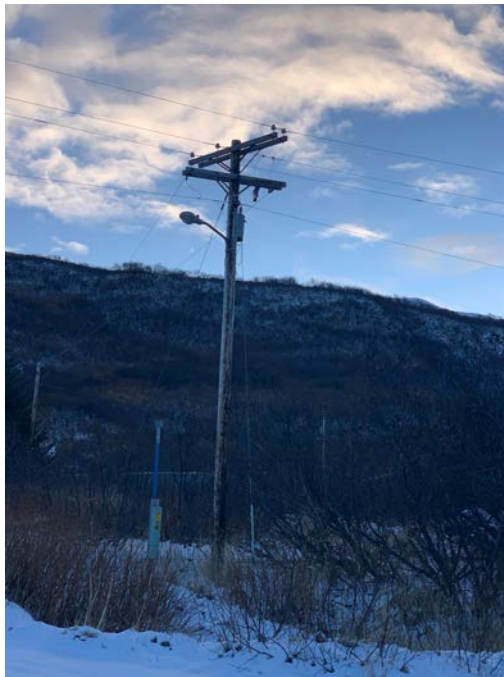
- The current system's cross arm design allows primary lines to contact one another during moderate winds resulting in frequent outages
- Timber overhead poles are weathered and beginning to split at their tops
- Many poles are leaning severely and several show evidence of scorching due to contact with conductors and failed insulators.
- As components break, they are replaced with what is readily available in the community which is sometimes different than the original component's kV rated class
- Many secondary service connections are improperly installed directly on the ground, unburied, and with no conduit posing a hazard to public safety
- Twelve out of fifteen streetlights do not work due to the installation of the wrong size conductors (size 14 installed, rather than size 4, which fails due to wind and sun exposure).

2 - Bleached Weathered Pole

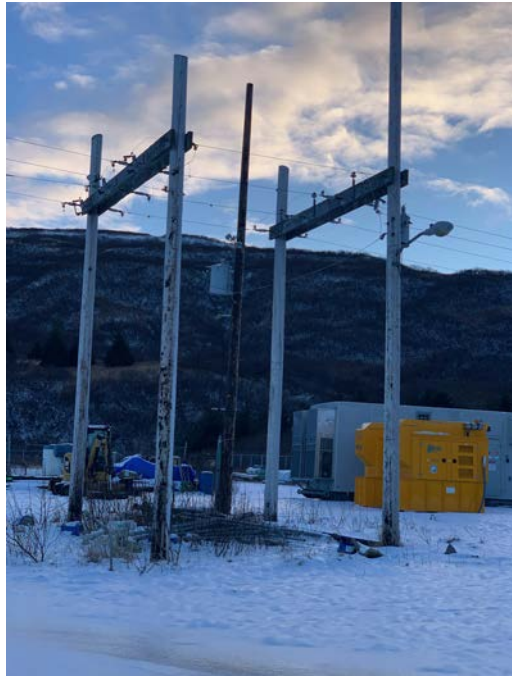
3 - Bleached Weathered Poles

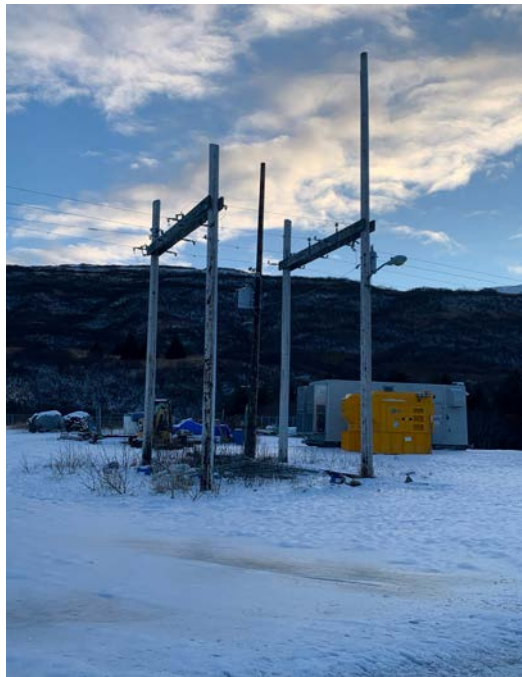
4 - Bleached Weathered Poles

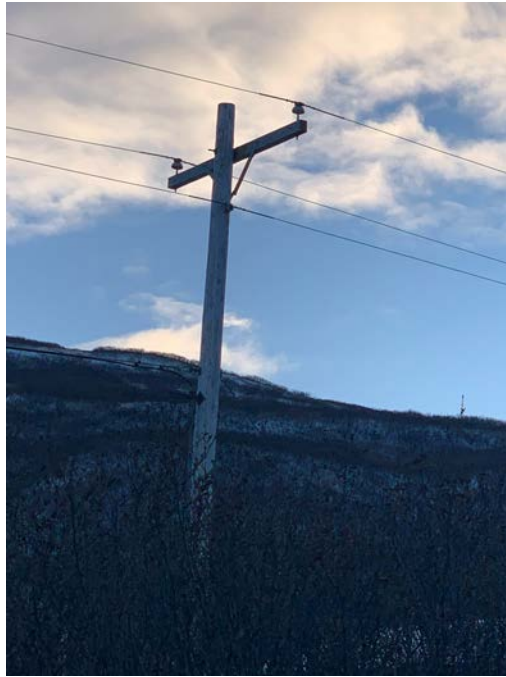
5 - Bleached Weathered Pole

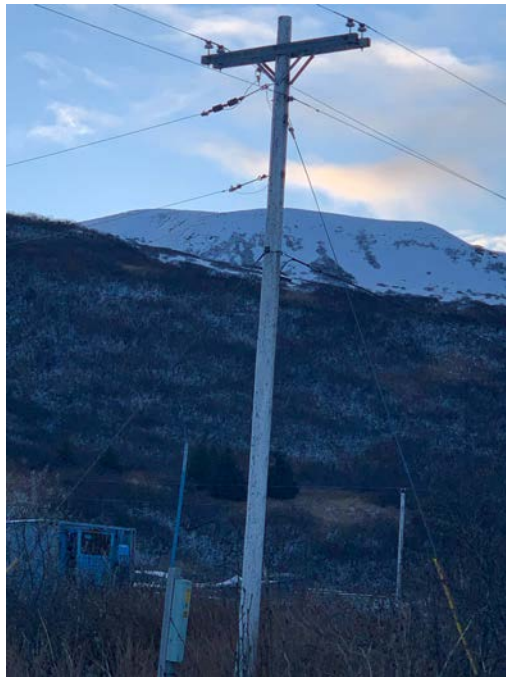
6 - Bleached Weathered Pole

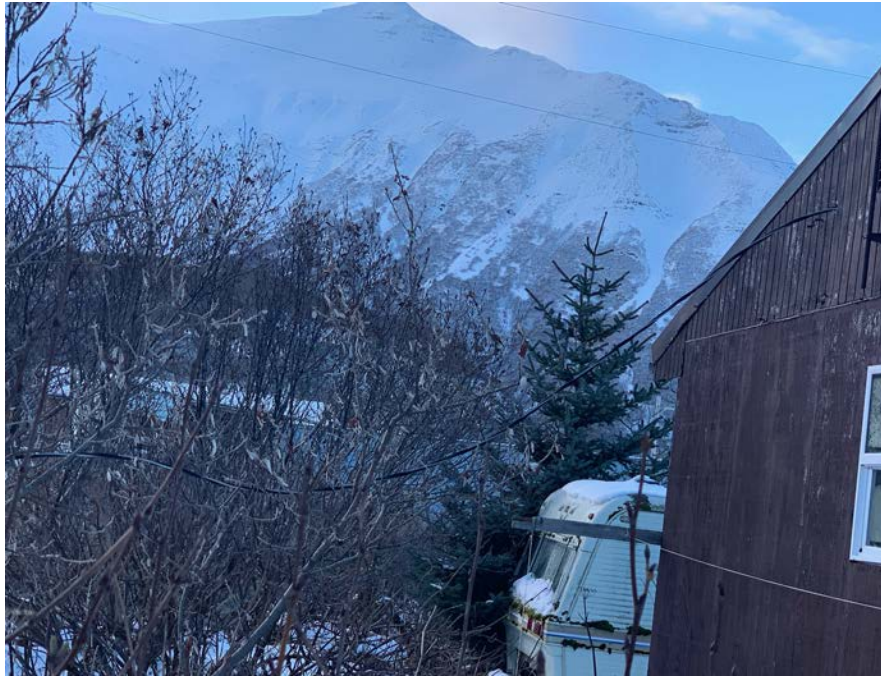
7 - Electric Service Line in Tree

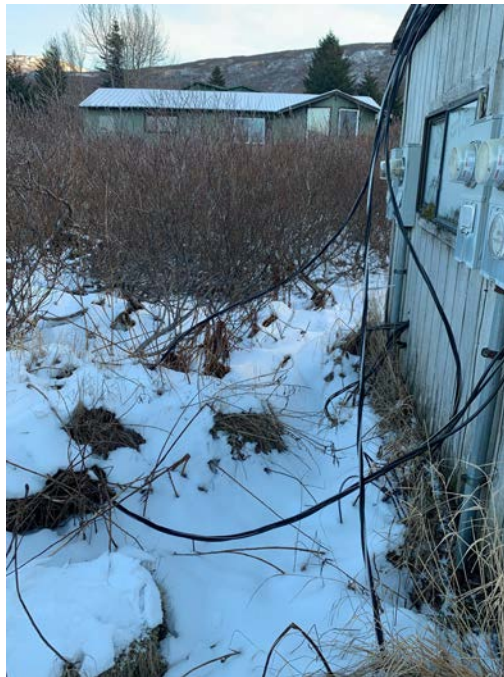
8 - Exposed Electric Service Line

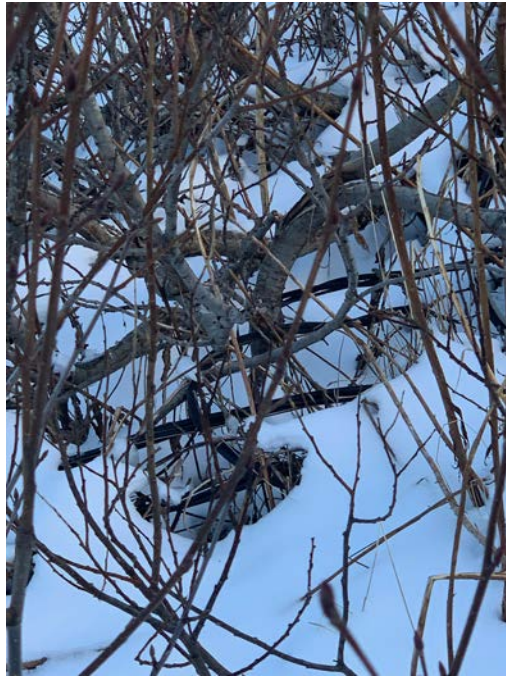
9 - Exposed Electric Service Line

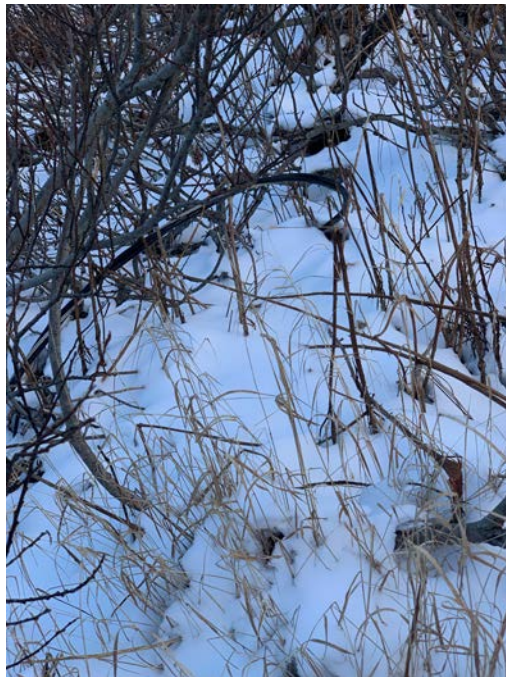
10 - Exposed Electric Service Line

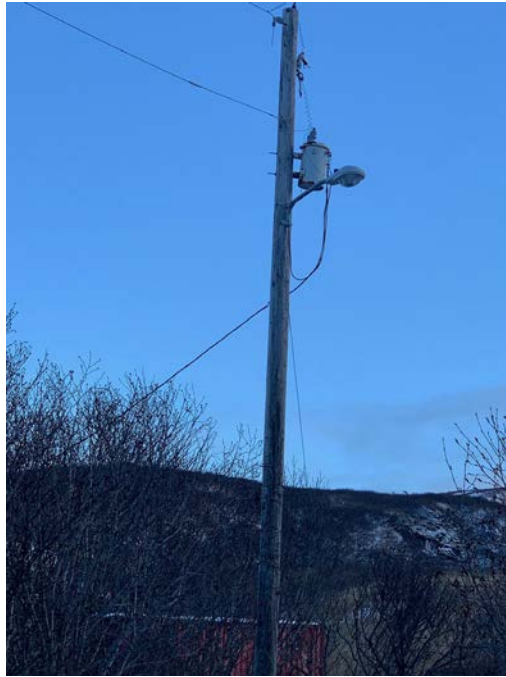
11 - Rusted Transformer

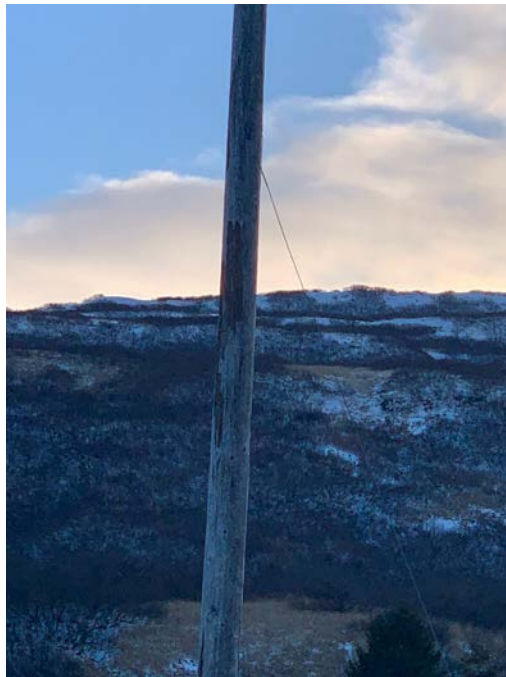
12 - Rotted Pole

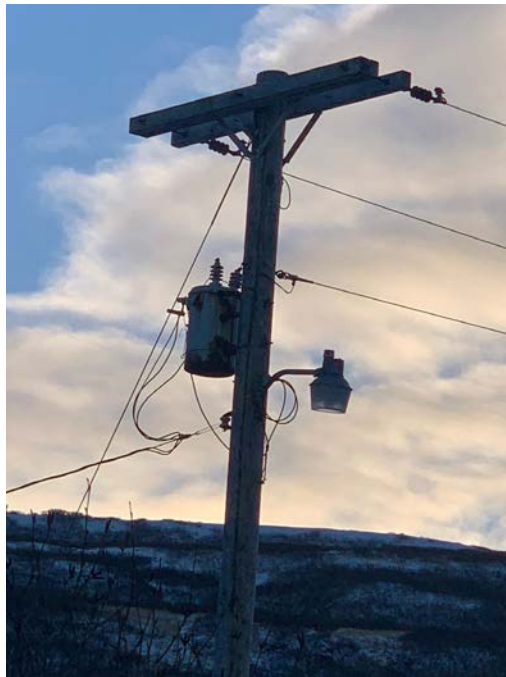
13 - Rusted Transformer

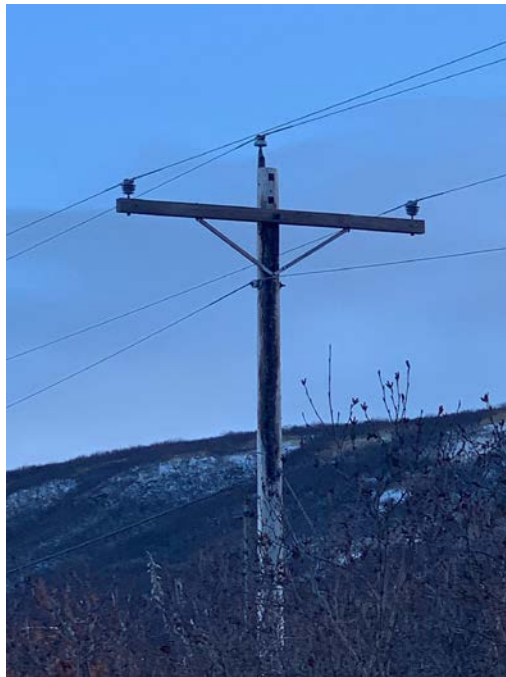
14 - New Cross Member from Prior Fire

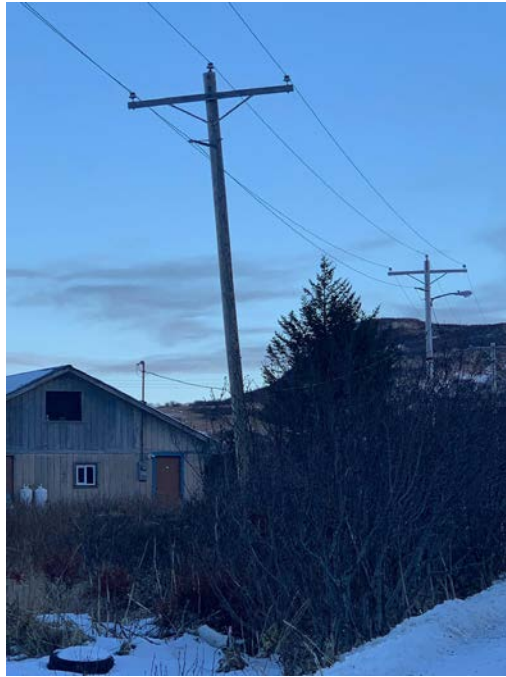
15 - Leaning Pole

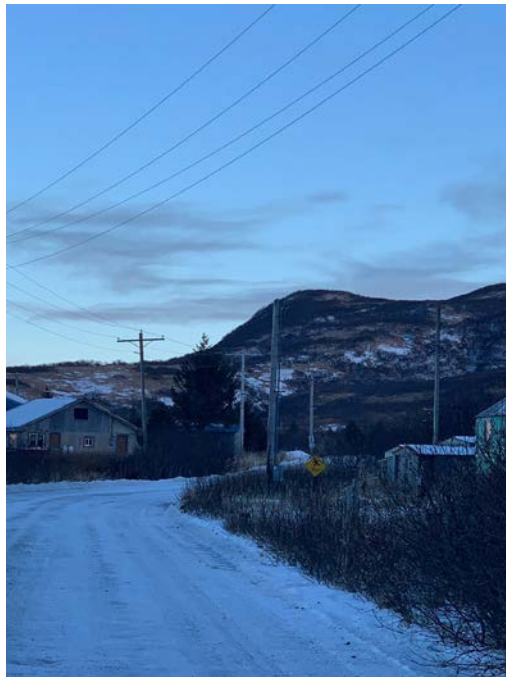
16 - Rotted Pole

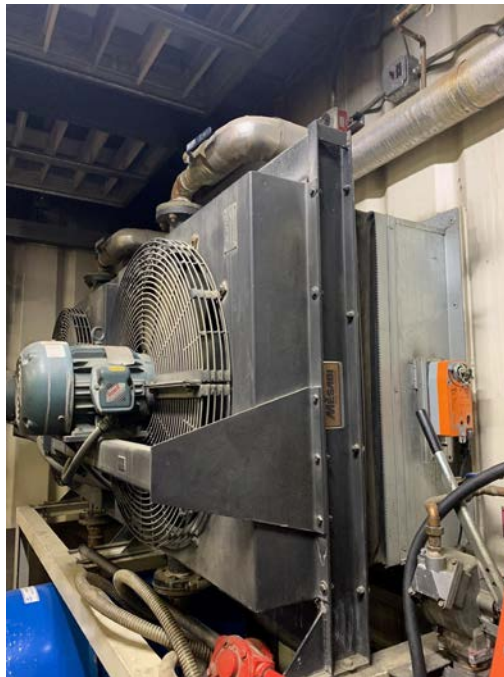
In addition to engine deficiencies, two radiators which connect to all three engines are plugged up with sediment build up and need to be replaced. Attempts to flush the radiators have been made with little success. Fuel tanks are also contaminated with red algae and sediment and need to be inspected and cleaned. A 1987 International bucket/utility truck used for electric distribution maintenance is not operational.

18 - Radiators and Fans

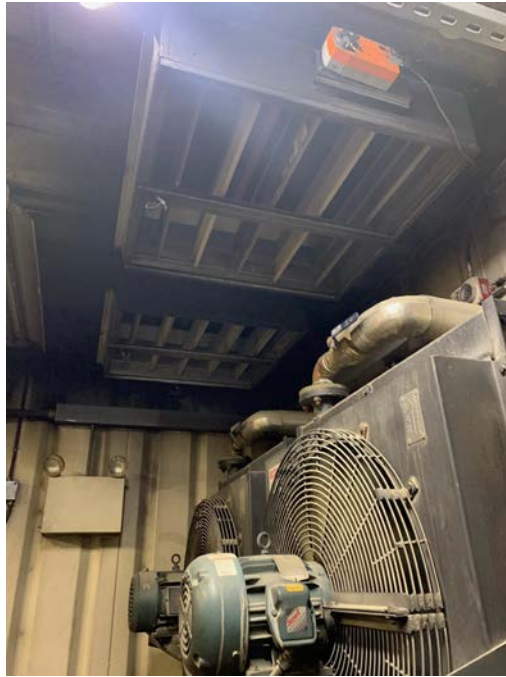
19 - Radiators and Fans

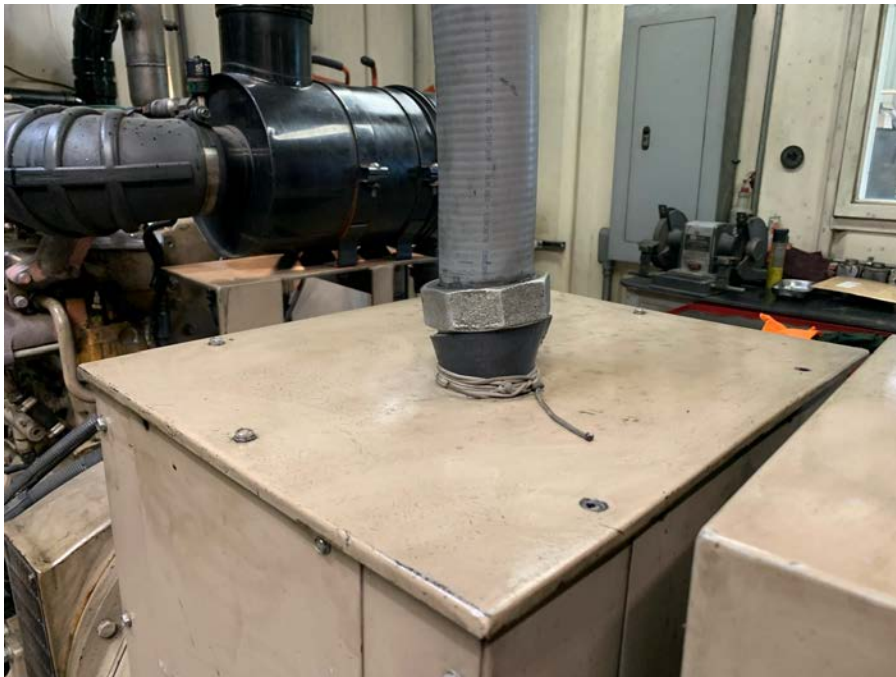
28 - #3 Generator Chafed Wire Temporary Fix
